Maintenance Rating Program

Triangle Expressway

2022 Second Quarter Report

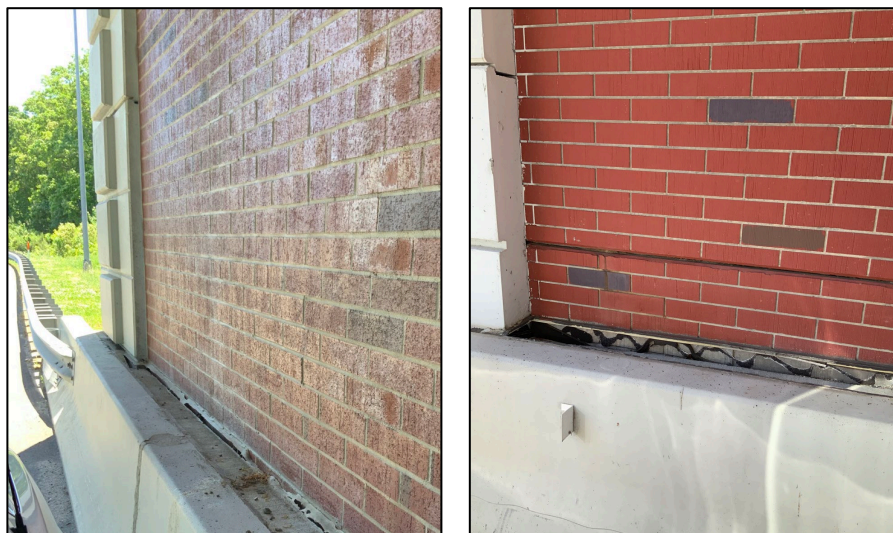
Figure 3: Retaining Walls and Sound Barrier Walls Inspection Results Sample

Retaining Walls and Sound Barrier Walls (75 rating –12 of the 16 assets passed): Three of the four wall sections that did not pass inspection had unsealed joints and scaling. Two of the sections that did not pass inspection are presented in **Figure 3**.

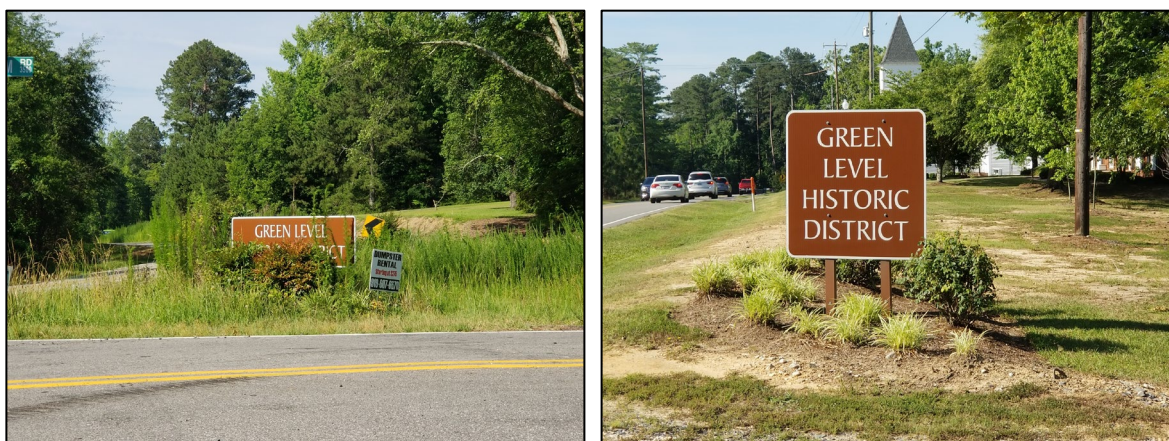
Figure 4: Green Level West Historic District Signs, Landscape Areas

As part of each quarterly inspection, an assessment team visits the two remaining Green Level Historic District signs to conduct a visual inspection of each sign and ensure they are in good standing. The two signs included in the inspection inventory were found to be in good condition. Of the two landscaped areas, one was well maintained while the other was overgrown and partially obstructed the sign text. **Figure 4** shows the two signs assessed.

This quarter, the two Green Level Historic District signs inspected were found to be in good condition. The landscaped area surrounding one of the two signs was found to be overgrown and in need of maintenance. The landscape area around the other sign on Green Level Church Road was found to be well maintained.

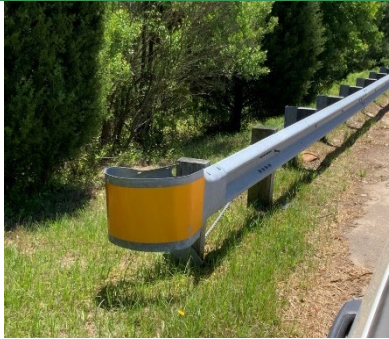
#	Material Type	Object ID	Failure Type	Photo	GIS Reference Page
1	Guardrail	BR_109	Missing Parts

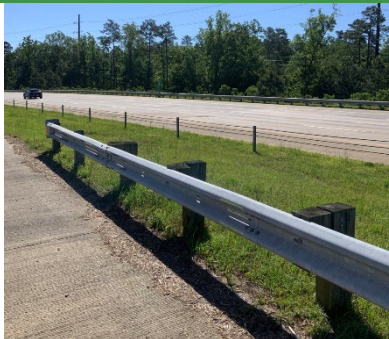
A14
2	Guardrail	BR_248	Twisted Blocks

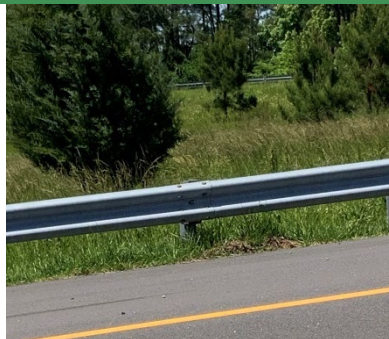
A5
3	Guardrail	BR_269	Missing Parts

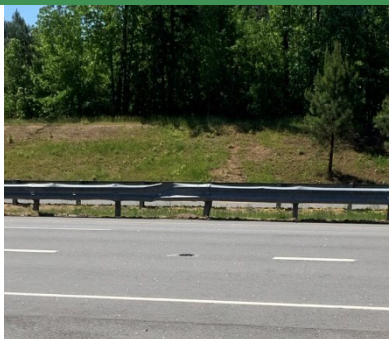
A3
4	Guardrail	BR_475	Functional Damage

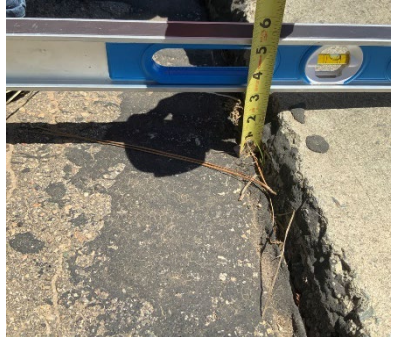
#	Material Type	Object ID	Failure Type	Photo	GIS Reference Page
1	Shoulder Berm Gutter	CG_18	Misalignment

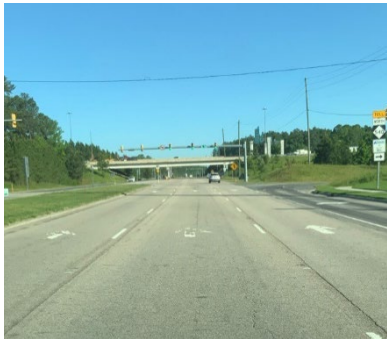
#	Material Type	Object ID	Failure Type	Photo	GIS Reference Page
1	Thru Lane	PS_412	Nighttime Reflectivity	 	A1
2	Left Turn	PS_421	Nighttime Reflectivity	 	A1
3	Left Turn	PS_431	Nighttime Reflectivity, Daytime Assessment	 	A6
4	Thru Lane	PS_443	Nighttime Reflectivity, Daytime Assessment
