Maintenance Rating Program Monroe Expressway

Quarter 3 MRP Assessment

November 2022

NCTA Monroe By-Pass Roadway Maintenance Performance Rating Program; Q3, FY 2022 Rating

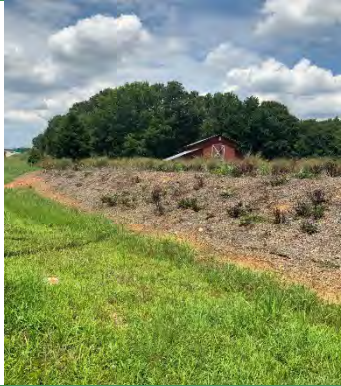
#	Material Type	Object ID	Failure Type	Photo	GIS Reference Page
1	Plant Bed	PB_31	Health

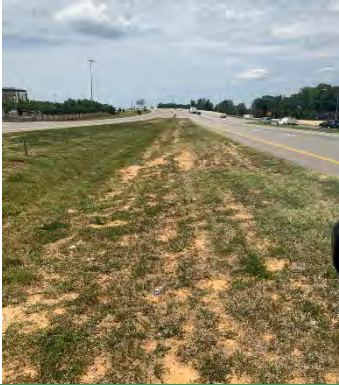
Turf scored a 65 in the survey. Deficiencies of the turf were directly related to bare ground. The MRP Maintenance and Evaluation Standards V7 are below.

#	Material Type	Object ID	Failure Type	Photo	GIS Reference Page
1	Turf	TF_113	Bare Ground

Seeding and fertilizing efforts were last performed in the Spring of 2022. Seeding and fertilizer applications are conducted biannually in both the spring and fall months. It is recommended that the maintenance provider continue with a consistent application of this schedule along with spot seeding as needed.

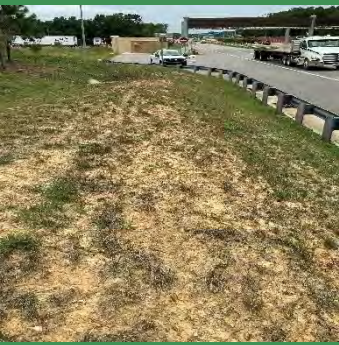
B1
2	Turf	TF_163	Bare Ground
