# Maintenance Rating Program

## Triangle Expressway

November 2022

2022 Third Quarter Report

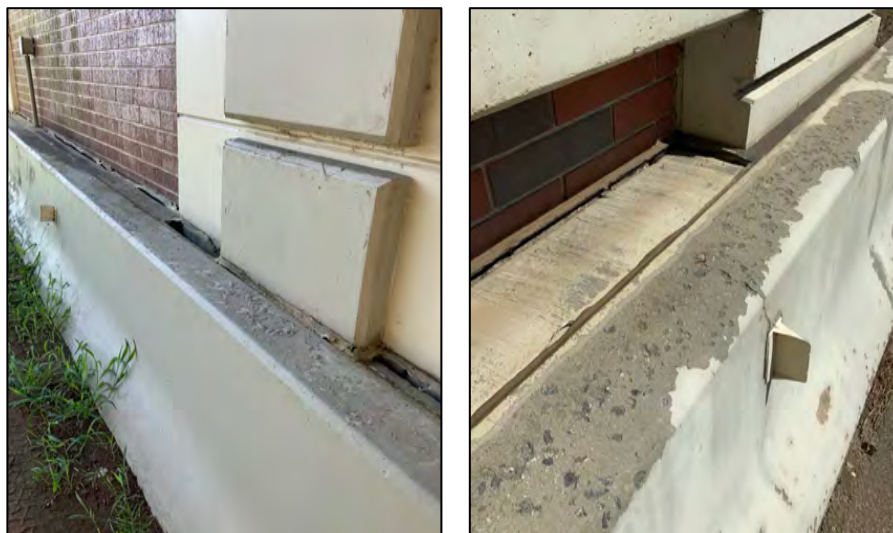
**Figure 3: Retaining Walls and Sound Barrier Walls Inspection Results Sample**

Retaining Walls and Sound Barrier Walls (75 rating –12 of the 16 assets passed): The four wall sections that did not pass inspection had unsealed joints. Two of the sections that did not pass inspection are presented in *Figure 3*.

- 1) Walls shall be inspected during daily patrols.
- 2) Unwanted vegetation and graffiti (see graffiti standard) shall be scheduled for removal.
- 3) Minor wall or column damage shall be scheduled for repair within the annual work program.
- 4) Staining damage shall be scheduled for repair within the annual work program.
- 5) Any structural damage that poses a safety risk shall be scheduled immediately upon observation. Mitigate any safety hazard upon observation.

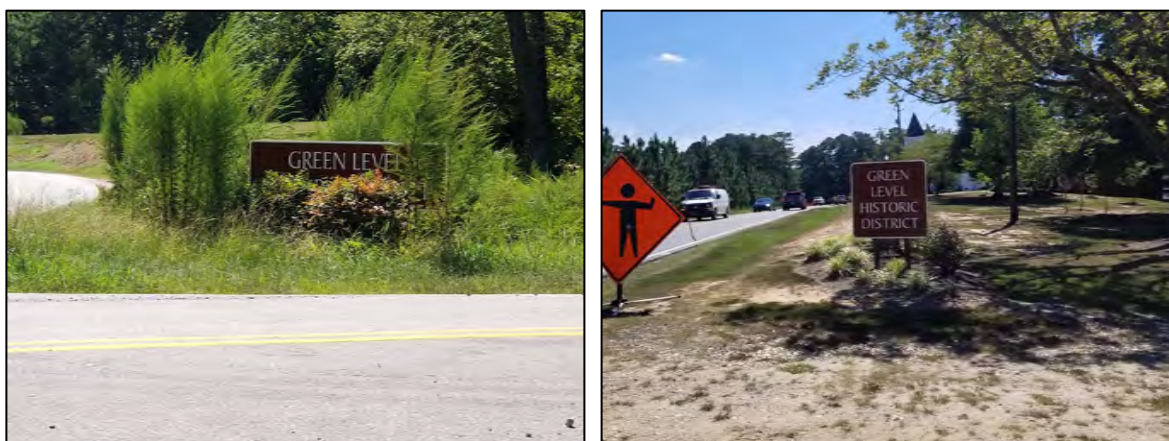
Figure 5: Green Level West Historic District Signs, Landscape Areas

As part of each quarterly inspection, an assessment team visits the two remaining Green Level Historic District signs to conduct a visual inspection of each sign and ensure they are in good standing. The two signs included in the inspection inventory were found to be in good condition. Of the two landscaped areas, one was well maintained while the other was overgrown and partially obstructed the sign text. **Figure 5** shows the two signs assessed.

This quarter, the two Green Level Historic District signs inspected were found to be in good condition. The landscaped area surrounding one of the two signs was found to be overgrown and in need of maintenance. The landscape area around the other sign on Green Level Church Road was found to be well maintained.

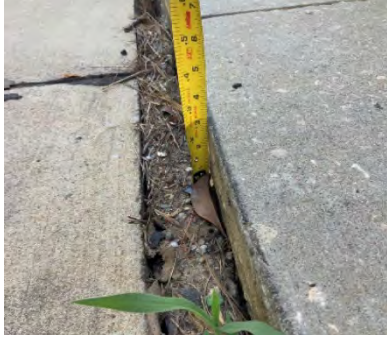
#	Material Type	Object ID	Failure Type	Photo	GIS Reference Page
1	Shoulder Berm Gutter	CG_52	Settlement

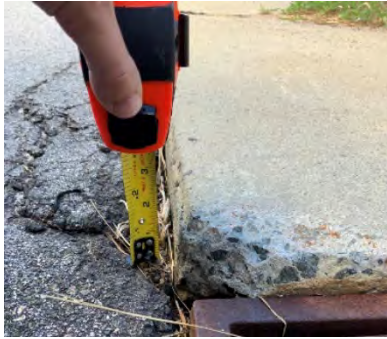
A11
2	Shoulder Berm Gutter	CG_153	Settlement

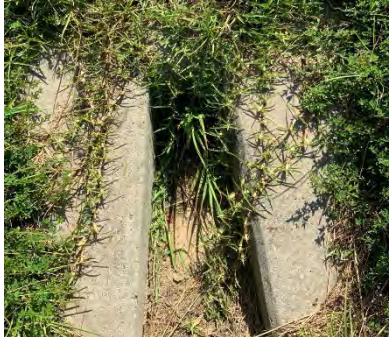
#	Material Type	Object ID	Failure Type	Photo	GIS Reference Page
1	Shoulder Drain	MDP_20	Obstruction

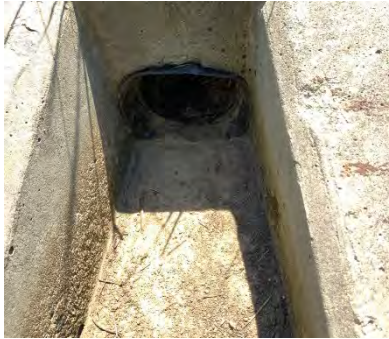
A9
2	Shoulder Drain	MDP_74	Rodent Screen

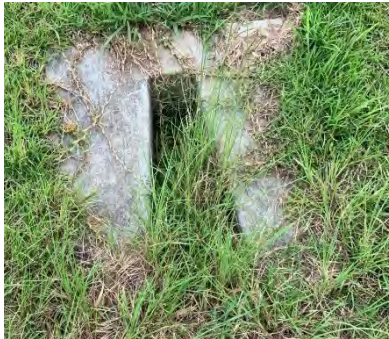
A15
3	Shoulder Drain	MDP_89	Obstruction

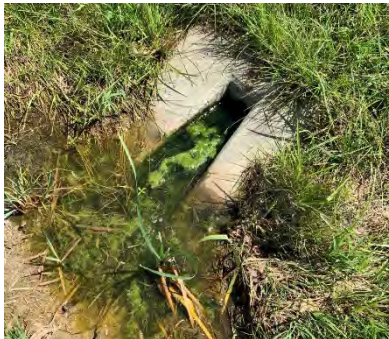
A17
4	Shoulder Drain	MDP_95	Obstruction

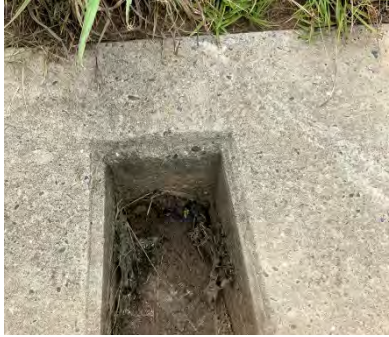
#	Material Type	Object ID	Failure Type	Photo	GIS Reference Page
5	Shoulder Drain	MDP_232	Obstruction

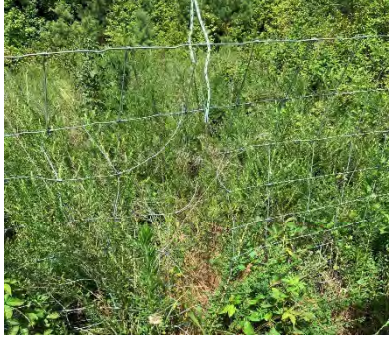
#	Material Type	Object ID	Failure Type	Photo	GIS Reference Page
1	Woven	FN_93	Fence Hole

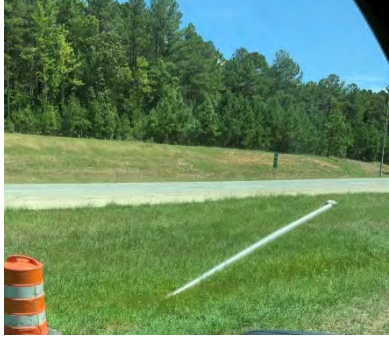
#	Material Type	Object ID	Failure Type	Photo	GIS Reference Page
1	Double Roadway	HL_43	Functional Damage

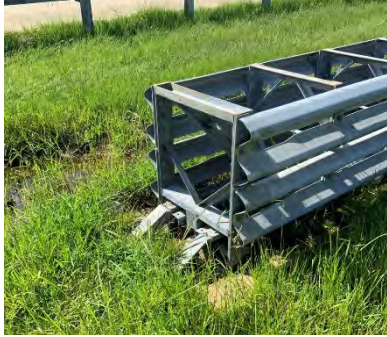
#	Material Type	Object ID	Failure Type	Photo	GIS Reference Page
1	Impact Attenuator	IA_12	Functional Damage

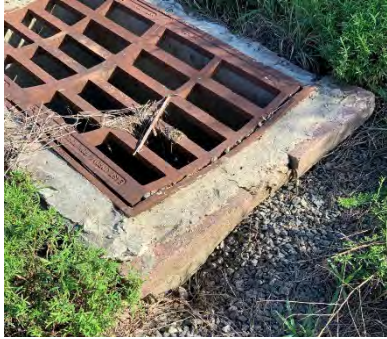
#	Material Type	Object ID	Failure Type	Photo	GIS Reference Page
1	Inlet	IN_523	Eroded Area

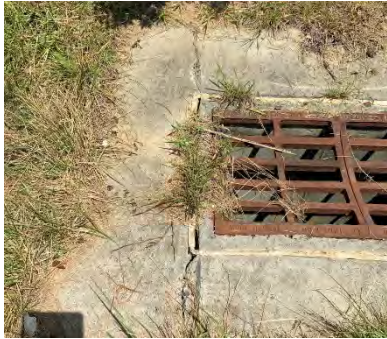
A35
2	Inlet	IN_635	Surface Damage

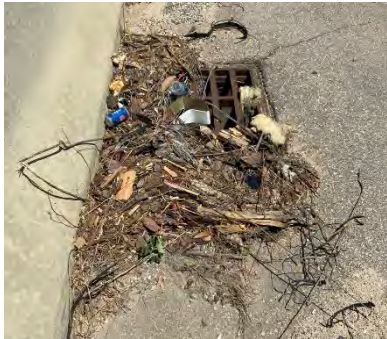
A20
3	Inlet	IN_767	Obstruction

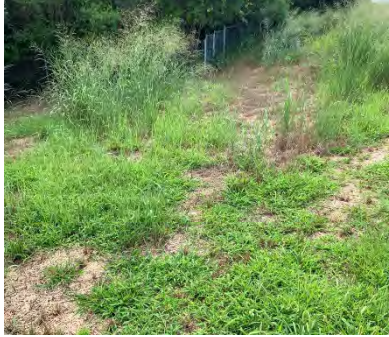
#	Material Type	Object ID	Failure Type	Photo	GIS Reference Page
1	Plant Bed	PB_47	Weeds

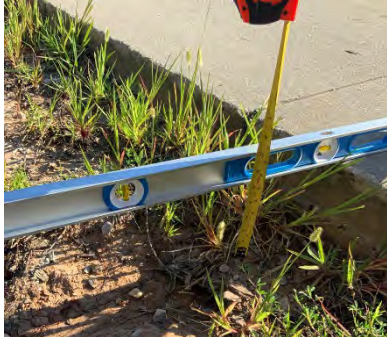
#	Material Type	Object ID	Failure Type	Photo	GIS Reference Page
1	Concrete	LS_148	Drop Off

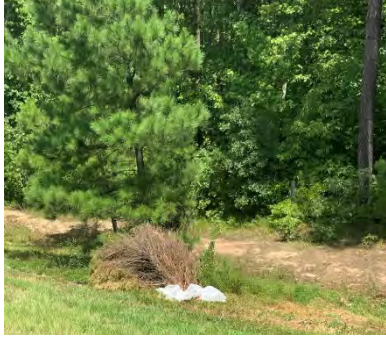
#	Material Type	Object ID	Failure Type	Photo	GIS Reference Page
1	Concrete	LS_101	Litter

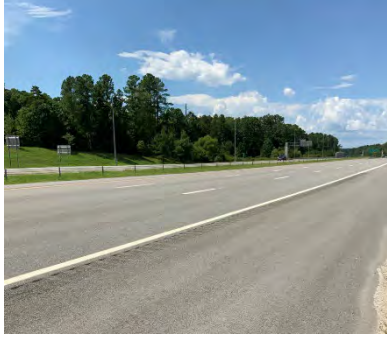
#	Material Type	Object ID	Failure Type	Photo	GIS Reference Page
1	Asphalt	LS_248	Nighttime Reflectivity

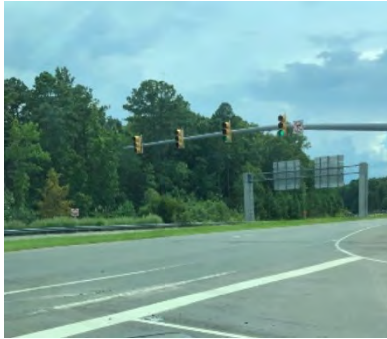
#	Material Type	Object ID	Failure Type	Photo	GIS Reference Page
1	Ped Xing	PS_137	Nighttime Reflectivity, Daytime Assessment

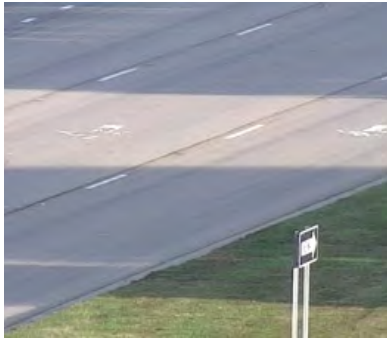
A34
2	Right Turn	PS_418	Nighttime Reflectivity	Not Available for Nighttime Failures	A1
3	Thru Lane	PS_444	Daytime Assessment

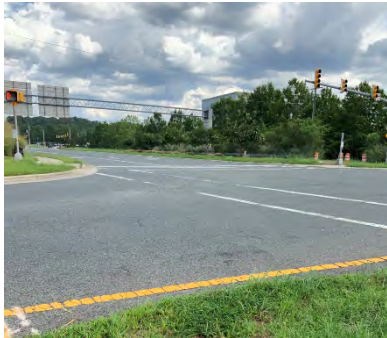
A6
4	Ped Xing	PS_527	Nighttime Reflectivity, Daytime Assessment

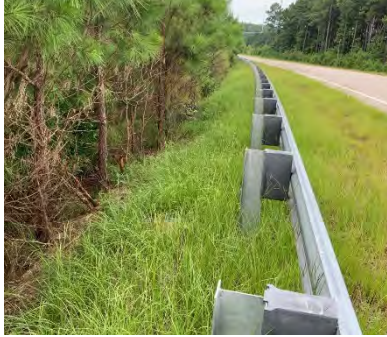
#	Material Type	Object ID	Failure Type	Photo	GIS Reference Page
1	Tree and Brush	TB_130	Barrier Clearance

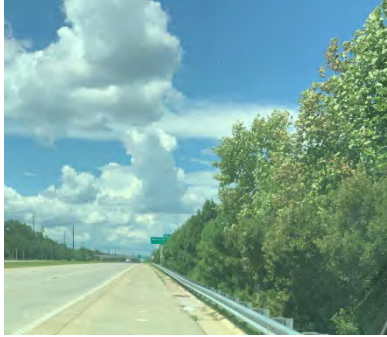
A27
2	Tree and Brush	TB_327	Sign Obstruction

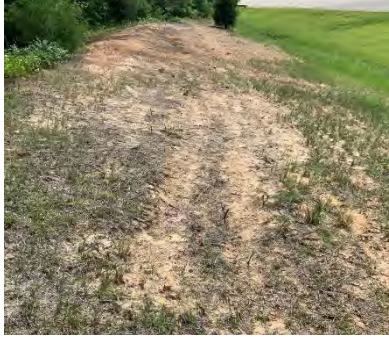
#	Material Type	Object ID	Failure Type	Photo	GIS Reference Page
5	Turf	TF_581	Bare Ground

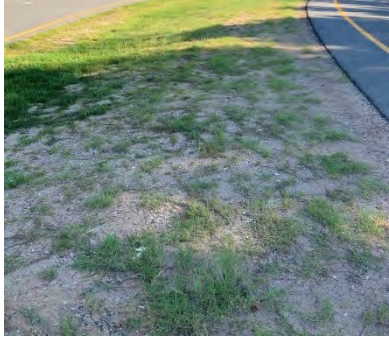
A12
6	Turf	TF_1073	Bare Ground
