Maintenance Rating Program Monroe Expressway

Quarter 4 MRP Assessment

February 2023

NCTA Monroe By-Pass Roadway Maintenance Performance Rating Program; Q4, CY 2022 Rating

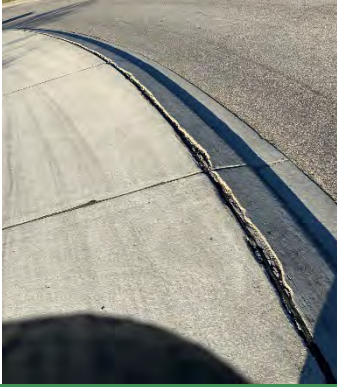
#	Material Type	Object ID	Failure Type	Photo	GIS Reference Page
1	Concrete	CG_120	Cracking

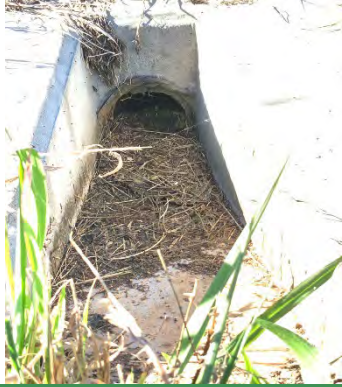
#	Material Type	Object ID	Failure Type	Photo	GIS Reference Page
1	Concrete	MDD_65	Obstruction

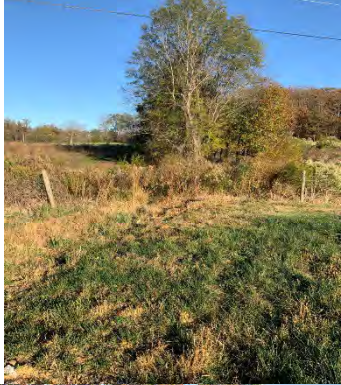
#	Material Type	Object ID	Failure Type	Photo	GIS Reference Page
1	Woven	FN_13	Hole

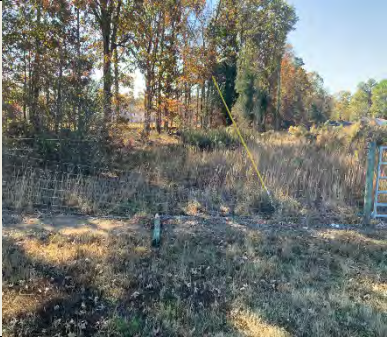
A9
2	Woven	FN_25	Hole

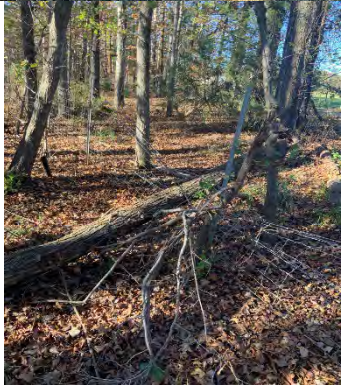
A15
3	Woven	FN_162	Hole

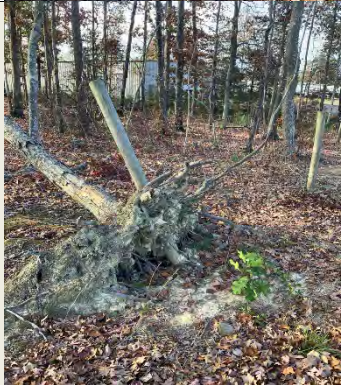
A15
4	Woven	FN_228	Hole

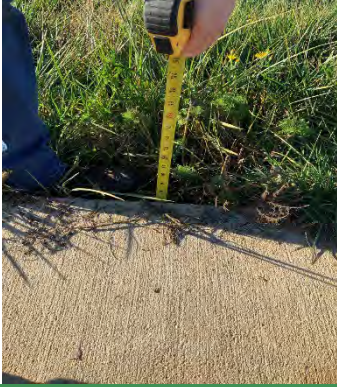
#	Material Type	Object ID	Failure Type	Photo	GIS Reference Page
1	Concrete	IN_475	Erosion

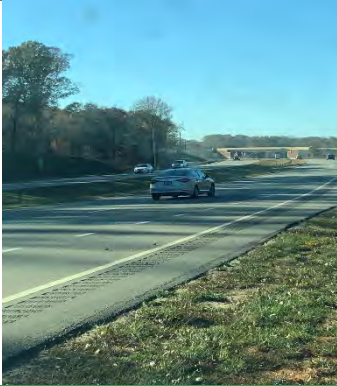
#	Material Type	Object ID	Failure Type	Photo	GIS Reference Page
1	Asphalt	LS_381	Cracking

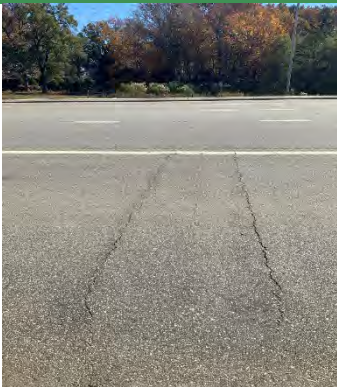
A14
2	Asphalt	LS_408	Markers

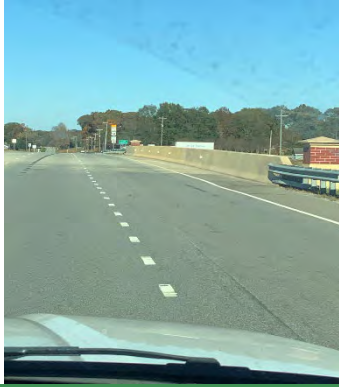
#	Material Type	Object ID	Failure Type	Photo	GIS Reference Page
1	Asphalt	LS_477	Missing Markers

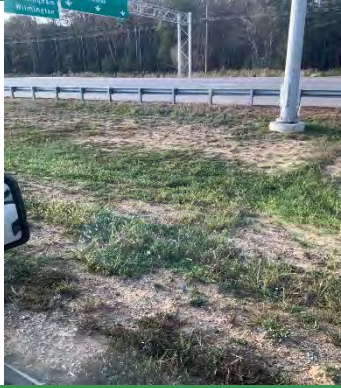
#	Material Type	Object ID	Failure Type	Photo	GIS Reference Page
1	Turf	TF_133	Bare Ground

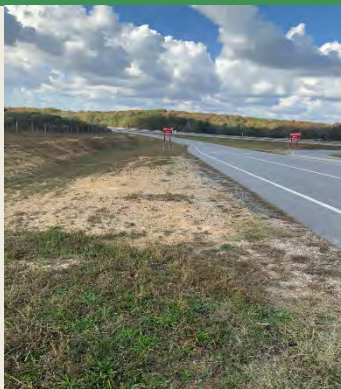
A1
2	Turf	TF_227	Bare Ground

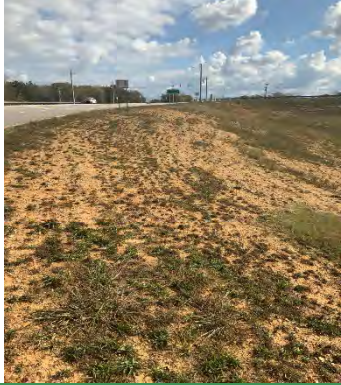
A4
3	Turf	TF_241	Bare Ground

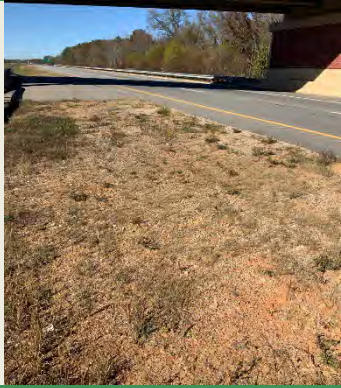
#	Material Type	Object ID	Failure Type	Photo	GIS Reference Page
4	Turf	TF_333	Bare Ground

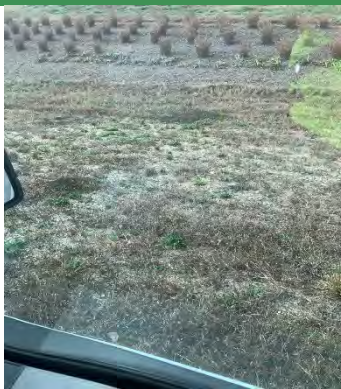
A15 & A16
5	Turf	TF_500	Bare Ground

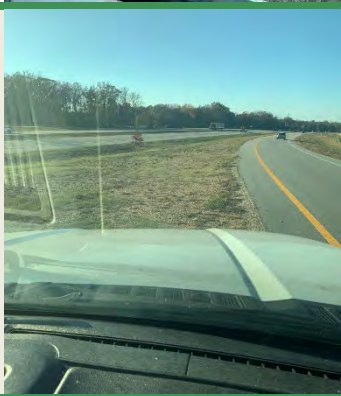
A7
6	Turf	TF_506	Bare Ground

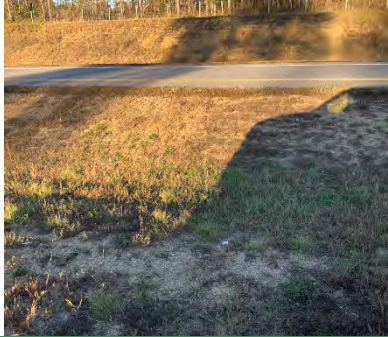
#	Material Type	Object ID	Failure Type	Photo	GIS Reference Page
7	Turf	TF_515	Bare Ground

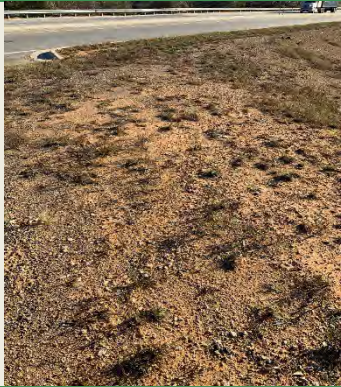
A7
8	Turf	TF_554	Bare Ground
