Maintenance Rating Program

Triangle Expressway

2022 Fourth Quarter Report

NCTA Triangle Expressway Roadway Maintenance Performance Rating Program; Q4, CY 2022 Rating

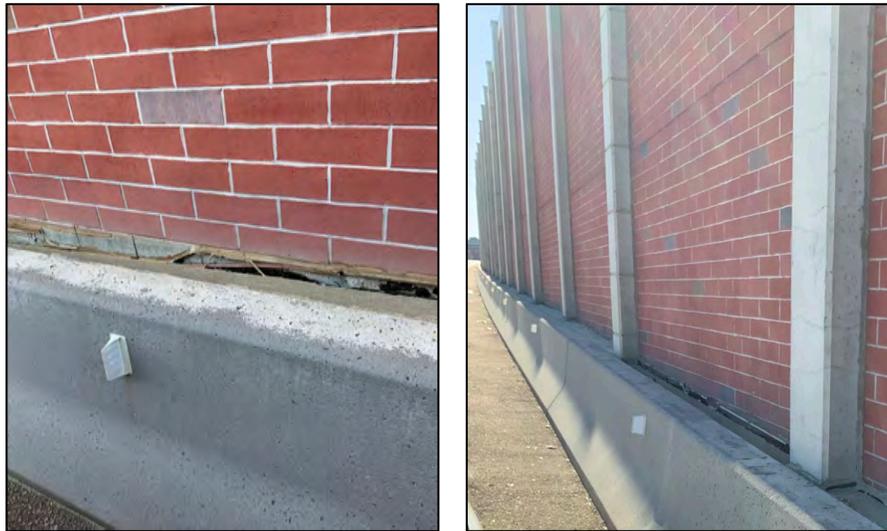
Figure 3: Retaining Walls and Sound Barrier Walls Inspection Results Sample

Retaining Walls and Sound Barrier Walls (75 rating –12 of the 16 assets passed): The four wall sections that did not pass inspection had unsealed joints. Two of the sections that did not pass inspection are presented in *Figure 3*.

- 1) Walls shall be inspected during daily patrols.
- 2) Unwanted vegetation and graffiti (see graffiti standard) shall be scheduled for removal.
- 3) Minor wall or column damage shall be scheduled for repair within the annual work program.
- 4) Staining damage shall be scheduled for repair within the annual work program.
- 5) Any structural damage that poses a safety risk shall be scheduled immediately upon observation. Mitigate any safety hazard upon observation.

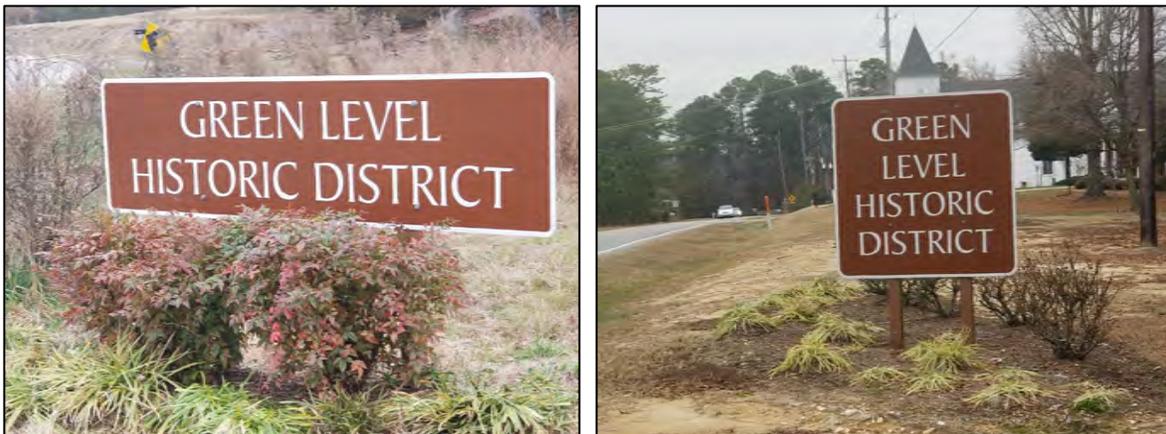
Figure 4: Green Level West Historic District Signs, Landscape Areas

As part of each quarterly inspection, an assessment team visits the two remaining Green Level Historic District signs to conduct a visual inspection of each sign and ensure they are in good standing. The two signs included in the inspection inventory were found to be in good condition. *Figure 4* shows the two signs assessed.

This quarter, the two Green Level Historic District signs inspected were found to be in good condition. Additionally, the landscaped areas surrounding the signs were found to be well maintained.

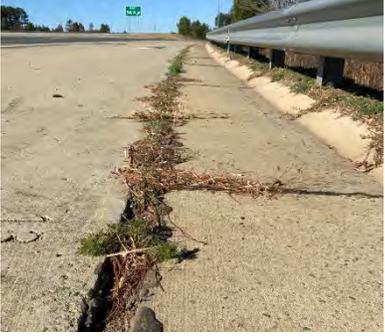
#	Material Type	Object ID	Failure Type	Photo	GIS Reference Page
1	Shoulder Berm Gutter	CG_16	Misalignment

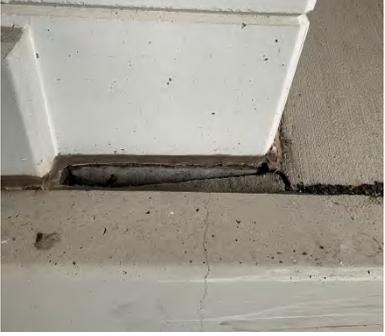
#	Material Type	Object ID	Failure Type	Photo	GIS Reference Page
1	Overpass Support	DS_277	Unsealed Cracks/Joints

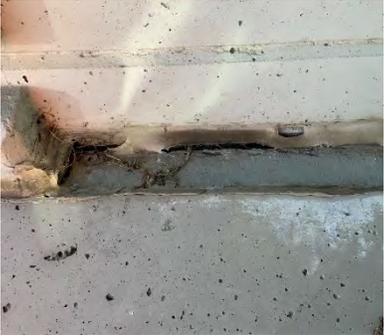
A29
2	Overpass Support	DS_281	Unsealed Cracks/Joints

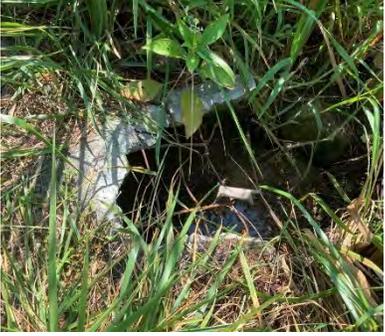
#	Material Type	Object ID	Failure Type	Photo	GIS Reference Page
1	Cross Pipe	DP_380	End Protection Damage

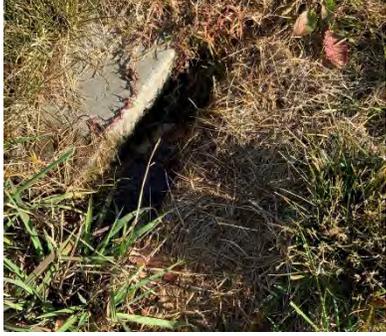
#	Material Type	Object ID	Failure Type	Photo	GIS Reference Page
1	Shoulder Drain	MDP_111	Obstruction

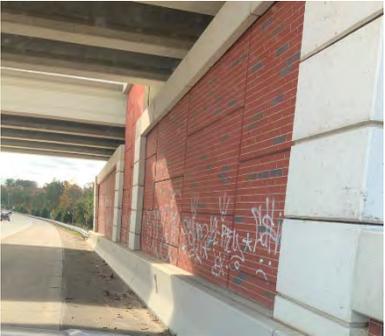
#	Material Type	Object ID	Failure Type	Photo	GIS Reference Page
1	Bridge Wall	GR_1	Graffiti

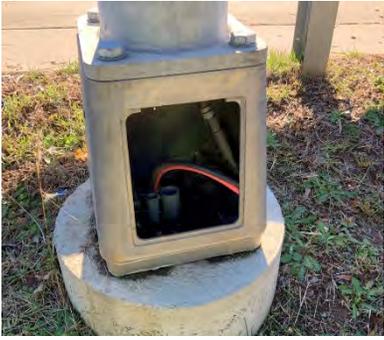
#	Material Type	Object ID	Failure Type	Photo	GIS Reference Page
1	Single Roadway	HL_8	Missing Part

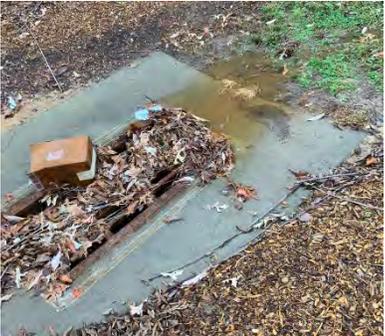
#	Material Type	Object ID	Failure Type	Photo	GIS Reference Page
1	Inlet	IN_52	Obstruction

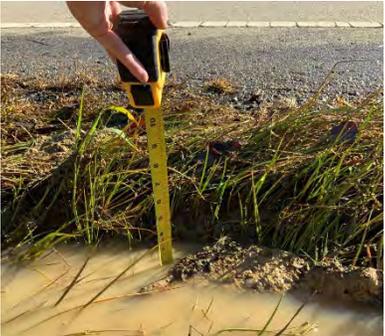
#	Material Type	Object ID	Failure Type	Photo	GIS Reference Page
1	Asphalt	LS_521	Drop-Off

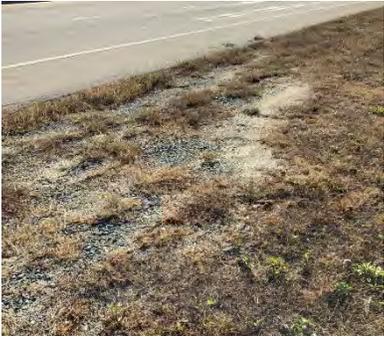
#	Material Type	Object ID	Failure Type	Photo	GIS Reference Page
1	Turf	TF_232	Bare Ground

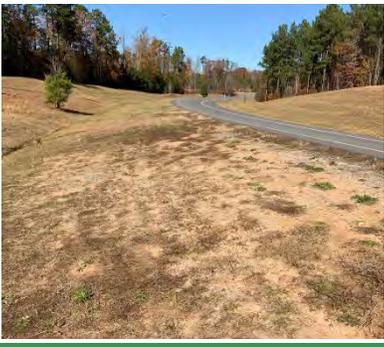
A26
4	Turf	TF_354	Bare Ground

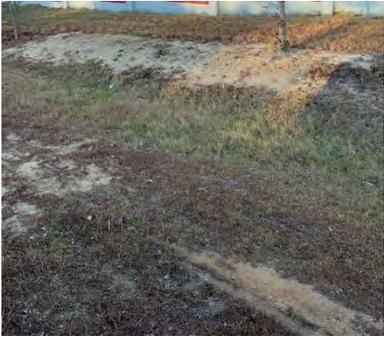
#	Material Type	Object ID	Failure Type	Photo	GIS Reference Page
5	Turf	TF_449	Bare Ground

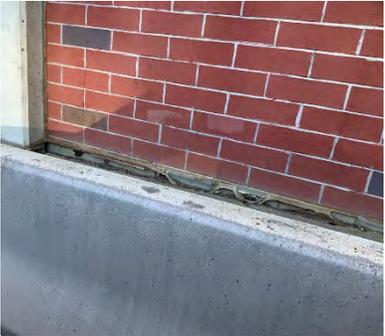
#	Material Type	Object ID	Failure Type	Photo	GIS Reference Page
1	Sound Wall	WL_47	Unsealed Cracks/Joints
