Maintenance Rating Program

Triangle Expressway

2023 First Quarter Report

NCTA Triangle Expressway Roadway Maintenance Performance Rating Program; Q1, FY 2023 Rating

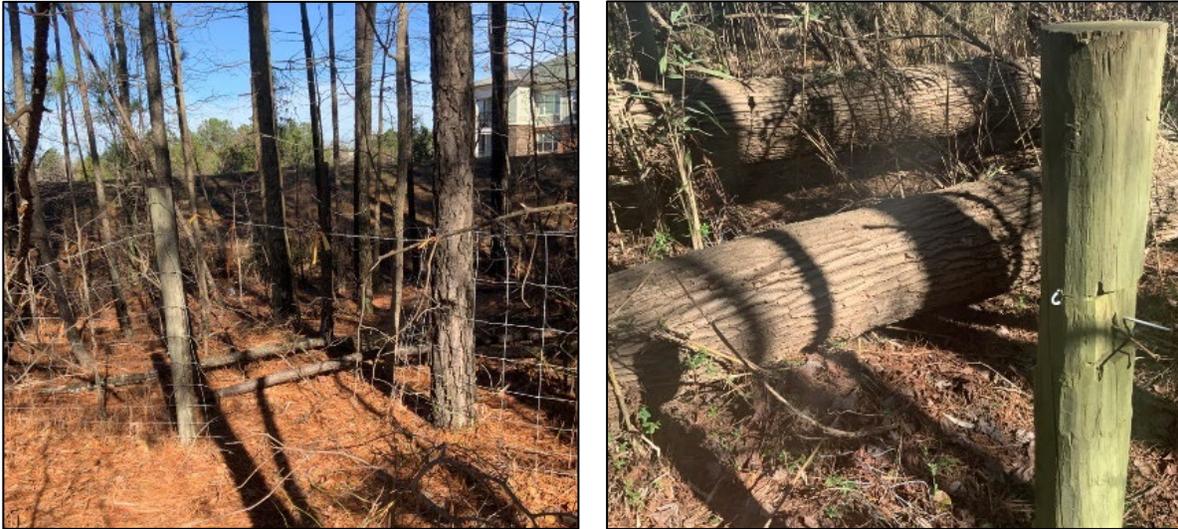
Figure 3: Fences and Control Access Inspection Results Sample

Fence and Control Access (71 rating – 20 of the 28 assets passed): Five of the eight wall sections that did not pass had failed for height. Two of the sections that did not pass inspection are presented in *Figure 3*.

Fence repair was ongoing through February and March when the inspection was occurring.

- 1) Fence shall be inspected every 4 months.
- 2) Areas where fence is adjacent to livestock or known pedestrian traffic must be secured until fence is fully restored.
- 3) Schedule and repair or replace damaged sections within the annual work program.

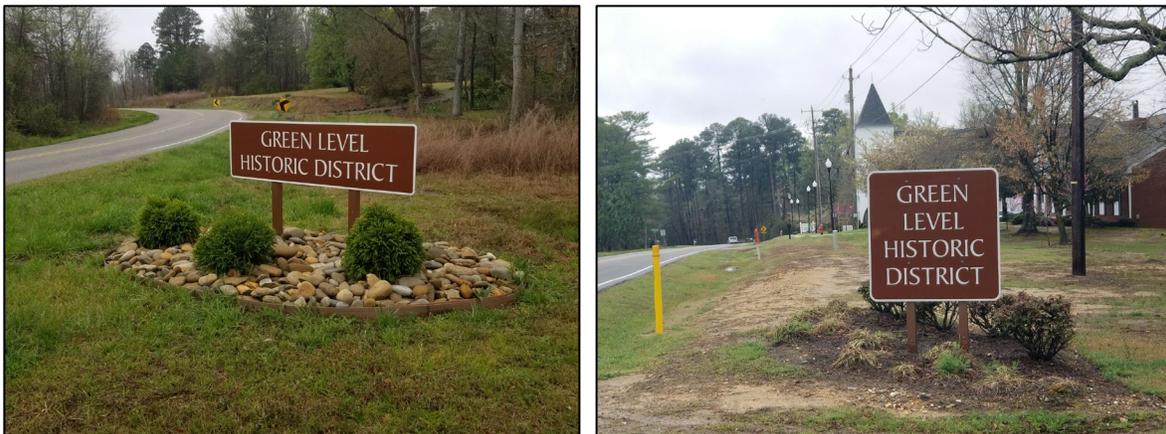
Figure 4: Green Level West Historic District Signs, Landscape Areas

As part of each quarterly inspection, an assessment team visits the two remaining Green Level Historic District signs to conduct a visual inspection of each sign and ensure they are in good standing. The two signs included in the inspection inventory were found to be in good condition. *Figure 4* shows the two signs assessed.

This quarter, the two Green Level Historic District signs inspected were found to be in good condition. Additionally, the landscaped areas surrounding the signs were found to be well maintained.

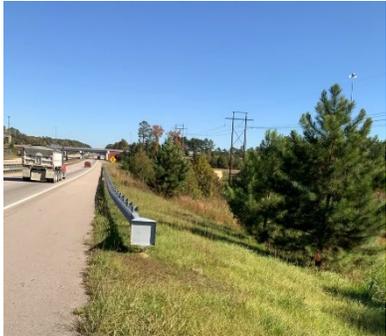
#	Material Type	Object ID	Failure Type	Photo	GIS Reference Page
1	Guardrail	BR_498	Missing Part

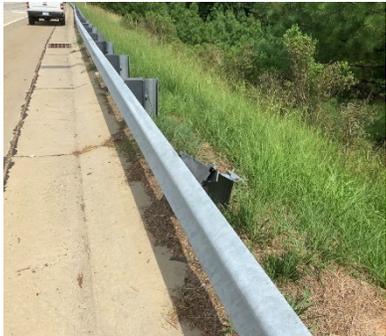
A24
2	Guardrail	BR_657	Post Damage

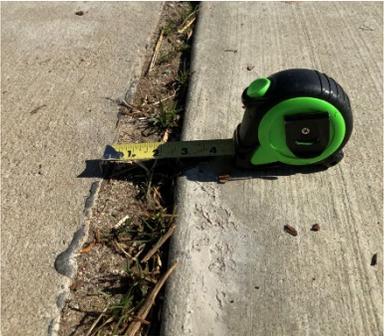
#	Material Type	Object ID	Failure Type	Photo	GIS Reference Page
1	Shoulder Berm Gutter	CG_4	Misalignment

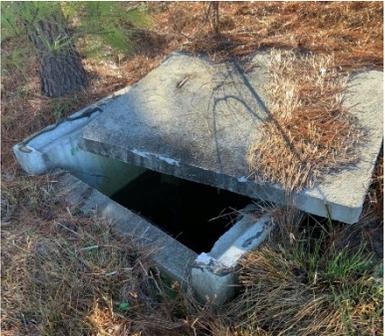
#	Material Type	Object ID	Failure Type	Photo	GIS Reference Page
1	Drain	DP_227	End Protection

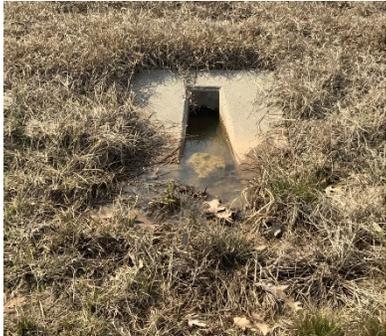
#	Material Type	Object ID	Failure Type	Photo	GIS Reference Page
1	Shoulder Drain	MDP_41	End Damage

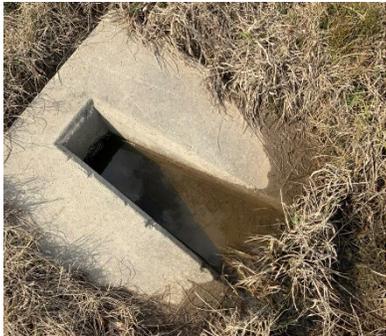
A10
2	Shoulder Drain	MDP_53	End Damage

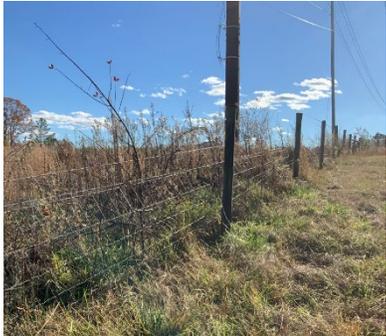
#	Material Type	Object ID	Failure Type	Photo	GIS Reference Page
1	Woven	FN_63	Height

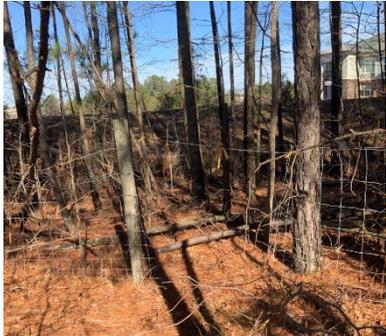
#	Material Type	Object ID	Failure Type	Photo	GIS Reference Page
5	Woven	FN_310	Fence Hole

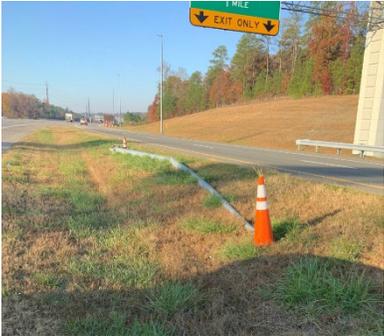
#	Material Type	Object ID	Failure Type	Photo	GIS Reference Page
1	Double Roadway	HL_142	Functional Damage

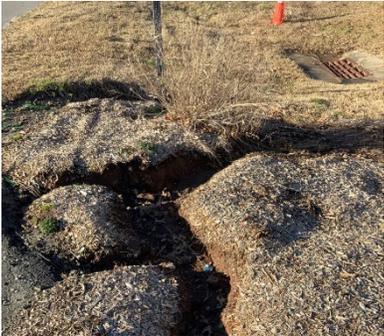
#	Material Type	Object ID	Failure Type	Photo	GIS Reference Page
1	Plant Bed	PB_37	Health

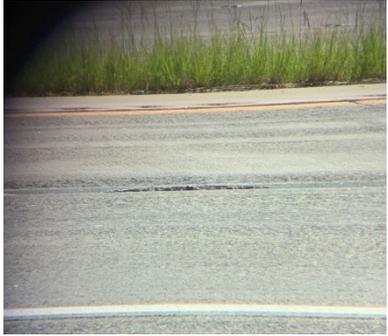
#	Material Type	Object ID	Failure Type	Photo	GIS Reference Page
1	Concrete	LS_462	Pothole

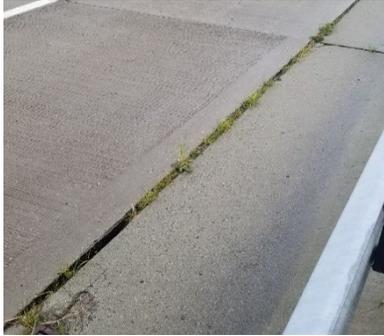
#	Material Type	Object ID	Failure Type	Photo	GIS Reference Page
1	Concrete	LS_318	Joint Separation

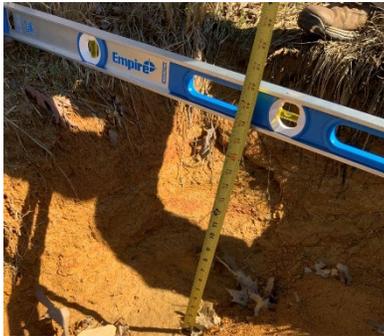
#	Material Type	Object ID	Failure Type	Photo	GIS Reference Page
1	Concrete	LS_456	Ditch Erosion

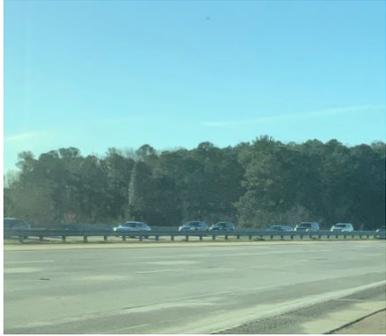
#	Material Type	Object ID	Failure Type	Photo	GIS Reference Page
1	Concrete	LS_43	Missing

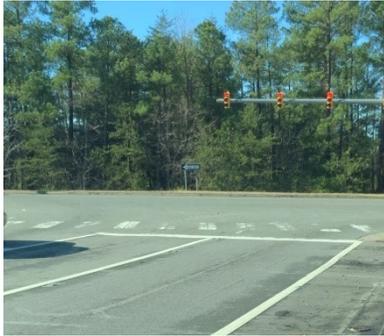
#	Material Type	Object ID	Failure Type	Photo	GIS Reference Page
1	Right Turn	PS_469	Nighttime Reflectivity	Not Available for Nighttime Failures	A5, A6
2	Ped Xing	PS_499	Nighttime Reflectivity, Daytime Assessment

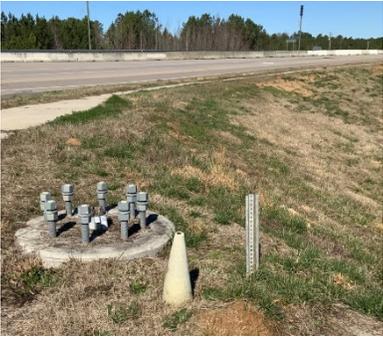
#	Sign Type	Object ID	Failure Type	Photo	GIS Reference Page
1	NC Route	SN_118	Missing

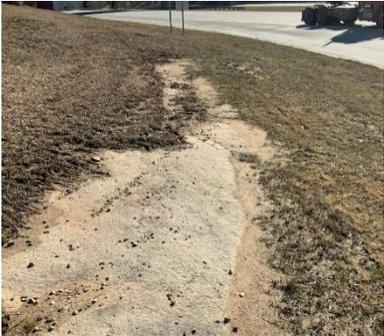
#	Material Type	Object ID	Failure Type	Photo	GIS Reference Page
1	Turf	TF_177	Bare Ground

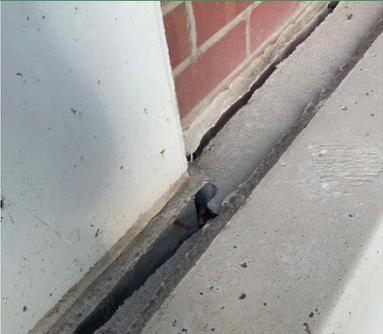
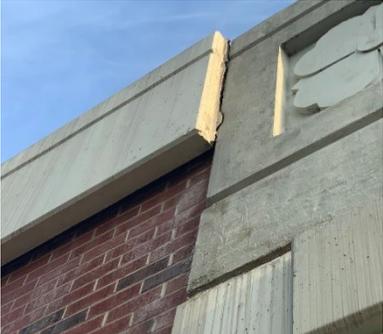
#	Material Type	Object ID	Failure Type	Photo	GIS Reference Page
1	Bridge Wall	WL_5	Unsealed Cracks/Joints

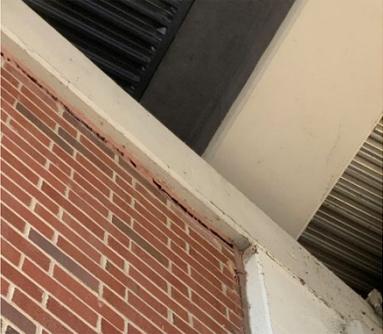
A29
2	Bridge Wall	WL_10	Unsealed Cracks/Joints

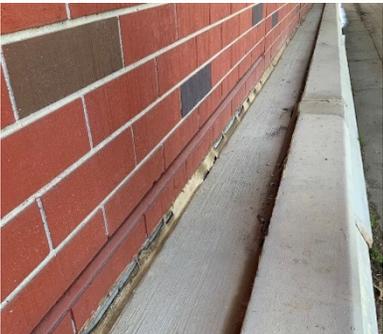
A33
3	Bridge Wall	WL_69	Unsealed Cracks/Joints
