Maintenance Rating Program

Triangle Expressway

2023 Second Quarter Report

NCTA Triangle Expressway Roadway Maintenance Performance Rating Program; Q2, FY 2023 Rating

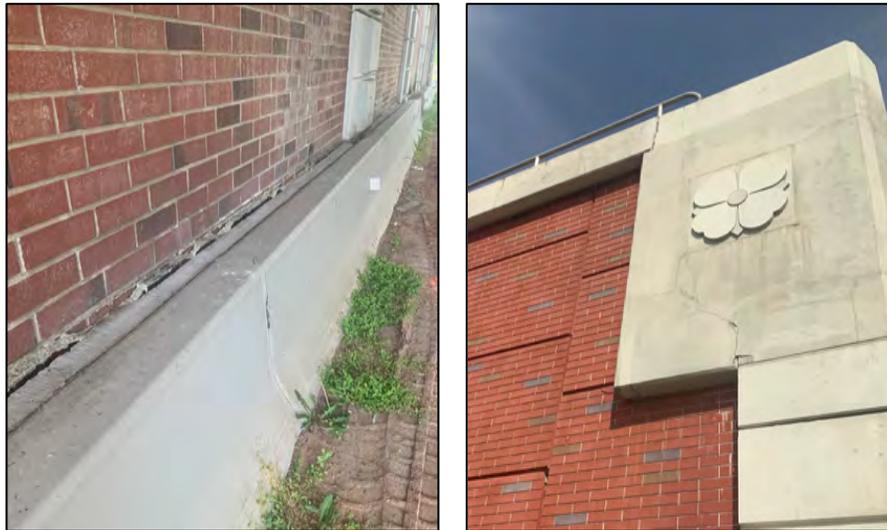
Figure 3: Retaining Walls and Sound Barrier Walls Inspection Results Sample

Retaining Walls and Sound Barrier Walls (78 rating –14 of the 18 assets passed): The four wall sections that did not pass inspection had unsealed cracks/joints. Two of the sections that did not pass inspection are presented in *Figure 3*.

- 1) Walls shall be inspected during daily patrols.
- 2) Unwanted vegetation and graffiti (see graffiti standard) shall be scheduled for removal.
- 3) Minor wall or column damage shall be scheduled for repair within the annual work program.
- 4) Staining damage shall be scheduled for repair within the annual work program.
- 5) Any structural damage that poses a safety risk shall be scheduled immediately upon observation. Mitigate any safety hazard upon observation.

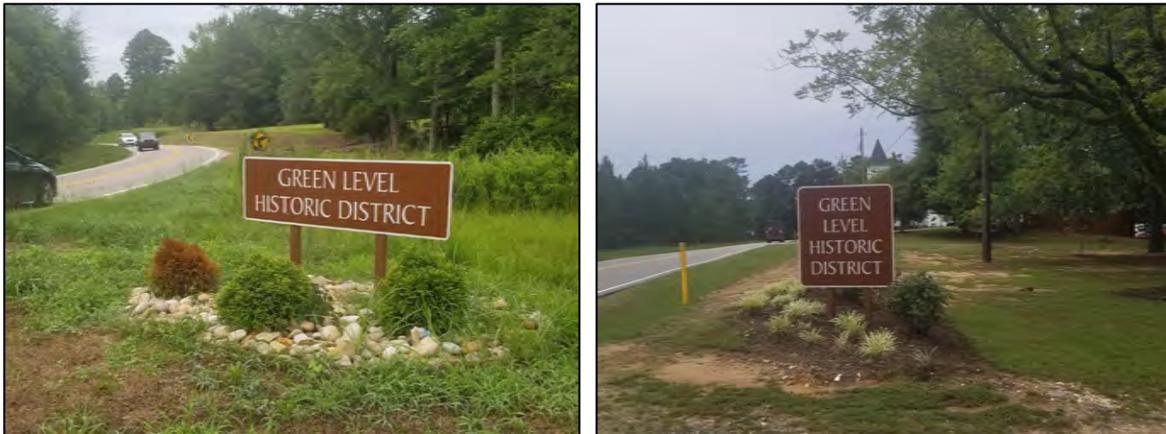
Figure 4: Green Level West Historic District Signs, Landscape Areas

As part of each quarterly inspection, an assessment team visits the two remaining Green Level Historic District signs to conduct a visual inspection of each sign and ensure they are in good standing. The two signs included in the inspection inventory were found to be in good condition. *Figure 4* shows the two signs assessed.

This quarter, the two Green Level Historic District signs inspected were found to be in good condition. Additionally, the landscaped areas surrounding the signs were found to be well maintained.

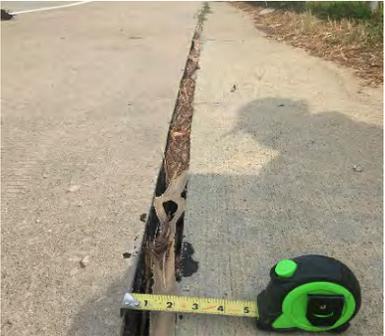
#	Material Type	Object ID	Failure Type	Photo	GIS Reference Page
1	Express-way Gutter	CG_337	Misalignment

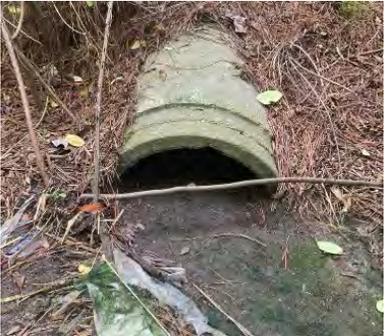
#	Material Type	Object ID	Failure Type	Photo	GIS Reference Page
1	Drain	DP_781	Obstruction

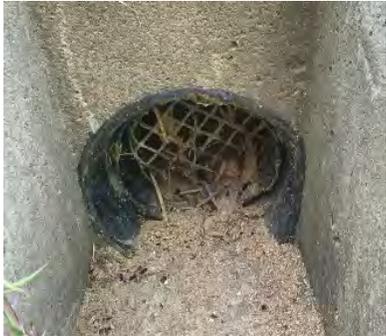
#	Material Type	Object ID	Failure Type	Photo	GIS Reference Page
1	Shoulder Drain	MDP_65	Rodent Screen

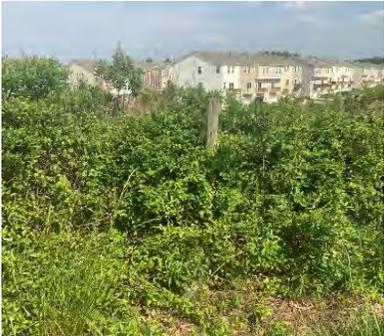
#	Material Type	Object ID	Failure Type	Photo	GIS Reference Page
1	Woven	FN_62	Hole Height

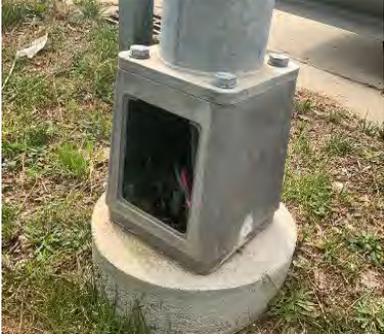
#	Material Type	Object ID	Failure Type	Photo	GIS Reference Page
1	Double Roadway	HL_5	Part Damage

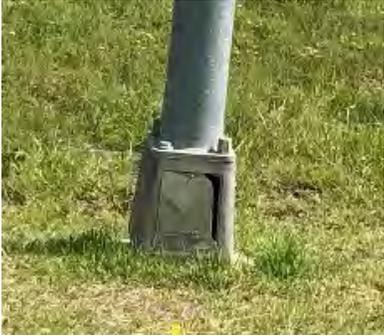
A26
1	Single Roadway	HL_8	Part Damage

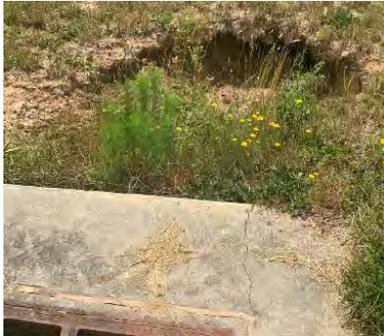
#	Material Type	Object ID	Failure Type	Photo	GIS Reference Page
1	Drop Inlet	IN_787	Eroded Area

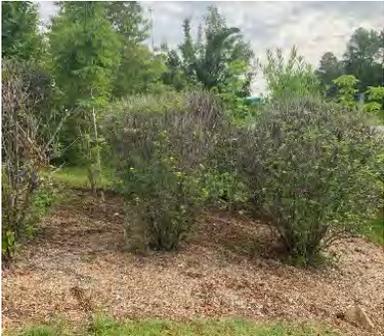
#	Material Type	Object ID	Failure Type	Photo	GIS Reference Page
1	Plant Bed	PB_75	Overgrown

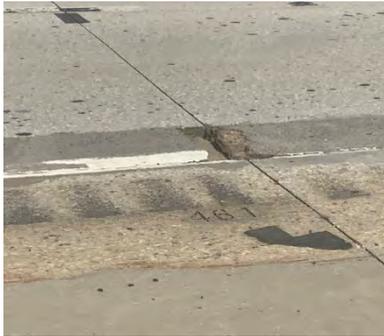
#	Material Type	Object ID	Failure Type	Photo	GIS Reference Page
1	Concrete	LS_6o8	Joint Malfunction

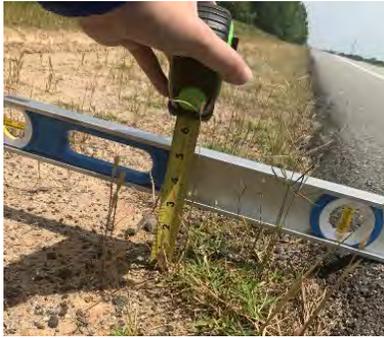
#	Material Type	Object ID	Failure Type	Photo	GIS Reference Page
1	Asphalt	LS_29	Drop off

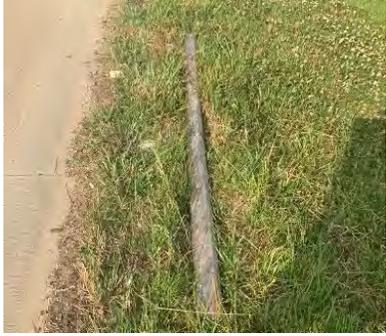
#	Material Type	Object ID	Failure Type	Photo	GIS Reference Page
1	Concrete	LS_33	Hazardous

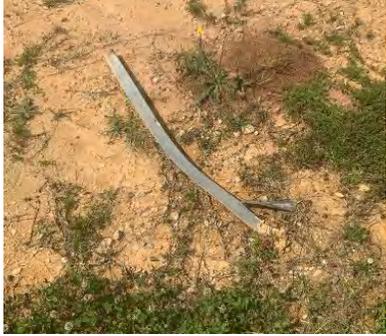
A6
2	Asphalt	LS_230	Hazardous

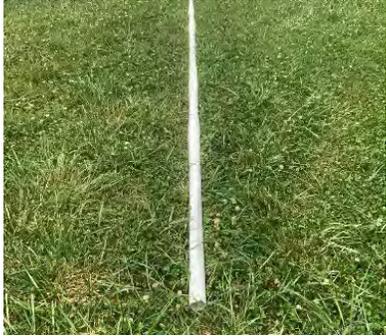
A32
3	Concrete	LS_441	Hazardous

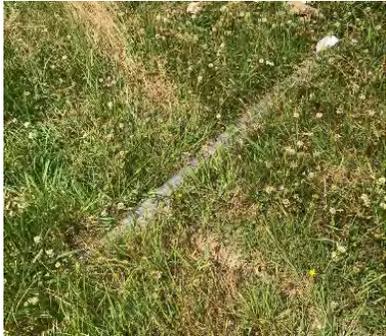
A20
4	Concrete	LS_588	Hazardous

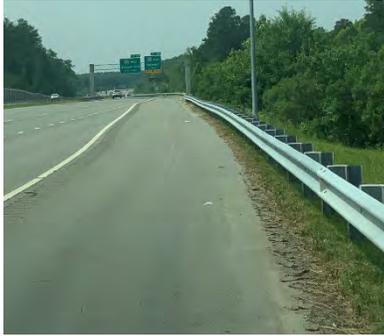
#	Material Type	Object ID	Failure Type	Photo	GIS Reference Page
1	Concrete	LS_100	Nighttime Reflectivity	Not available for nighttime failure	A13
2	Asphalt	LS_250	Missing, Nighttime Reflectivity

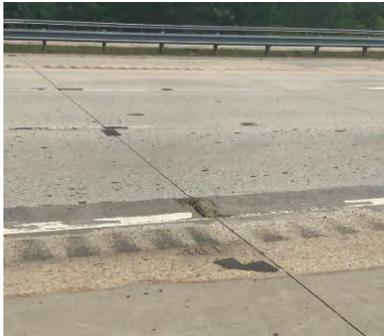
A29
3	Concrete	LS_588	Nighttime Reflectivity	Not available for nighttime failure	A1
4	Concrete	LS_608	Missing, Nighttime Reflectivity

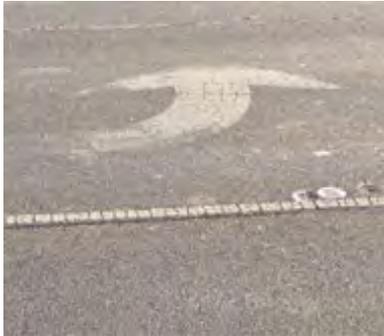
#	Material Type	Object ID	Failure Type	Photo	GIS Reference Page
1	Left Turn	PS_409	Nighttime Reflectivity

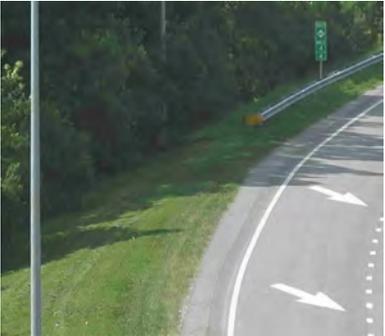
#	Sign Type	Object ID	Failure Type	Photo	GIS Reference Page
1	Speed Limit Interstate	SN_1040	Missing

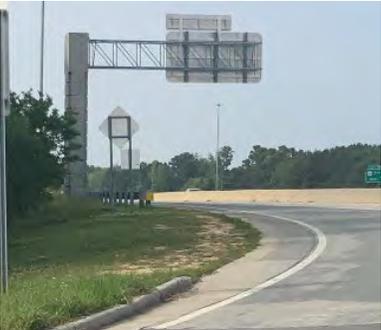
#	Material Type	Object ID	Failure Type	Photo	GIS Reference Page
1	Turf	TF_210	Bare Ground

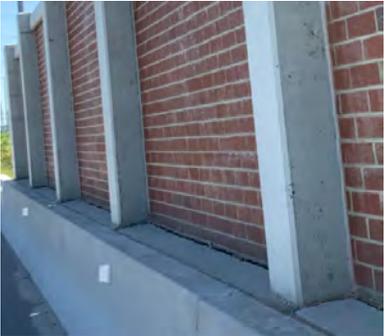
#	Material Type	Object ID	Failure Type	Photo	GIS Reference Page
1	Sound Wall	WL_7	Unsealed Cracks/Joints

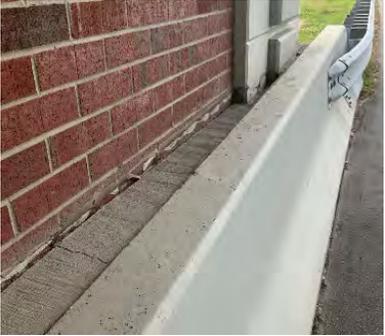
A29
2	Bridge Wall	WL_9	Unsealed Cracks/Joints

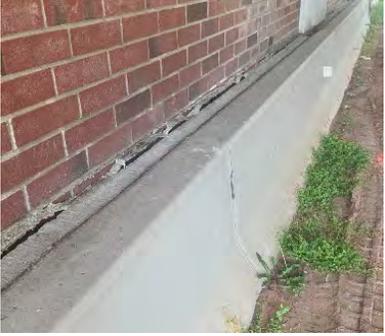
A30
3	Bridge Wall	WL_11	Unsealed Cracks/Joints

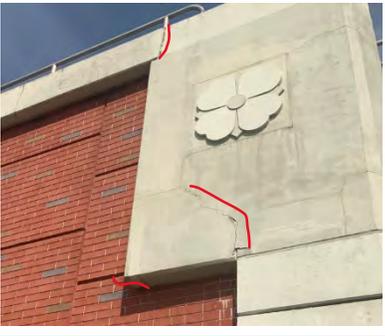
A31
4	Bridge Wall	WL_58	Unsealed Cracks/Joints
