Maintenance Rating Program Monroe Expressway

Quarter 2 MRP Assessment

August 2023

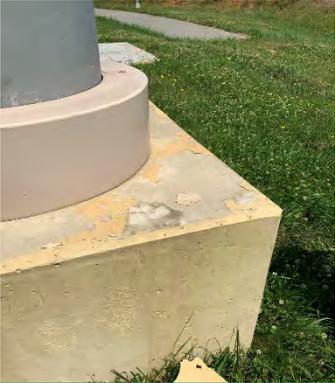
#	Material Type	Object ID	Failure Type	Photo	GIS Reference Page
1	Concrete	GN_3	Scaling	No Photo Provided	B2
2	Concrete	GN_13	Scaling

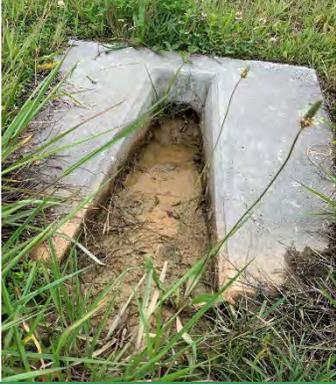
#	Material Type	Object ID	Failure Type	Photo	GIS Reference Page
1	Concrete	MDD_98	Obstruction

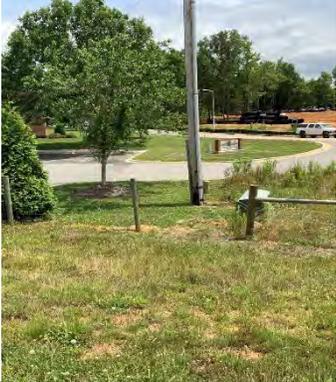
#	Material Type	Object ID	Failure Type	Photo	GIS Reference Page
1	Woven	FN_5	Hole

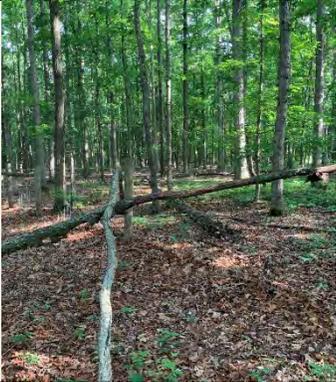
B1 & B2
2	Woven	FN_38	Height

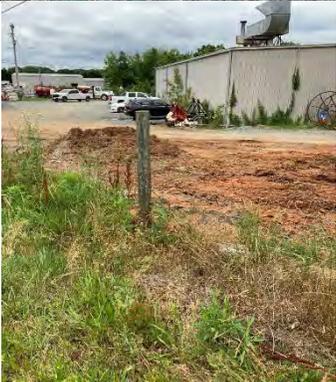
B16 & B17
3	Woven	FN_188	Hole

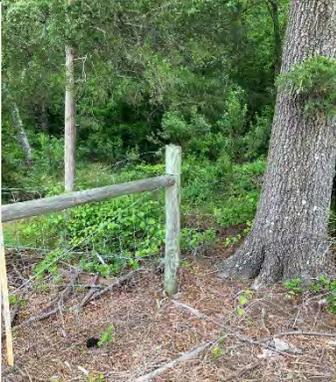
B1
4	Woven	FN_238	Hole

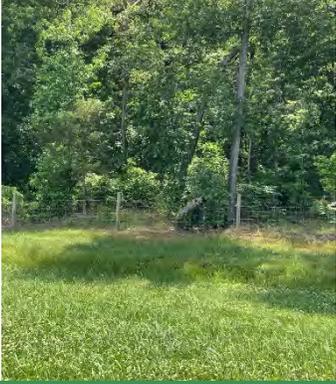
5	Woven	FN_287	Height

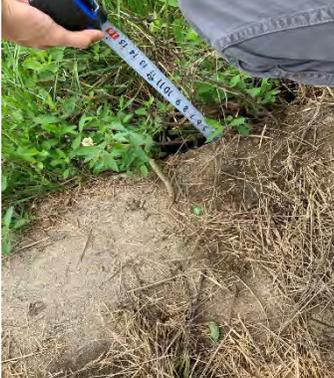
#	Material Type	Object ID	Failure Type	Photo	GIS Reference Page
1	Concrete	IN_94	Erosion

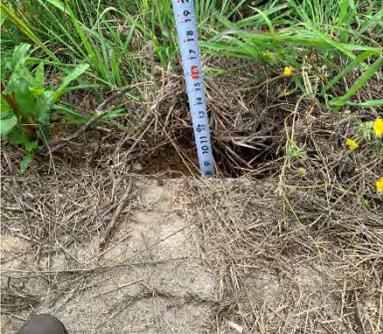
B24 & B25
2	Concrete	IN_200	Erosion

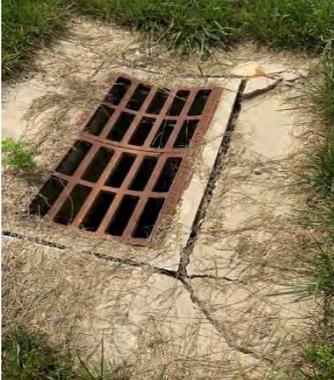
B20
3	Concrete	IN_564	Surface Damage

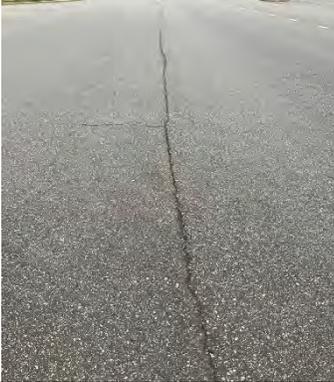
#	Material Type	Object ID	Failure Type	Photo	GIS Reference Page
1	Asphalt	LS_146	Cracking

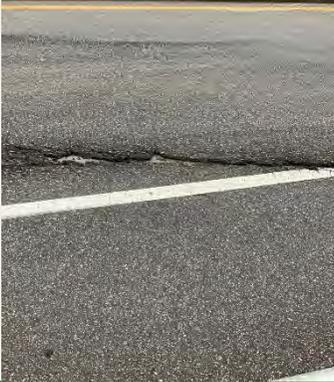
B4
2	Asphalt	LS_682	Cracking

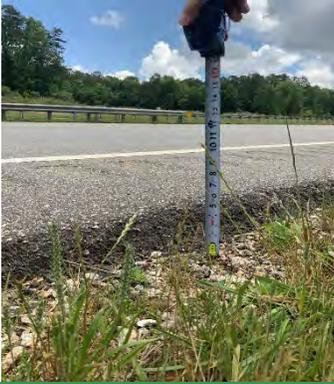
#	Material Type	Object ID	Failure Type	Photo	GIS Reference Page
1	Asphalt	LS_672	Drop-off

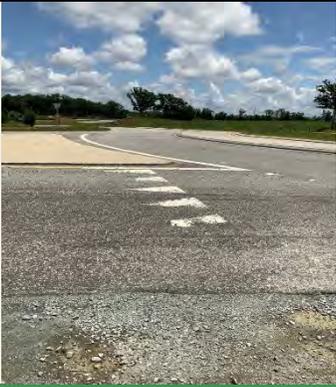
#	Material Type	Object ID	Failure Type	Photo	GIS Reference Page
1	Asphalt	PS_122	Nighttime Reflectivity	No Photo Provided	B9
2	Asphalt	PS_268	Nighttime Reflectivity/Daytime Assessment

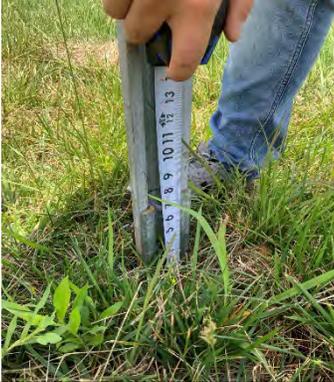
#	Sign Type	Object ID	Failure Type	Photo	GIS Reference Page
1	Mile Marker	SN_644	Sign Support

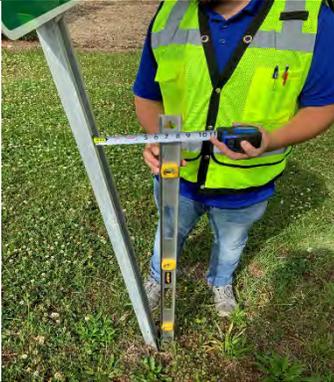
B18
2	Toll Sign	SN_703	Nighttime Reflectivity	No Photo Provided	B16
3	Mile Marker	SN_1077	Leaning

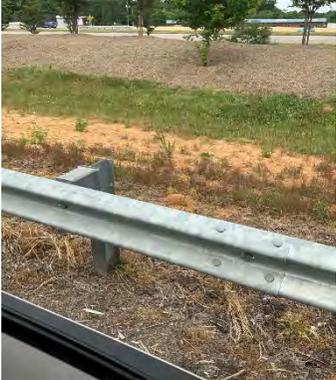
#	Material Type	Object ID	Failure Type	Photo	GIS Reference Page
1	Turf	TF_114	Bare Ground

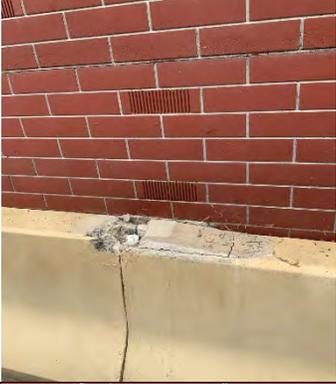
Retaining Walls scored a 71 in the survey. Deficiencies in the retaining walls were directly related to spalling. The MRP Maintenance and Evaluation Standards V7 are below.

#	Material Type	Object ID	Failure Type	Photo	GIS Reference Page
1	Concrete	WL_10	Cracking

Efforts are underway to identify and provide solutions for both the Decorative Supports and Retaining Walls.

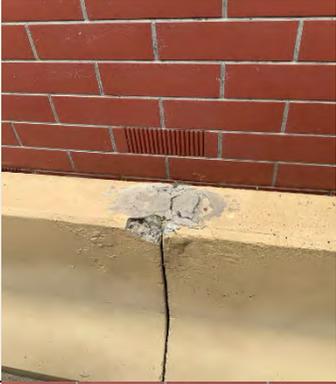
B2 & B3
2	Concrete	WL_72	Cracking

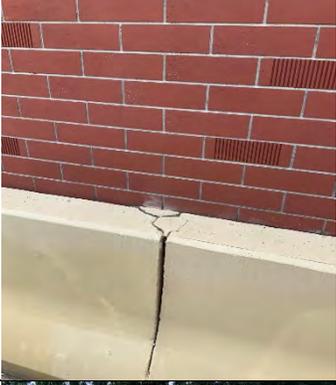
B2 & B3
3	Concrete	WL_74	Cracking

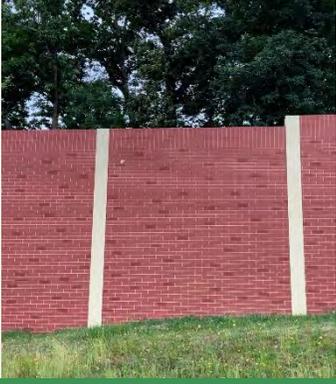
B4
4	Concrete	WL_85	Spalling
