Maintenance Rating Program Monroe Expressway

Quarter 3 MRP Assessment

November 2023

NCTA Monroe By-Pass Roadway Maintenance Performance Rating Program; Q3, FY 2023 Rating

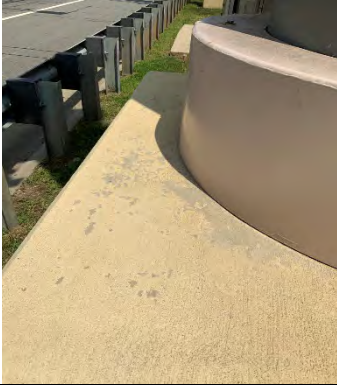
Decorative Supports scored a 75 in the survey. Deficiencies in the decorative supports were directly related to paint scaling. The MRP Maintenance and Evaluation Standards V7 are below.

| # | Material Type | Object ID | Failure Type | Photo | GIS Reference Page |
|---|---|---|---|--|---|
| 1 | Concrete | GN_6 | Scaling | | B2 |

Work is currently underway to rectify the decorative supports.

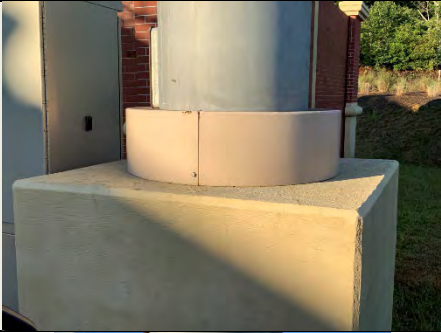
| # | Material Type | Object ID | Failure Type | Photo | GIS Reference Page |
|---|---|---|---|--|---|
| 2 | Concrete | GN_23 | Scaling | | B11 |

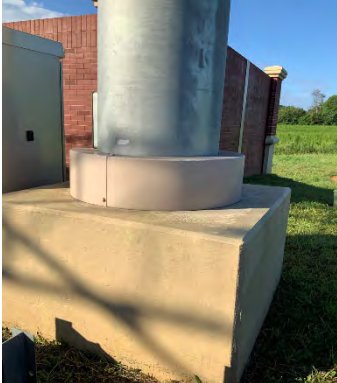
| # | Material Type | Object ID | Failure Type | Photo | GIS Reference Page |
|---|---|---|---|--|---|
| 3 | Concrete | GN_30 | Scaling | | B16 |

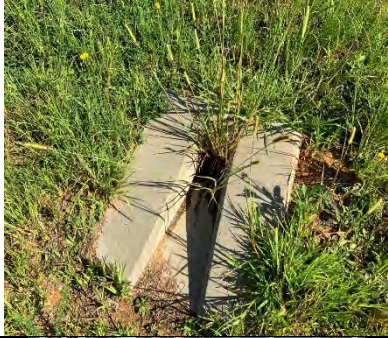
| # | Material Type | Object ID | Failure Type | Photo | GIS Reference Page |
|---|---|---|---|--|---|
| 1 | Concrete | MDD_29 | Obstruction | | B22 |

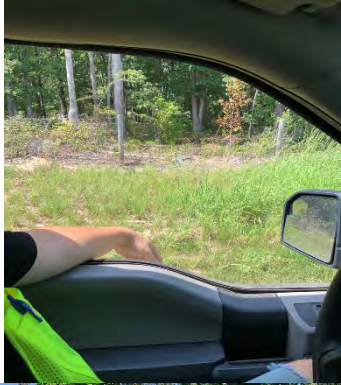
| # | Material Type | Object ID | Failure Type | Photo | GIS Reference Page |
|---|---|---|---|---|---|
| 1 | Woven | FN_234 | Hole | | B1 & B2 |

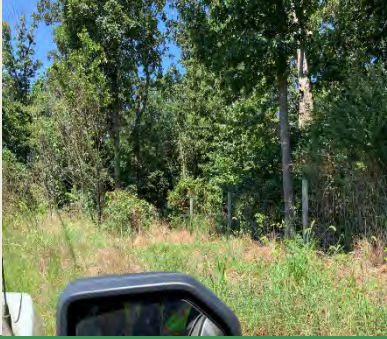
| # | Material Type | Object ID | Failure Type | Photo | GIS Reference Page |
|---|---|---|---|---|---|
| 2 | Woven | FN_499 | Height | | B25 |

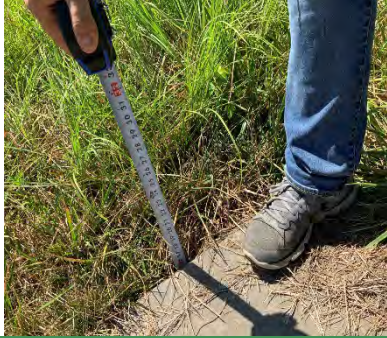
| # | Material Type | Object ID | Failure Type | Photo | GIS Reference Page |
|---|---|---|---|--|---|
| 1 | Concrete | IN_153 | Erosion | | B22 |

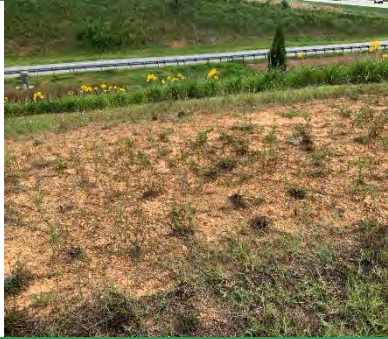
| # | Material Type | Object ID | Failure Type | Photo | GIS Reference Page |
|---|---|---|---|--|---|
| 1 | Plant Bed | PB_24 | Health | | B14 |

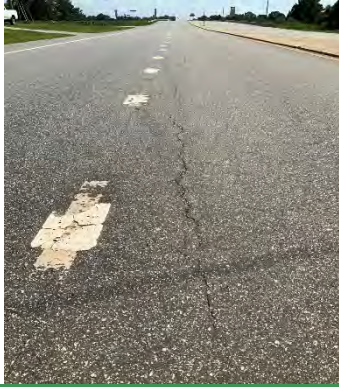
| # | Material Type | Object ID | Failure Type | Photo | GIS Reference Page |
|---|---|---|---|--|---|
| 1 | Asphalt | LS_475 | Cracking | | B17 |

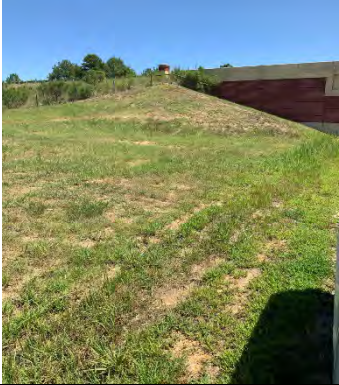
| | Material Type | Object ID | Failure Type | | Photo | | GIS Reference Page |
|---|---|---|---|--|---|--|---|
| 5 | Turf | TF_817 | Bare Ground | | | | B24 |

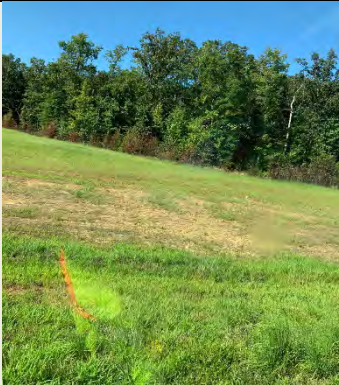
| | Material Type | Object ID | Failure Type | | Photo | | GIS Reference Page |
|---|---|---|---|--|---|--|---|
| 6 | Turf | TF_834 | Bare Ground | | | | B25 |
