# Maintenance Rating Program

Triangle Expressway

2024 Fourth Quarter Report

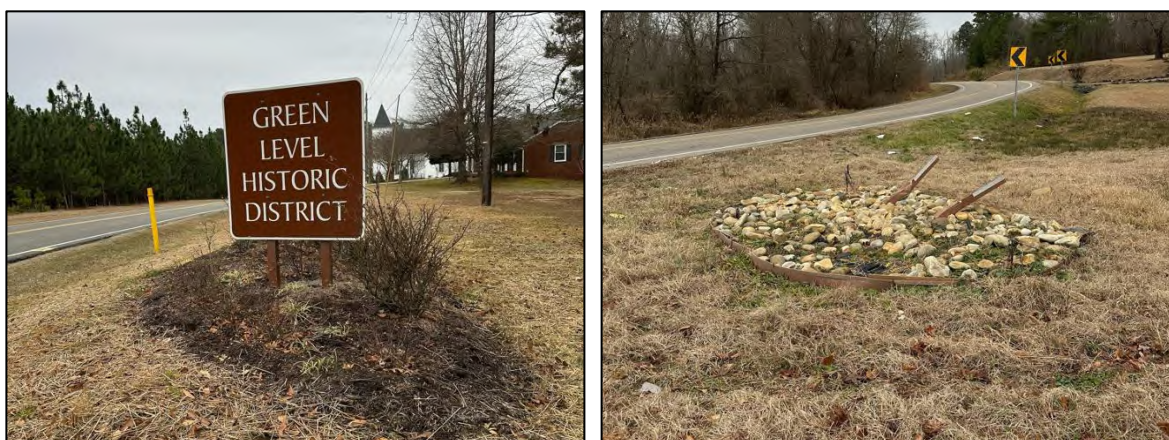
**Figure 4:** Green Level West Historic District Signs, Landscape Areas

As part of each quarterly inspection, an assessment team visits the two remaining Green Level Historic District signs to conduct a visual inspection of each sign and ensure they are in good standing. One of the two signs included in the inspection inventory was found to be in good condition, while the other has been stuck, damaged and in need of repair. **Figure 4** shows the two signs assessed.

This quarter, one of the two Green Level Historic District signs inspected was found to be in good condition, and the other will need to be repaired. The landscaped areas surrounding the signs were found to be well maintained.

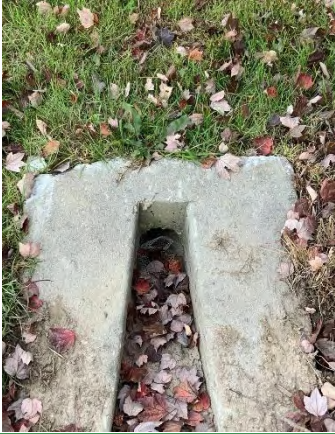
| # | Material Type | Object ID | Failure Type | Photo | GIS Reference Page |
|---|---|---|---|---|---|
| 1 | Shoulder Drain | MDP_70 | Rodent Screen | | A14 |

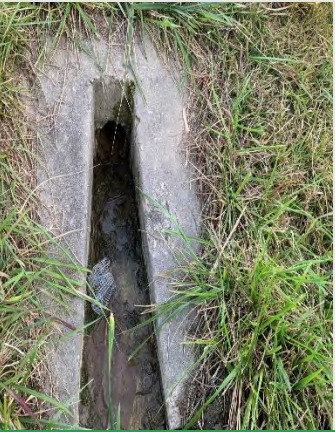
| # | Material Type | Object ID | Failure Type | Photo | GIS Reference Page |
|---|---|---|---|---|---|
| 2 | Shoulder Drain | MDP_93 | Rodent Screen | | A18 |

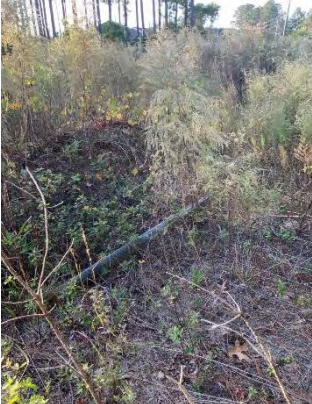
| # | Material Type | Object ID | Failure Type | Photo | GIS Reference Page |
|---|---|---|---|--|---|
| 1 | Woven | FN_76 | Hole Height | | A14 |

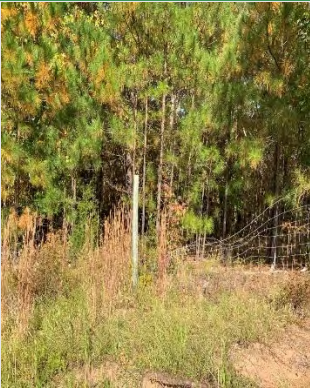
| # | Material Type | Object ID | Failure Type | Photo | GIS Reference Page |
|---|---|---|---|--|---|
| 2 | Woven | FN_206 | Fence Hole | | A4 |

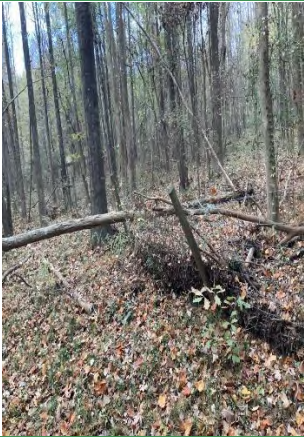
| # | Material Type | Object ID | Failure Type | Photo | GIS Reference Page |
|---|---|---|---|--|---|
| 3 | Woven | FN_290 | Hole Height | | A32 |

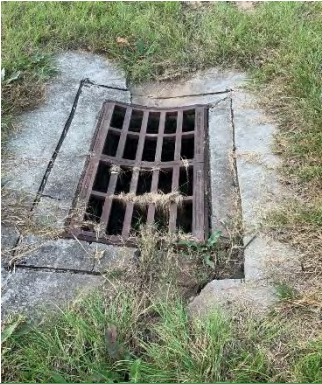
| # | Material Type | Object ID | Failure Type | Photo | GIS Reference Page |
|---|---|---|---|---|---|
| 1 | Drop Inlet | IN_3 | Eroded Area / Surface Damage | | A6 |

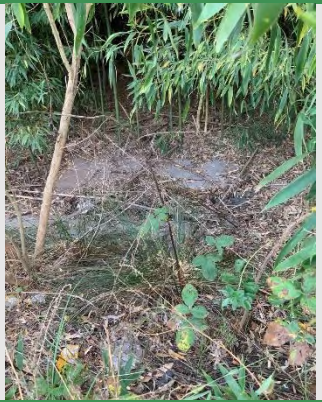
| # | Material Type | Object ID | Failure Type | Photo | GIS Reference Page |
|---|---|---|---|---|---|
| 2 | Drop Inlet | IN_1066 | Obstruction | | A6 |

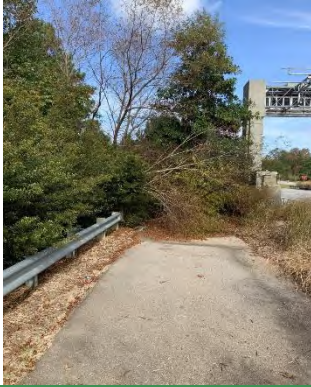
| # | Material Type | Object ID | Failure Type | Photo | GIS Reference Page |
|---|---|---|---|---|---|
| 1 | Plant Bed | PB_143 | Overgrown | | A12 |

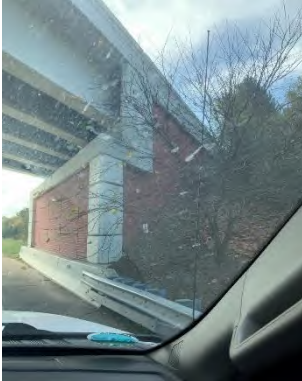
| # | Material Type | Object ID | Failure Type | Photo | GIS Reference Page |
|---|---|---|---|---|---|
| 2 | Tree | PB_285 | Overgrown | | A11 |

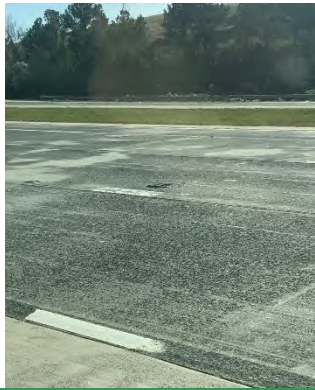
| # | Material Type | Object ID | Failure Type | Photo | GIS Reference Page |
|---|---|---|---|---|---|
| 1 | Pavement - Concrete | LS_478 | Pothole | | A27 |

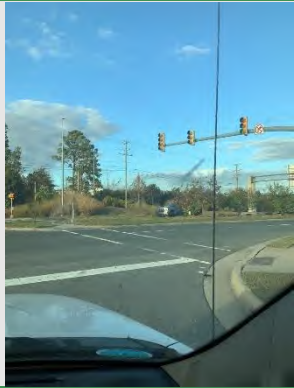
| # | Material Type | Object ID | Failure Type | Photo | GIS Reference Page |
|---|---|---|---|--|---|
| 6 | Ped Xing | PS_529 | Daytime Assessment / Nighttime Reflectivity | | A30 |

To maintain/improve the condition ratings, it is recommended that markings that are fading, chipping and/or showing signs of aging be prioritized for attention as appropriate in the capital budget.

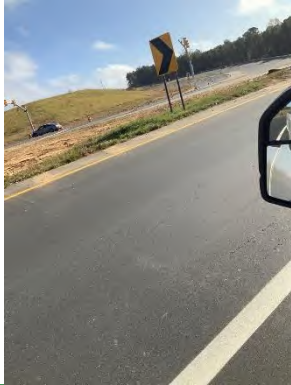
| 7 | Thru Lane | PS_546 | Daytime Assessment<br>(Symbol Missing) | | A34 |

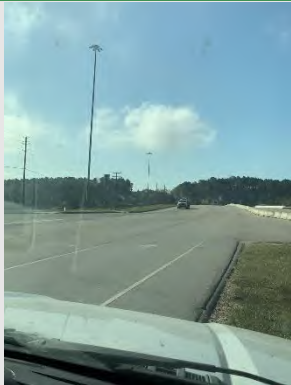
| 8 | Thru Lane | PS_584 | Daytime Assessment /<br>Nighttime Reflectivity | | A26 |

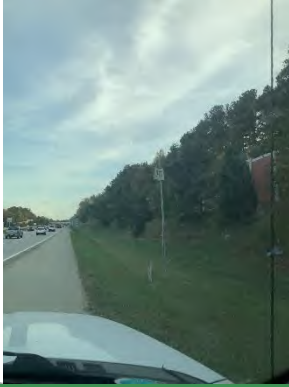
| # | Sign Type | Object ID | Failure Type | Photo | GIS Reference Page |
|---|---|---|---|--|---|
| 1 | NC Route | SN_1235 | Missing Parts / Damaged | | A19 |
