Maintenance Rating Program Monroe Expressway

Quarter 4 MRP Assessment

NCTA Monroe By-Pass Roadway Maintenance Performance Rating Program; Q4, 2024 Rating

Maintenance Rating Program for the Monroe Expressway
2024 Fourth Quarter (October - December)

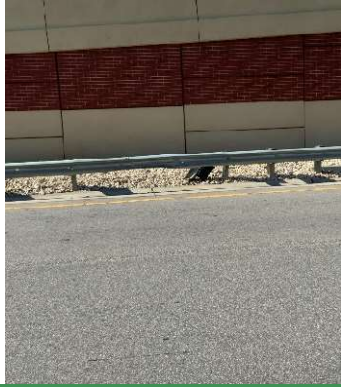
#	Material Type	Object ID	Failure Type	Photo	GIS Reference Page
1	Steel	BR_229	Functional Damage

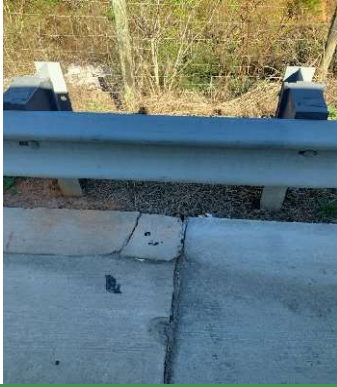
#	Material Type	Object ID	Failure Type	Photo	GIS Reference Page
1	Concrete	CG_27	Structural Damage

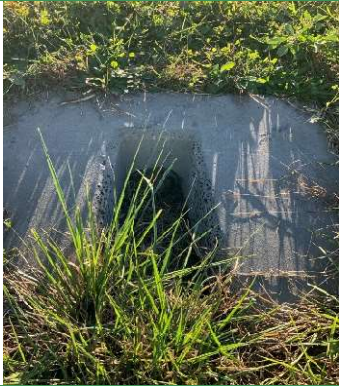
#	Material Type	Object ID	Failure Type	Photo	GIS Reference Page
1	Concrete	MDD_11	Blockage

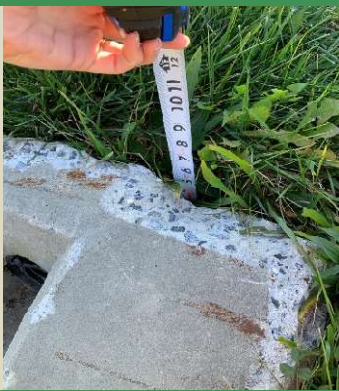
B9
2	Concrete	MDD_66	Erosion

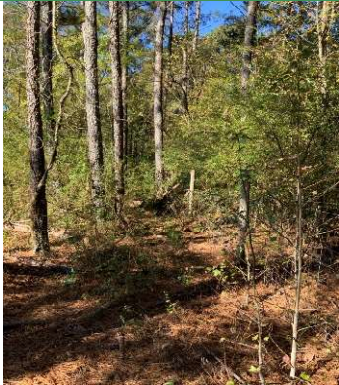
#	Material Type	Object ID	Failure Type	Photo	GIS Reference Page
1	Woven	FN_454	Functional Damage

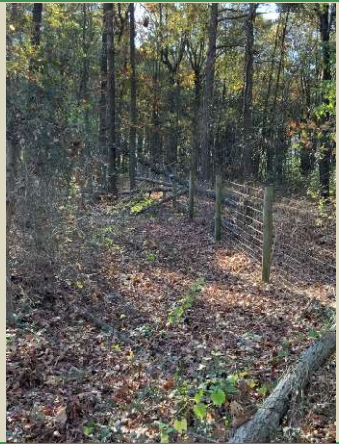
B24
2	Woven	FN_493	Hole Height

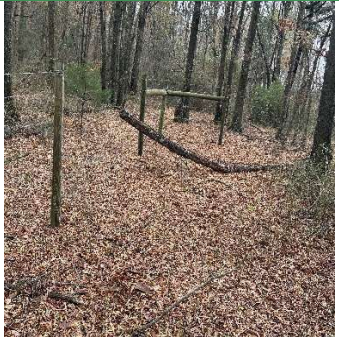
B25
3	Woven	FN_509	Functional Damage

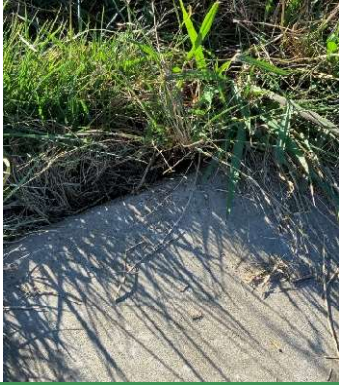
#	Material Type	Object ID	Failure Type	Photo	GIS Reference Page
1	Concrete	IN_46	Erosion

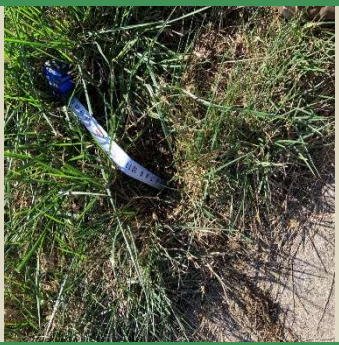
B26
2	Concrete	IN_284	Erosion

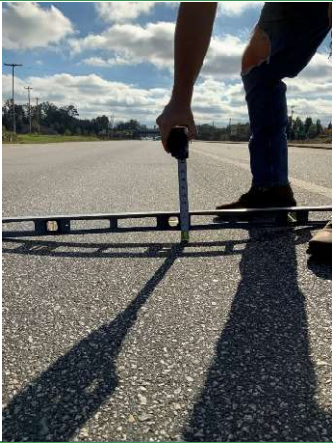
#	Material Type	Object ID	Failure Type	Photo	GIS Reference Page
1	Asphalt	LS_409	Rutting

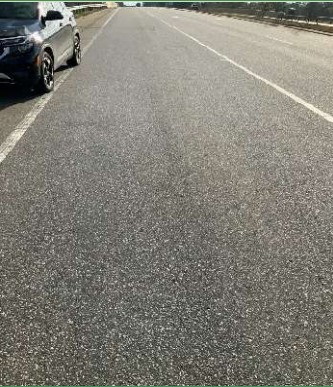
B14
2	Asphalt	LS_476	Pavement Flushing

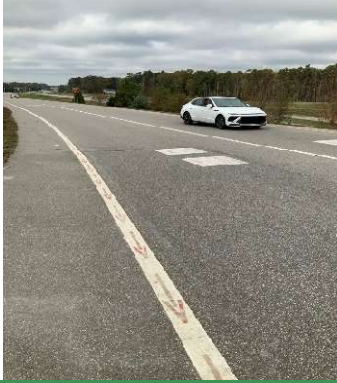
#	Material Type	Object ID	Failure Type	Photo	GIS Reference Page
1	Asphalt	PS_271	Nighttime Reflectivity

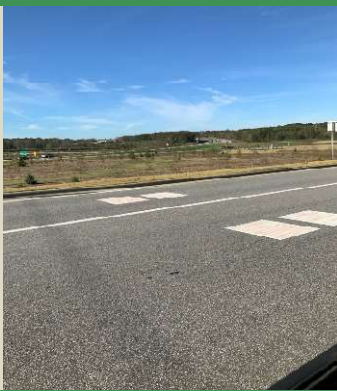
B7
2	Asphalt	PS_283	Nighttime Reflectivity

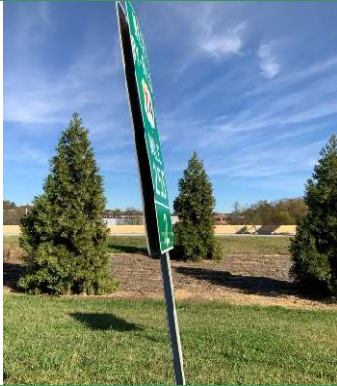
#	Material Type	Object ID	Failure Type	Photo	GIS Reference Page
1	Mile Marker	SN_58	Leaning

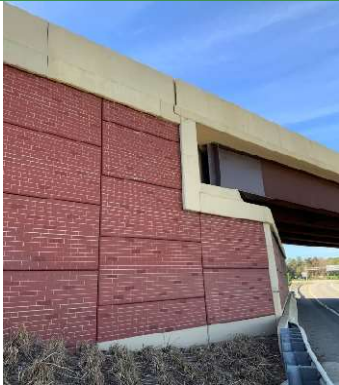
#	Material Type	Object ID	Failure Type	Photo	GIS Reference Page
1	Brick	WL_8	Scaling

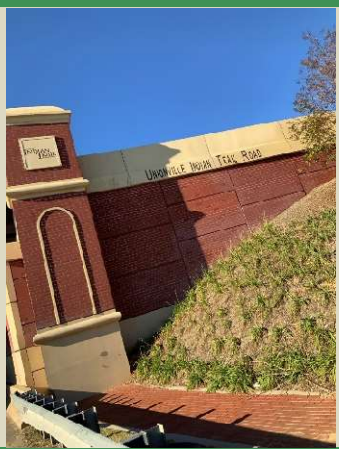
B1
2	Brick	WL_25	Cracking
