Maintenance Rating Program Monroe Expressway

Quarter 1 MRP Assessment

May 2025

NCTA Monroe By-Pass Roadway Maintenance Performance Rating Program; Q1, 2025 Rating

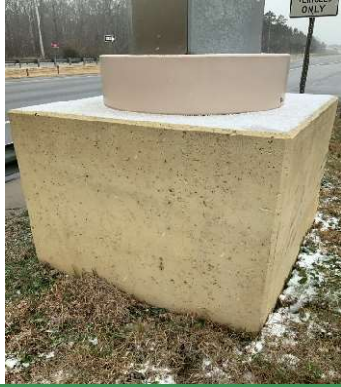
#	Material Type	Object ID	Failure Type	Photo	GIS Reference Page
1	Concrete	GN_7	Spalling

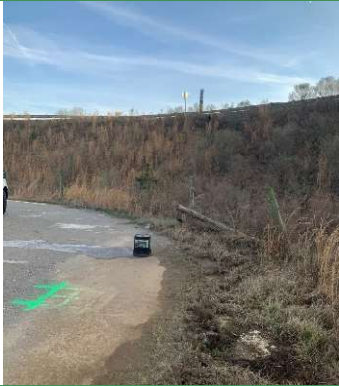
#	Material Type	Object ID	Failure Type	Photo	GIS Reference Page
1	Woven	FN_434	Hole Height

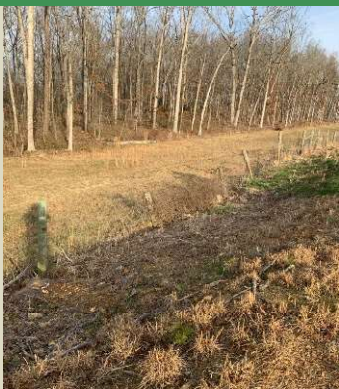
B9
2	Woven	FN_458	Hole Height

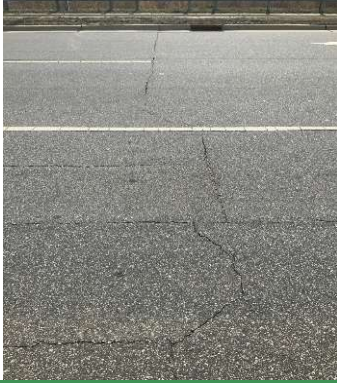
#	Material Type	Object ID	Failure Type	Photo	GIS Reference Page
1	Asphalt	LS_146	Cracking

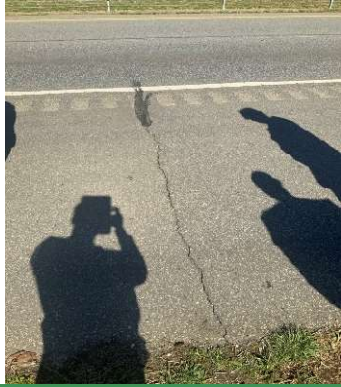
#	Material Type	Object ID	Failure Type	Photo	GIS Reference Page
1	Asphalt	LS_433	Cracking

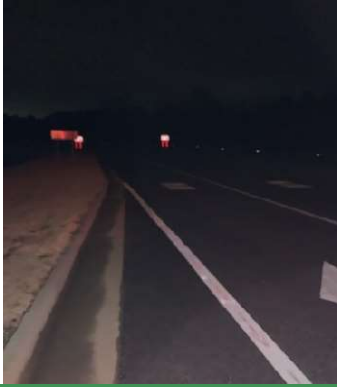
#	Material Type	Object ID	Failure Type	Photo	GIS Reference Page
1	Thermoplastic	PS_282	Nighttime Reflectivity

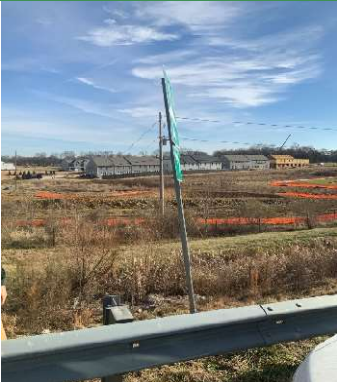
#	Sign Type	Object ID	Failure Type	Photo	GIS Reference Page
1	Airport	SN_289	Leaning

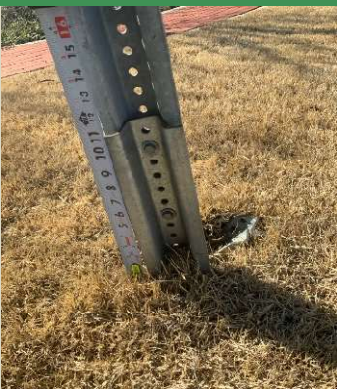
B9
2	Direction	SN_302	Sign Support

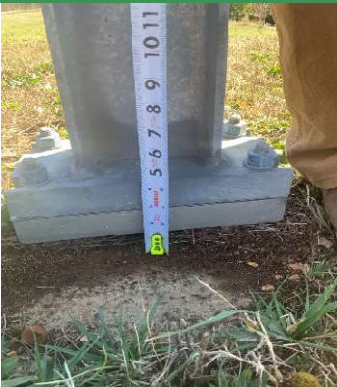
B9
3	74 BYP	SN_367	Slip Base

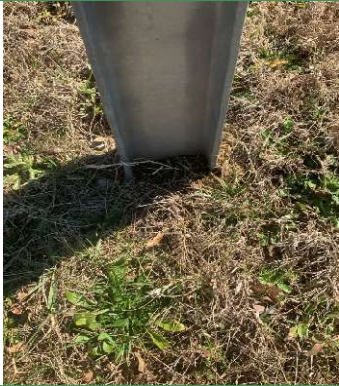
#	Sign Type	Object ID	Failure Type	Photo	GIS Reference Page
4	74 BYP	SN_410	Slip Base

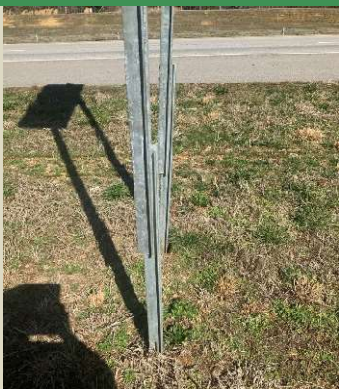
B7
5	Merge	SN_433	Sign Support

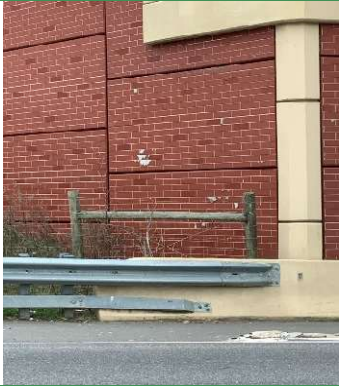
#	Material Type	Object ID	Failure Type	Photo	GIS Reference Page
1	Brick	WL_44	Scaling

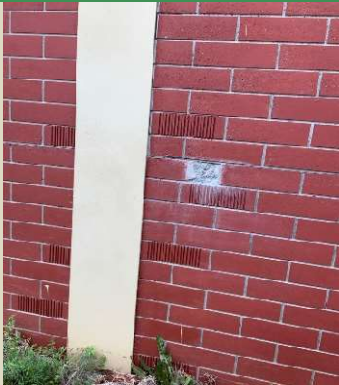
B20 & B21
2	Brick	WL_69	Spalling
