Maintenance Rating Program Monroe Expressway

Quarter 3 MRP Assessment

November 2022

NCTA Monroe By-Pass Roadway Maintenance Performance Rating Program; Q3, FY 2022 Rating

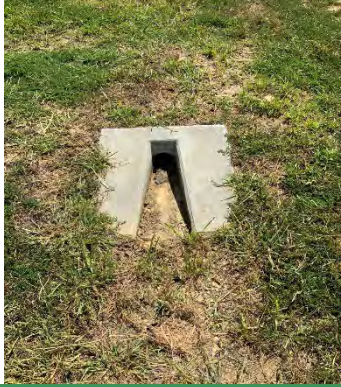
#	Material Type	Object ID	Failure Type	Photo	GIS Reference Page
1	Concrete	MDD_98	Part Missing

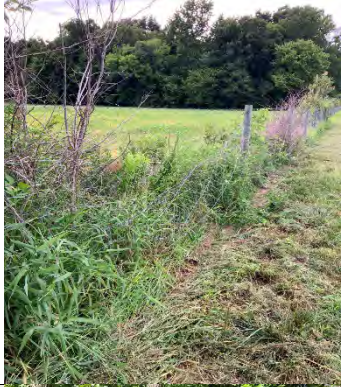
#	Material Type	Object ID	Failure Type	Photo	GIS Reference Page
1	Woven	FN_421	Hole

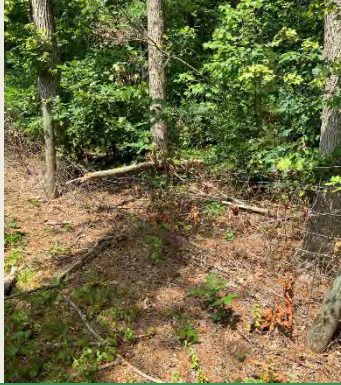
B7
2	Woven	FN_470	Hole

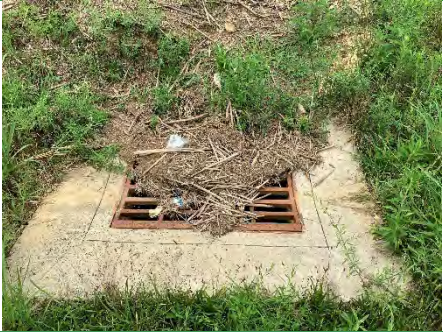
#	Material Type	Object ID	Failure Type	Photo	GIS Reference Page
1	Concrete	IN_665	Blockage

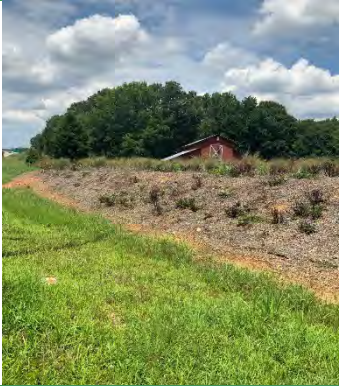
#	Material Type	Object ID	Failure Type	Photo	GIS Reference Page
1	Plant Bed	PB_31	Health

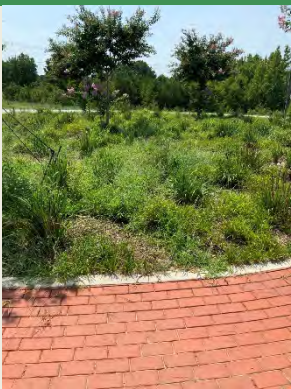
B11
2	Plant Bed	PB_36	Weeds

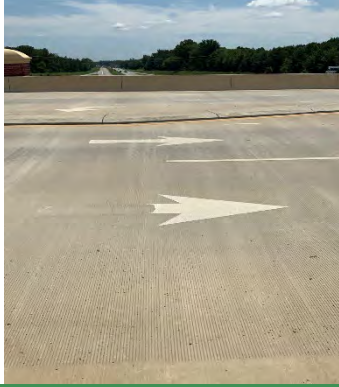
#	Material Type	Object ID	Failure Type	Photo	GIS Reference Page
1	Symbol	PS_89	Visibility

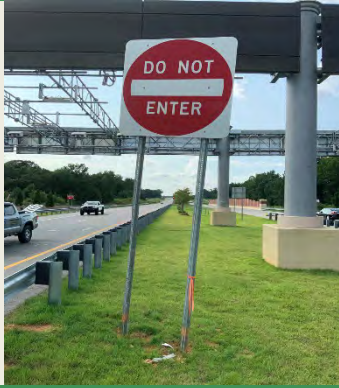
#	Sign Type	Object ID	Failure Type	Photo	GIS Reference Page
4	Do Not Enter	SN_504	Sign Support & Leaning

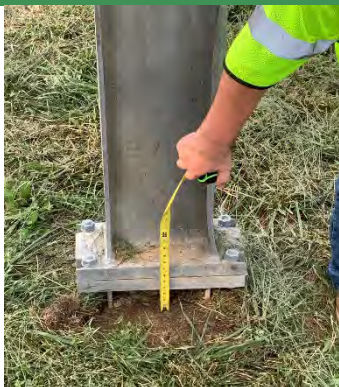
B11
5	Road Sign	SN_535	Sign Support

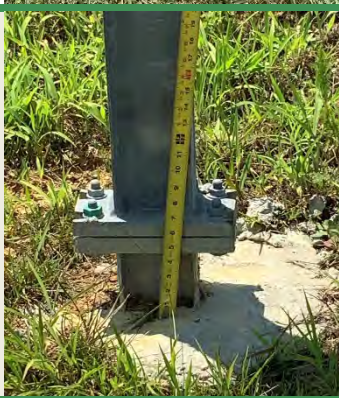
B13
6	Road Sign	SN_1220	Sign Support

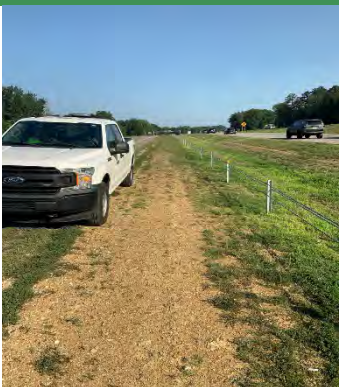
Turf scored a 65 in the survey. Deficiencies of the turf were directly related to bare ground. The MRP Maintenance and Evaluation Standards V7 are below.

#	Material Type	Object ID	Failure Type	Photo	GIS Reference Page
4	Turf	TF_255	Bare Ground	 	B5
5	Turf	TF_267	Bare Ground

Seeding and fertilizing efforts were last performed in the Spring of 2022. Seeding and fertilizer applications are conducted biannually in both the spring and fall months. It is recommended that the maintenance provider continue with a consistent application of this schedule along with spot seeding as needed.

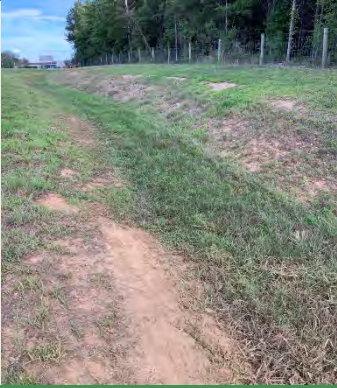
#	Material Type	Object ID	Failure Type	Photo	GIS Reference Page
10	Turf	TF_478	Bare Ground

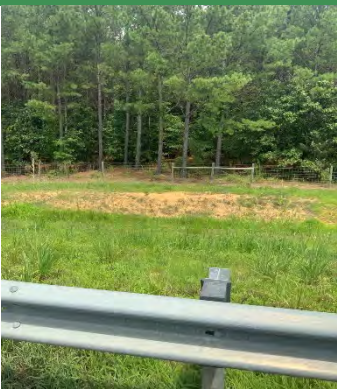
B6
11	Turf	TF_523	Bare Ground

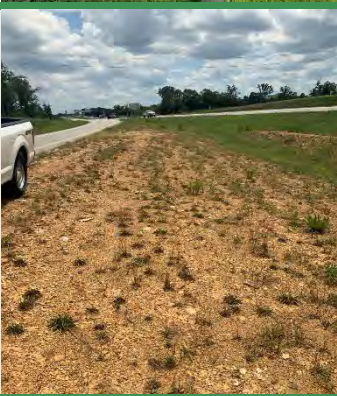
B8
12	Turf	TF_563	Bare Ground

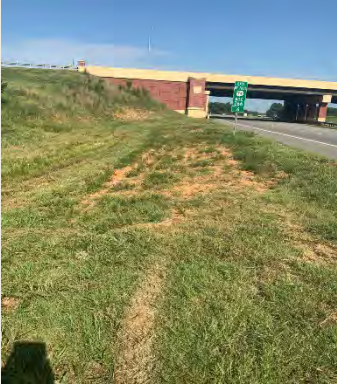
13	Turf	TF_624	Bare Ground	 	B14
14	Turf	TF_680	Bare Ground

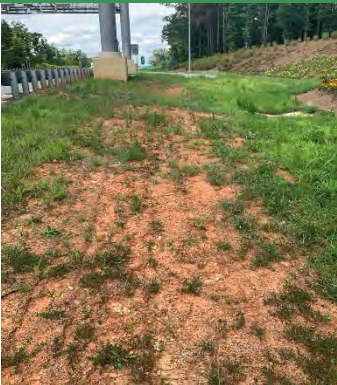
B17
15	Turf	TF_727	Bare Ground
