Maintenance Rating Program Monroe Expressway

Quarter 4 MRP Assessment

February 2023

NCTA Monroe By-Pass Roadway Maintenance Performance Rating Program; Q4, CY 2022 Rating

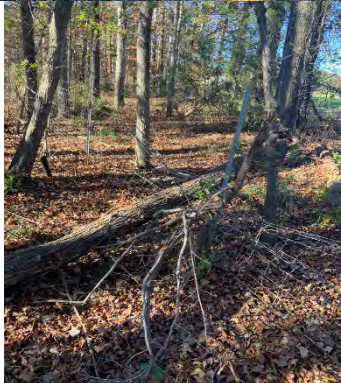
A15
3	Woven	FN_162	Hole

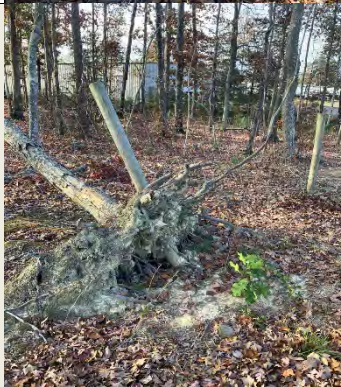
A15
4	Woven	FN_228	Hole

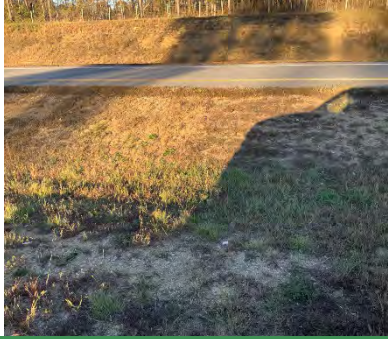
#	Material Type	Object ID	Failure Type	Photo	GIS Reference Page
7	Turf	TF_515	Bare Ground

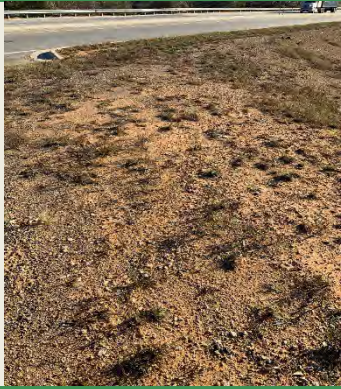
A7
8	Turf	TF_554	Bare Ground
