# Maintenance Rating Program Monroe Expressway

Quarter 1 MRP Assessment

May 2023

NCTA Monroe By-Pass Roadway Maintenance Performance Rating Program; Q1, FY 2023 Rating

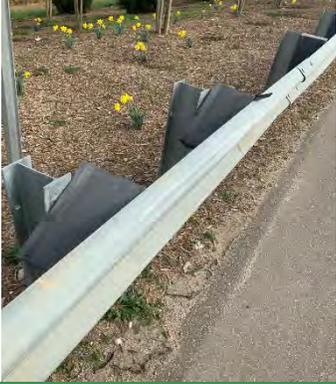
| # | Material Type | Object ID | Failure Type | Photo | GIS Reference Page |
|---|---|---|---|---|---|
| 1 | Steel | BR_392 | Twisted Post | | B14 & B15 |

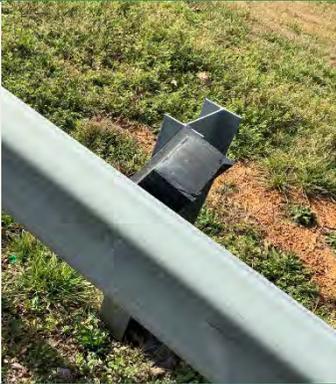
| # | Material Type | Object ID | Failure Type | Photo | GIS Reference Page |
|---|---|---|---|---|---|
| 2 | Steel | BR_412 | Twisted Post | | B11 |

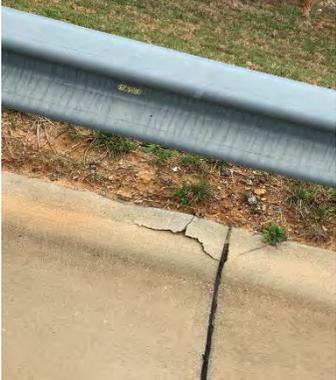
| # | Material Type | Object ID | Failure Type | Photo | GIS Reference Page |
|---|---|---|---|--|---|
| 1 | Concrete | CG_291 | Cracking | | B1 |

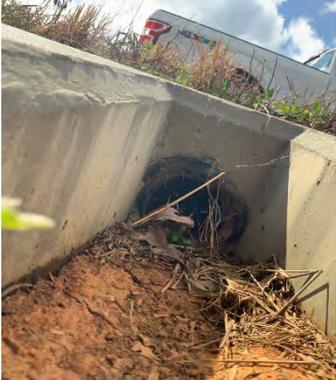
| # | Material Type | Object ID | Failure Type | Photo | GIS Reference Page |
|---|---|---|---|--|---|
| 1 | Concrete | MDD_68 | Rodent Screen | | B11 |

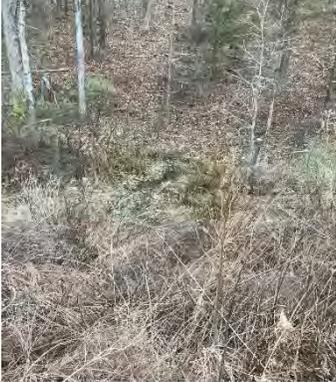
| # | Material Type | Object ID | Failure Type | Photo | GIS Reference Page |
|---|---|---|---|--|---|
| 1 | Woven | FN_264 | Hole | | B4 |

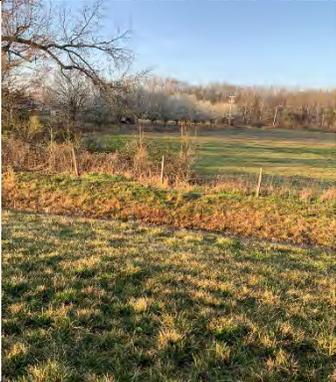
| # | Material Type | Object ID | Failure Type | Photo | GIS Reference Page |
|---|---|---|---|--|---|
| 2 | Woven | FN_331 | Hole | | B7 |

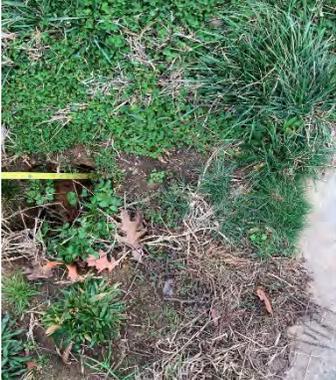
| # | Material Type | Object ID | Failure Type | Photo | GIS Reference Page |
|---|---|---|---|--|---|
| 1 | Concrete | IN_622 | Erosion | | B3 & B4 |

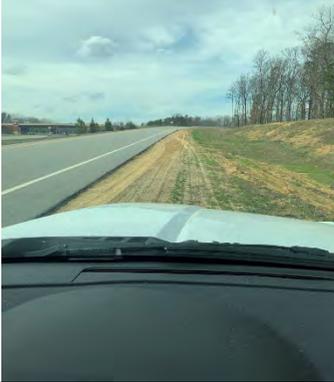
| # | Material Type | Object ID | Failure Type | Photo | GIS Reference Page |
|---|---|---|---|---|---|
| 1 | Asphalt | LS_247 | Drop-off | | B7 & B8 |

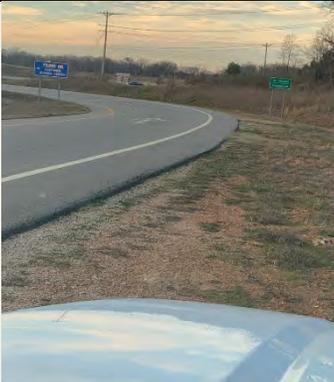
| # | Material Type | Object ID | Failure Type | Photo | GIS Reference Page |
|---|---|---|---|---|---|
| 2 | Asphalt | LS_421 | Drop-off | | B14 & B15 |

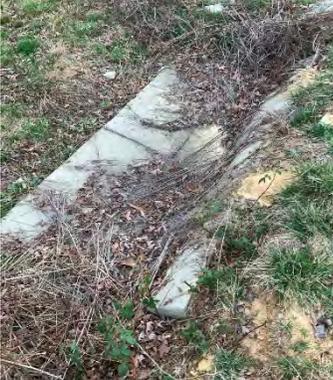
| # | Material Type | Object ID | Failure Type | Photo | GIS Reference Page |
|---|---|---|---|--|---|
| 1 | Concrete | PD_9 | Blockage | | B22 & B23 |

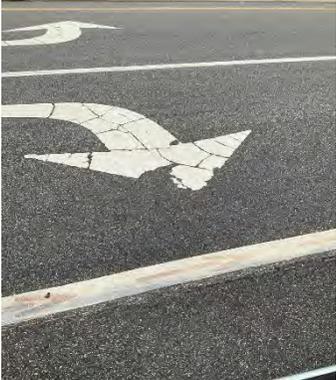
| # | Material Type | Object ID | Failure Type | Photo | GIS Reference Page |
|---|---|---|---|--|---|
| 1 | Asphalt | PS_8 | Daytime Assessment | | B4 |

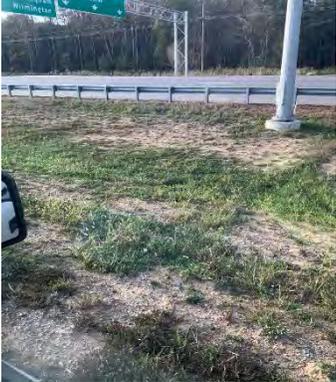
| # | Material Type | Object ID | Failure Type | Photo | GIS Reference Page |
|---|---|---|---|--|---|
| 1 | Turf | TF_133 | Bare Ground | | B1 |

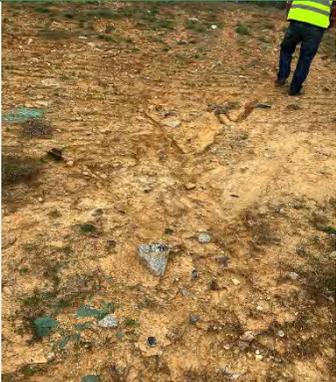
| # | Material Type | Object ID | Failure Type | Photo | GIS Reference Page |
|---|---|---|---|--|---|
| 2 | Turf | TF_219 | Bare Ground | | B4 |

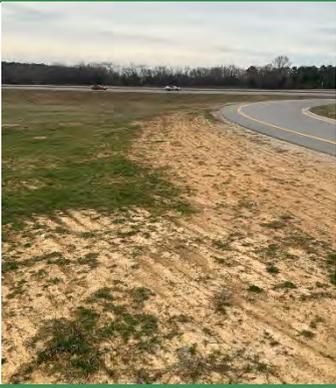
| # | Material Type | Object ID | Failure Type | Photo | GIS Reference Page |
|---|---|---|---|--|---|
| 3 | Turf | TF_231 | Bare Ground | | B4 |

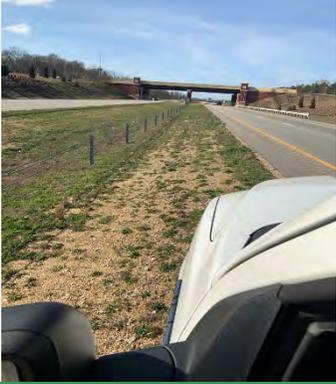
| # | Material Type | Object ID | Failure Type | Photo | GIS Reference Page |
|---|---|---|---|--|---|
| 4 | Turf | TF_270 | Bare Ground | | B7 |

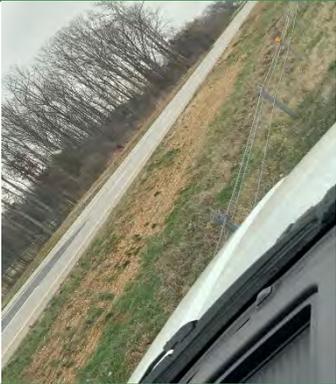
| # | Material Type | Object ID | Failure Type | Photo | GIS Reference Page |
|---|---|---|---|--|---|
| 5 | Turf | TF_346 | Bare Ground | | B17 |

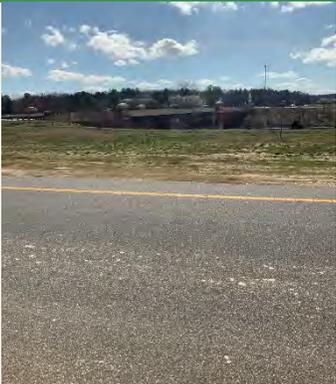
| # | Material Type | Object ID | Failure Type | Photo | GIS Reference Page |
|---|---|---|---|--|---|
| 6 | Turf | TF_447 | Bare Ground | | B7 |

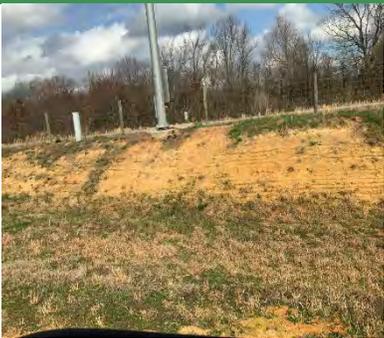
| # | Material Type | Object ID | Failure Type | Photo | GIS Reference Page |
|---|---|---|---|--|---|
| 7 | Turf | TF_578 | Bare Ground | | B10 |

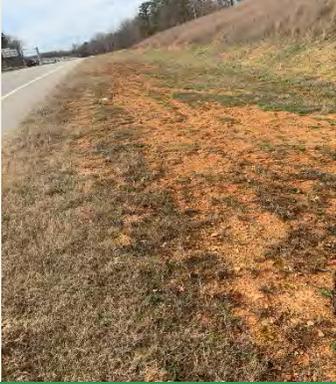
| # | Material Type | Object ID | Failure Type | Photo | GIS Reference Page |
|---|---|---|---|--|---|
| 8 | Turf | TF_627 | Bare Ground | | B14 |

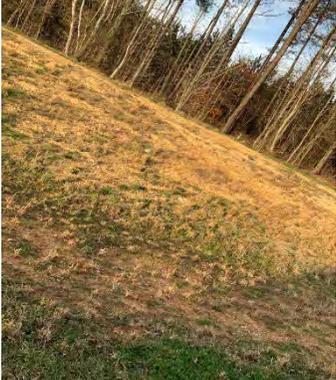
| # | Material Type | Object ID | Failure Type | Photo | GIS Reference Page |
|---|---|---|---|--|---|
| 9 | Turf | TF_726 | Bare Ground | | B19 |

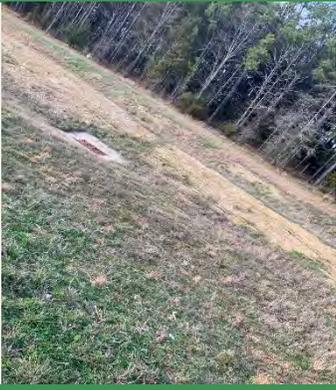
| # | Material Type | Object ID | Failure Type | Photo | GIS Reference Page |
|---|---|---|---|--|---|
| 10 | Turf | TF_825 | Bare Ground | | B24 |

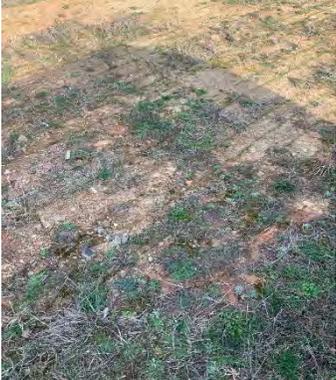
| # | Material Type | Object ID | Failure Type | Photo | GIS Reference Page |
|---|---|---|---|--|---|
| 11 | Turf | TF_836 | Bare Ground | | B25 |
