Maintenance Rating Program Monroe Expressway

Quarter 4 MRP Assessment

February 2024

Maintenance Rating Program for the Monroe Expressway
2023 Fourth Quarter (October - December)

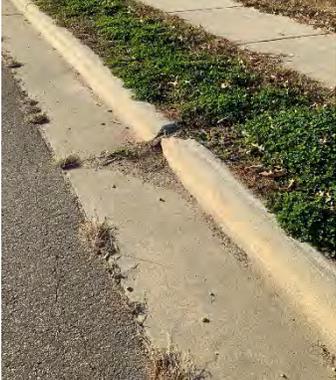
B7

#	Material Type	Object ID	Failure Type	Photo	GIS Reference Page
1	Concrete	CG_167	Structural Damage

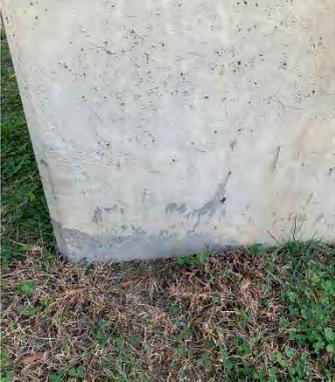
B8

#	Material Type	Object ID	Failure Type	Photo	GIS Reference Page
1	Concrete	GN_17	Scaling

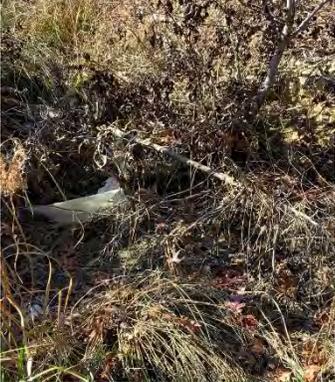
B3

#	Material Type	Object ID	Failure Type	Photo	GIS Reference Page
1	Concrete	DP_511	Obstruction

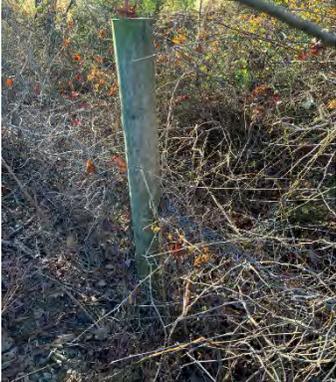
#	Material Type	Object ID	Failure Type	Photo	GIS Reference Page
1	Woven	FN_30	Hole

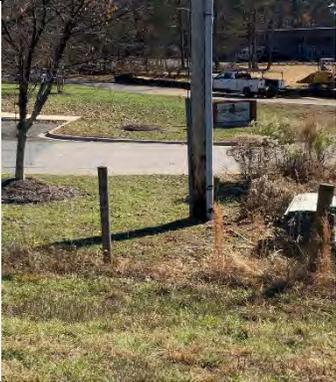
B15
2	Woven	FN_218	Hole

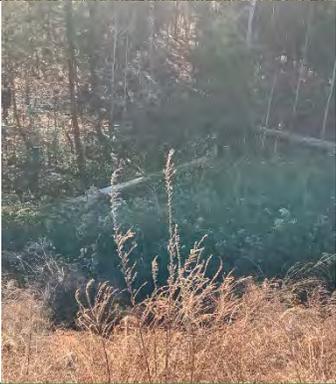
B5

B1 & B2
3	Woven	FN_283	Hole

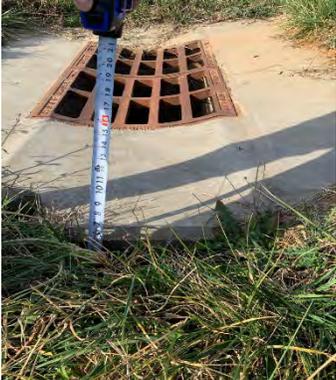
B26

#	Material Type	Object ID	Failure Type	Photo	GIS Reference Page
1	Concrete	IN_46	Erosion

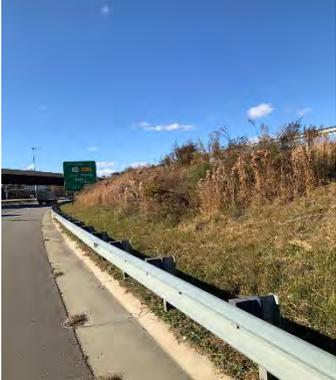
B1

#	Material Type	Object ID	Failure Type	Photo	GIS Reference Page
1	Plant Bed	PB_45	Undesirable Vegetation

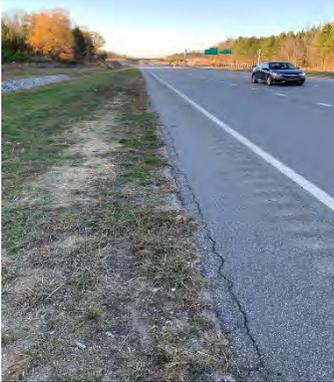
#	Material Type	Object ID	Failure Type	Photo	GIS Reference Page
1	Asphalt	LS_262	Cracking

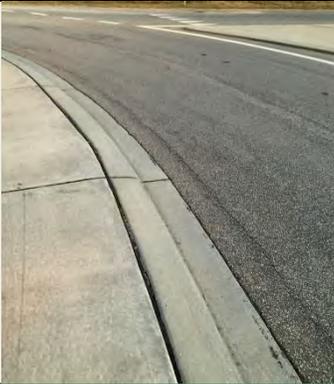
B9

B8
2	Asphalt	LS_311	Cracking/Rutting

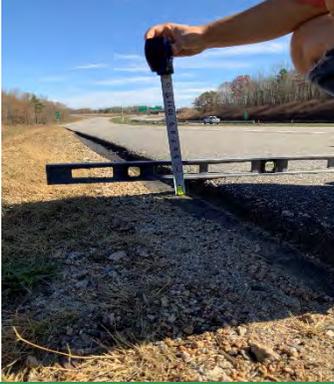
B3

#	Material Type	Object ID	Failure Type	Photo	GIS Reference Page
1	Asphalt	LS_115	Dropoff

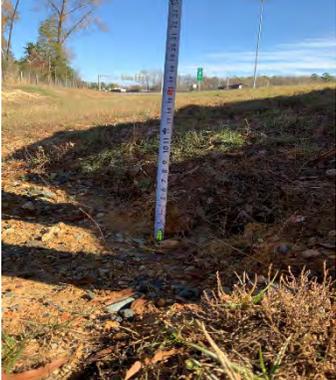
B1

#	Material Type	Object ID	Failure Type	Photo	GIS Reference Page
1	Asphalt	LS_65	Erosion

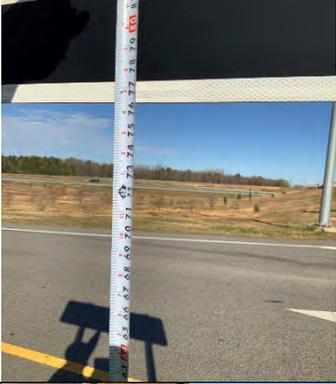
#	Sign Type	Object ID	Failure Type	Photo	GIS Reference Page
1	Wrong Way	SN_234	Height

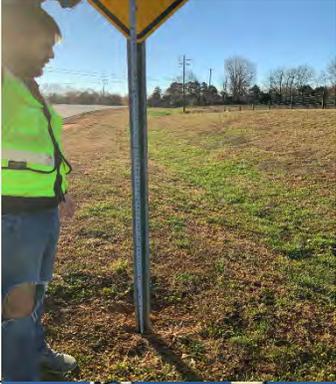
B4
2	Speed Limit Ahead	SN_791	Height

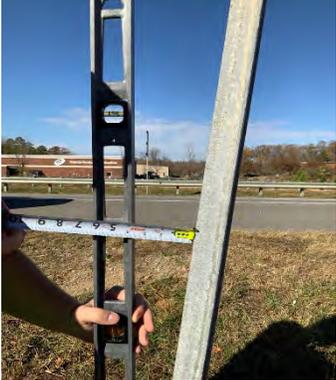
B1 & B2

B23
3	Speed Limit	SN_1156	Leaning

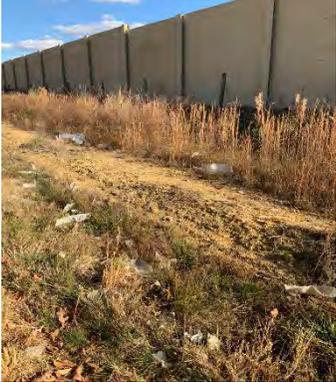
#	Material Type	Object ID	Failure Type	Photo	GIS Reference Page
1	Turf	TF_164	Bare Ground

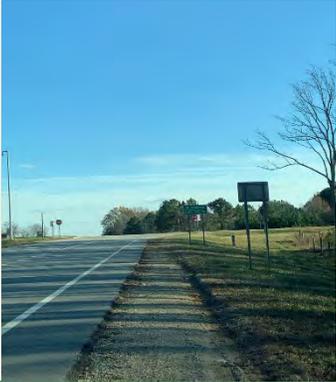
B7

B2
2	Turf	TF_501	Bare Ground
