# Maintenance Rating Program Monroe Expressway

Quarter 1 MRP Assessment

May 2024

### NCTA Monroe By-Pass Roadway Maintenance Performance Rating Program; Q1, FY 2024 Rating

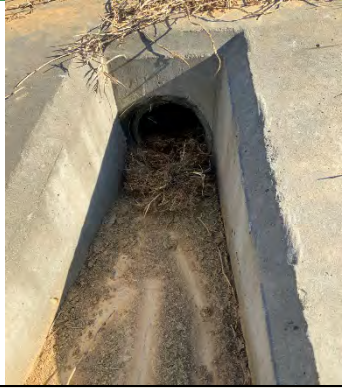
#	Material Type	Object ID	Failure Type	Photo	GIS Reference Page
1	Concrete	MDD_19	Blockage/Missing Parts

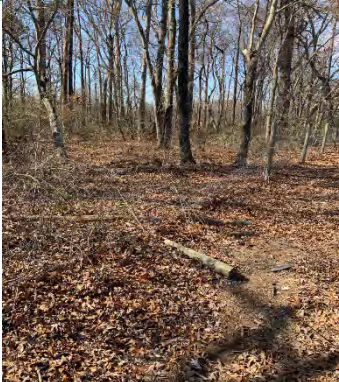
#	Material Type	Object ID	Failure Type	Photo	GIS Reference Page
1	Woven	FN_408	Hole

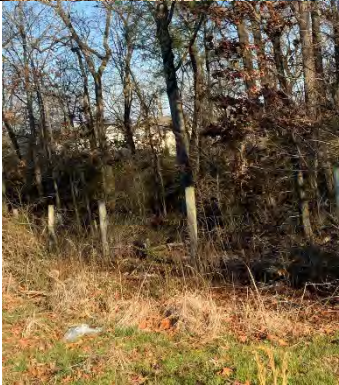
B22
3	Woven	FN_499	Hole

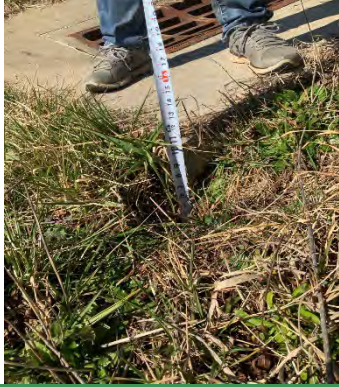
#	Material Type	Object ID	Failure Type	Photo	GIS Reference Page
1	Concrete	IN_305	Erosion

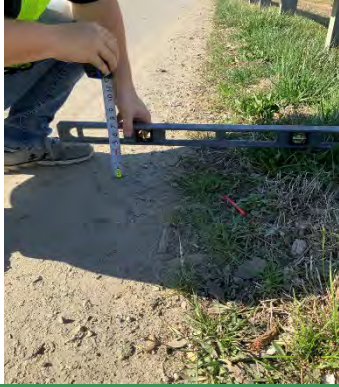
#	Material Type	Object ID	Failure Type	Photo	GIS Reference Page
1	Asphalt	LS_630	Shoulder Buildup

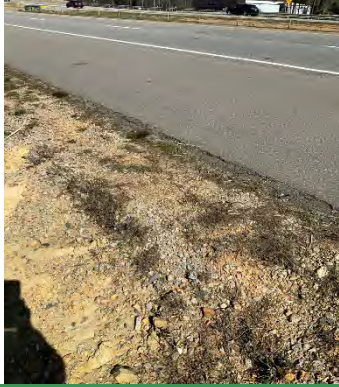
#	Material Type	Object ID	Failure Type	Photo	GIS Reference Page
1	Asphalt	LS_89	Dropoff

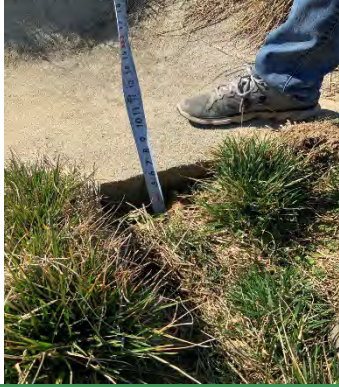
#	Material Type	Object ID	Failure Type	Photo	GIS Reference Page
1	Concrete	PD_19	Undermining/Cracking

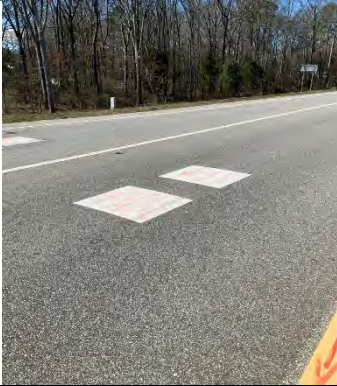
#	Material Type	Object ID	Failure Type	Photo	GIS Reference Page
1	Asphalt	PS_270	Nighttime Reflectivity/Daytime Assessment

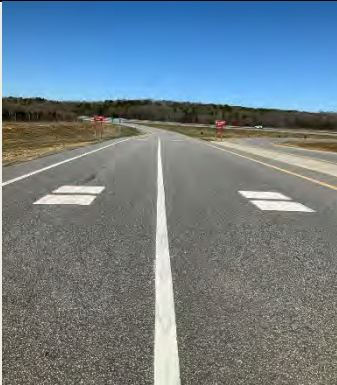
B7
2	Asphalt	PS_281	Nighttime Reflectivity/Daytime Assessment

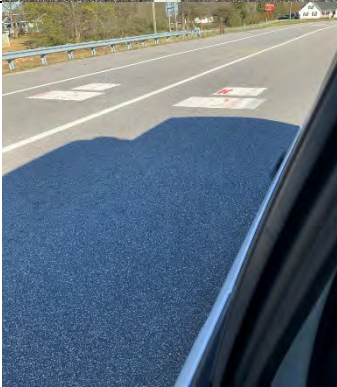
B4
3	Asphalt	PS_300	Nighttime Reflectivity/Daytime Assessment

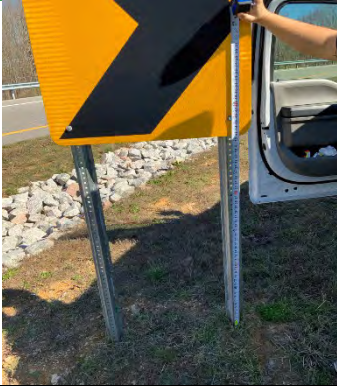
#	Sign Type	Object ID	Failure Type	Photo	GIS Reference Page
1	Exit Chevron	SN_206	Height

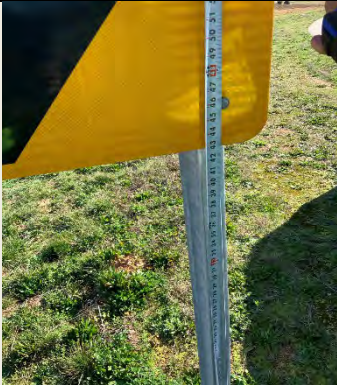
B4
2	Exit Chevron	SN_606	Height

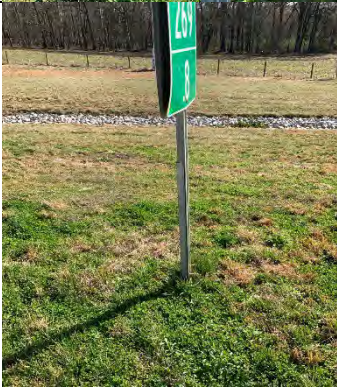
B17
3	Mile Marker	SN_779	Sign Support

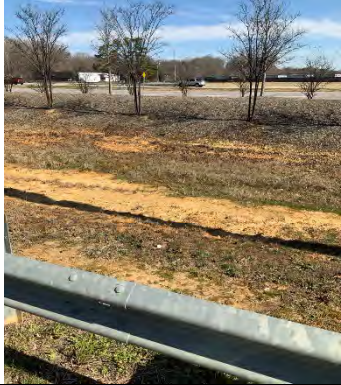
#	Material Type	Object ID	Failure Type	Photo	GIS Reference Page
1	Turf	TF_114	Bare Ground

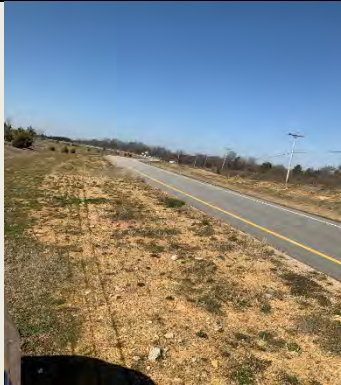
B1
2	Turf	TF_564	Bare Ground

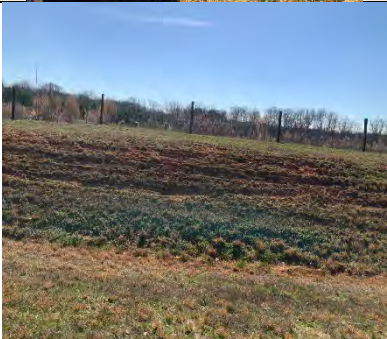
B9 & B10
3	Turf	TF_610	Bare Ground

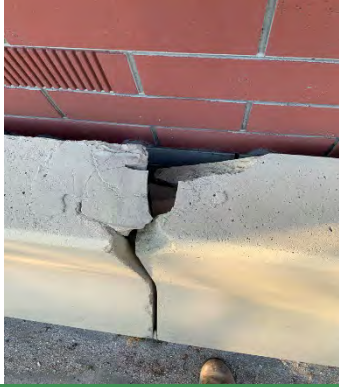
#	Material Type	Object ID	Failure Type	Photo	GIS Reference Page
1	Concrete	WL-76	Unsealed Cracks
