Maintenance Rating Program Monroe Expressway

Quarter 3 MRP Assessment

November 2024

NCTA Monroe By-Pass Roadway Maintenance Performance Rating Program; Q3, 2024 Rating

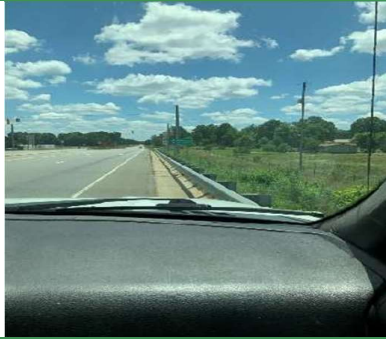
#	Material Type	Object ID	Failure Type	Photo	GIS Reference Page
1	Steel	BR_563	Missing Part

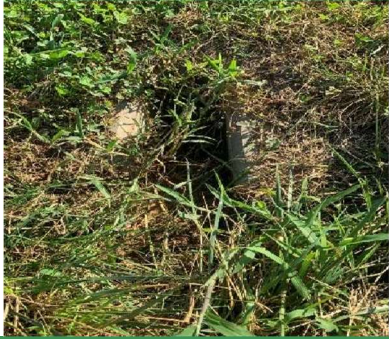
#	Material Type	Object ID	Failure Type	Photo	GIS Reference Page
1	Concrete	MDD_70	Blockage

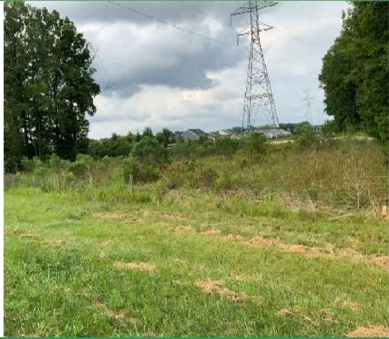
#	Material Type	Object ID	Failure Type	Photo	GIS Reference Page
1	Woven	FN_310	Functional Damage

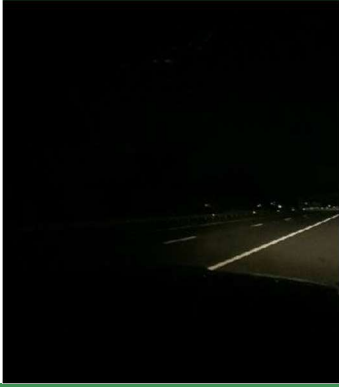
Highway Lighting scored a 67 in the survey due to one sample failure out of three total samples. Deficiencies of highway lighting were directly related to functional damage. The MRP Maintenance and Evaluation Standards V7 are below.

#	Material Type	Object ID	Failure Type	Photo	GIS Reference Page
1	Steel	HL_1	Functional Damage

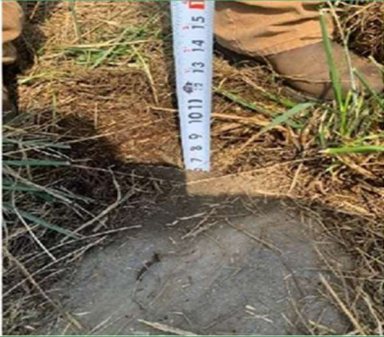
#	Material Type	Object ID	Failure Type	Photo	GIS Reference Page
1	Concrete	IN_150	Erosion

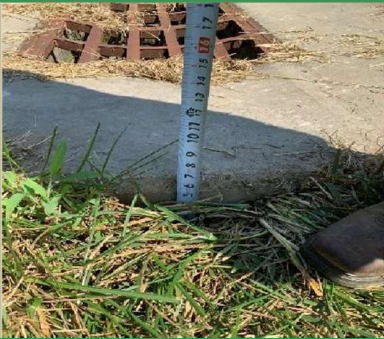
B22
2	Concrete	IN_172	Erosion

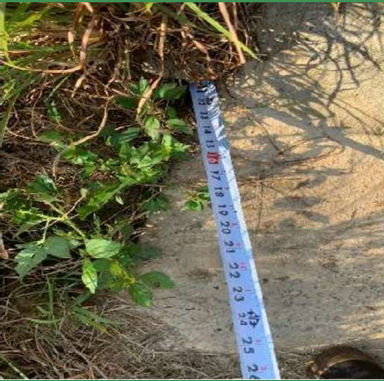
B21
3	Concrete	IN_945	Erosion

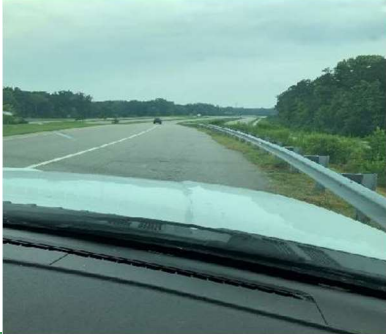
#	Material Type	Object ID	Failure Type	Photo	GIS Reference Page
1	Asphalt	LS_214	Shoulder Buildup

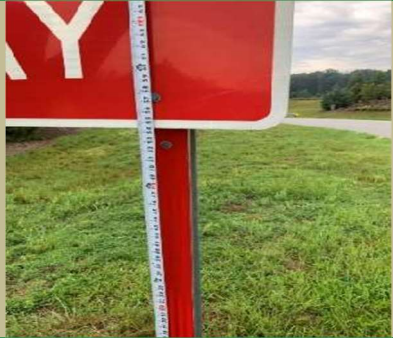
#	Sign Type	Object ID	Failure Type	Photo	GIS Reference Page
4	Wrong Way	SN_862	Sign Height

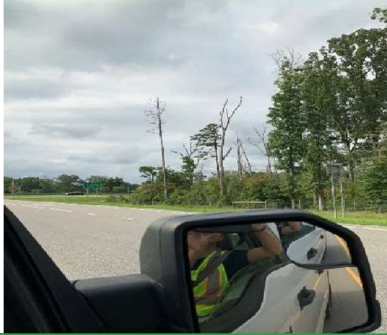
#	Sign Type	Object ID	Failure Type	Photo	GIS Reference Page
1	Tree	TB_72	Hazard
