# Maintenance Rating Program Monroe Expressway

Quarter 2 MRP Assessment

NCTA Monroe By-Pass Roadway Maintenance Performance Rating Program; Q2, FY 2022 Rating

2022 Second Quarter (April - June)

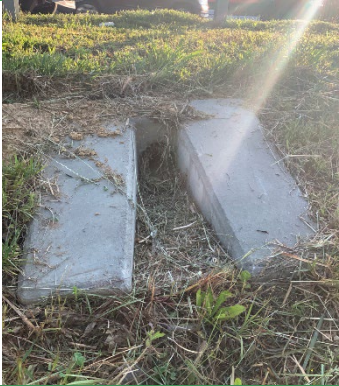
#	Material Type	Object ID	Failure Type	Photo	GIS Reference Page
1	Concrete	MDD_91	Part Missing

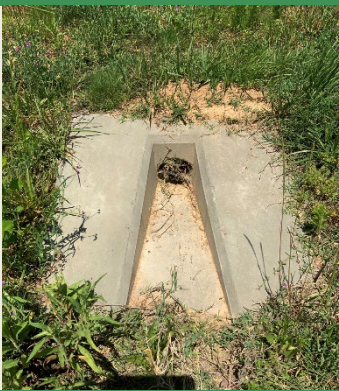
B8
2	Concrete	MDD_112	Part Missing

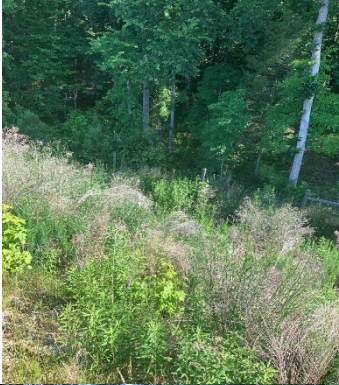
#	Material Type	Object ID	Failure Type	Photo	GIS Reference Page
1	Woven	FN_287	Hole

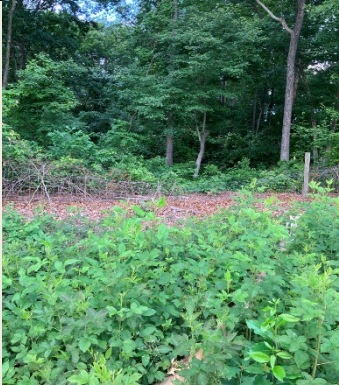
B4
2	Woven	FN_448	Hole

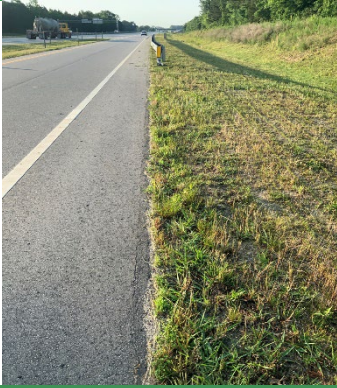
#	Material Type	Object ID	Failure Type	Photo	GIS Reference Page
1	Asphalt	LS_254	Cracking

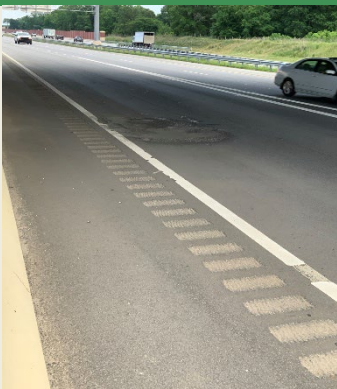
B7
2	Asphalt	LS_665	Rutting

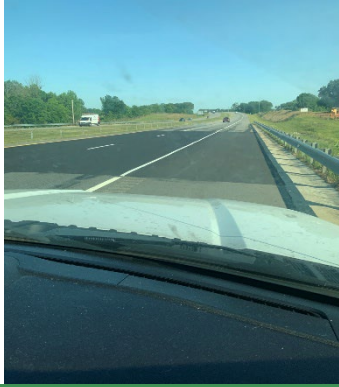
#	Material Type	Object ID	Failure Type	Photo	GIS Reference Page
1	Asphalt	LS_335	Rumble Strip

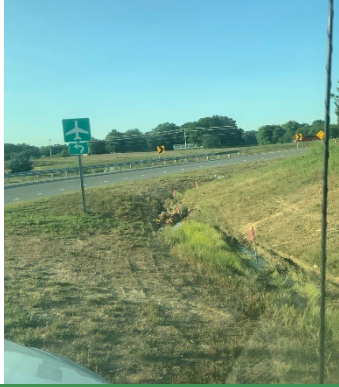
#	Material Type	Object ID	Failure Type	Photo	GIS Reference Page
1	Turf	LS_304	Elevation Deviation

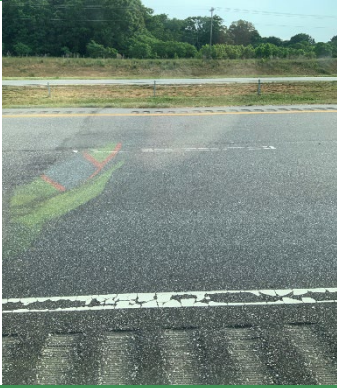
#	Material Type	Object ID	Failure Type	Photo	GIS Reference Page
1	Asphalt	LS_388	Visibility

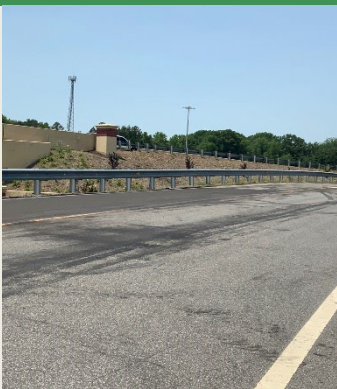
B14
2	Asphalt	LS_721	Line Missing

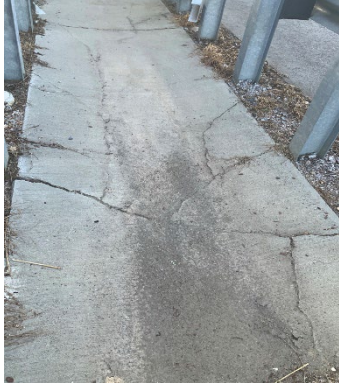
#	Material Type	Object ID	Failure Type	Photo	GIS Reference Page
1	Concrete	PD_41	Cracking

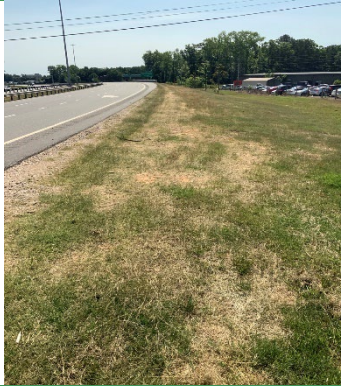
Turf scored a 74 in the survey. Deficiencies of the turf were directly related to bare ground. The MRP Maintenance and Evaluation Standards V7 are below.

#	Material Type	Object ID	Failure Type	Photo	GIS Reference Page
1	Turf	TF_138	Bare Ground

Seeding and fertilizing efforts were last performed in the Spring of 2022. Seeding and fertilizer applications are conducted biannually in both the spring and fall months. Consistent application of this schedule will continue to improve turf conditions on a quarterly basis.

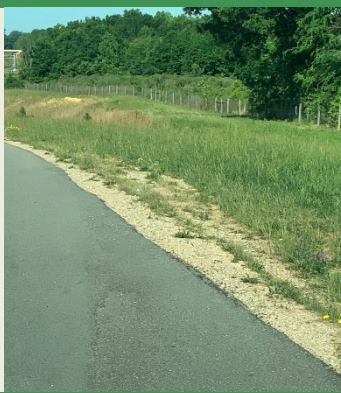
B1
2	Turf	TF_215	Bare Ground

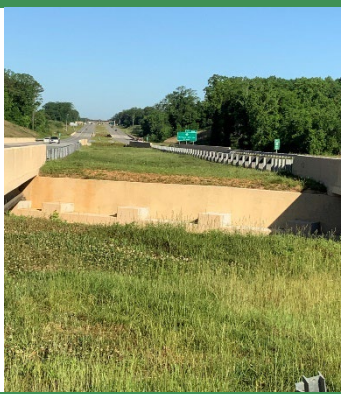
B4
3	Turf	TF_371	Bare Ground

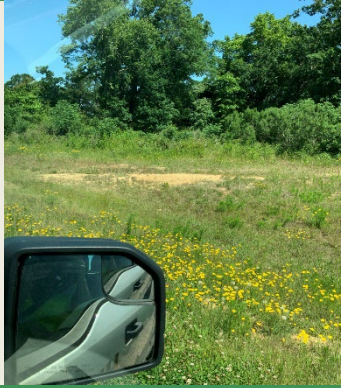
#	Material Type	Object ID	Failure Type	Photo	GIS Reference Page
10	Turf	TF_831	Bare Ground

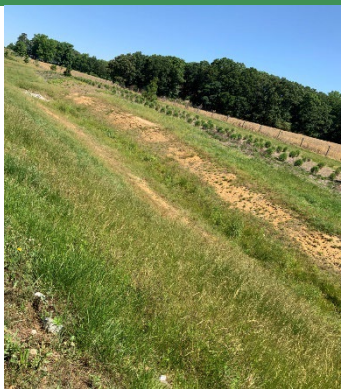
B25
11	Turf	TF_847	Bare Ground

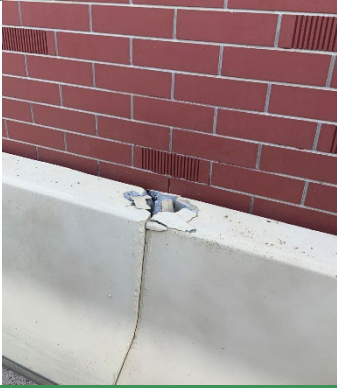
#	Material Type	Object ID	Failure Type	Photo	GIS Reference Page
1	MSE Wall	WL_82	Crack

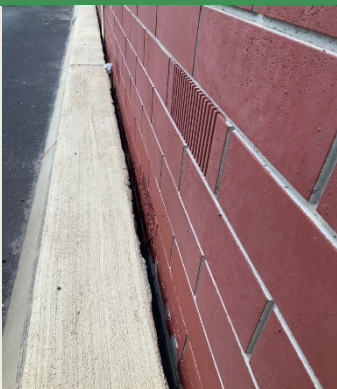
B11
2	MSE Wall	WL_90	Crack
