NORTH CAROLINA  
**Turnpike Authority**

## Maintenance Rating Program

Triangle Expressway

### 2020 First Quarter Report

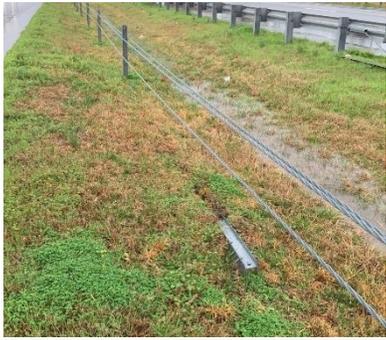
#	Material Type	Object ID	Failure Type	Photo	GIS Reference Page
1	Cable Guardrail	BR_295	Functional Damage

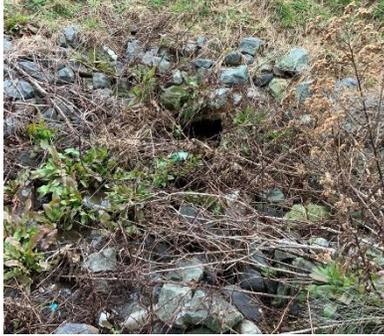
#	Material Type	Object ID	Failure Type	Photo	GIS Reference Page
1	Drainage Pipe	DP_10	Obstruction

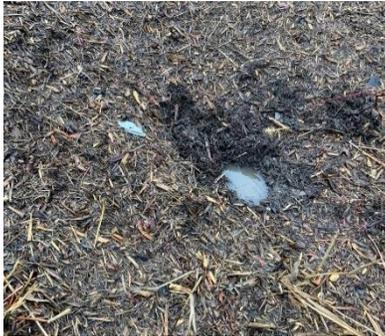
#	Material Type	Object ID	Failure Type	Photo	GIS Reference Page
1	Shoulder Drain	MDP_150	Obstruction

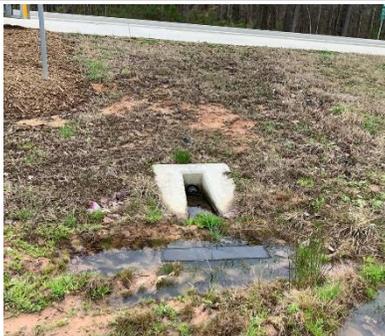
A12
2	Shoulder Drain	MDP_165	End Damage – Build Up

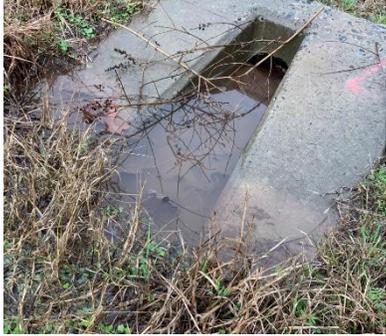
#	Material Type	Object ID	Failure Type	Photo	GIS Reference Page
5	Shoulder Drain	MDP_223	End Damage – Build Up

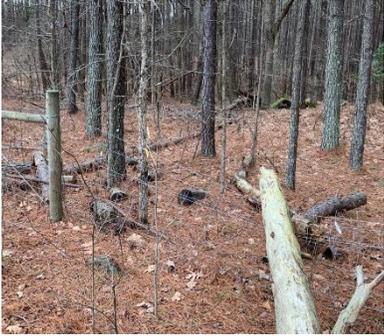
#	Material Type	Object ID	Failure Type	Photo	GIS Reference Page
1	Woven	FN_15	Fence Height

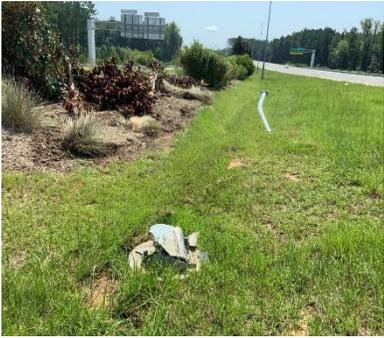
#	Material Type	Object ID	Failure Type	Photo	GIS Reference Page
1	High Mast	HL_14	Part Damage, Missing Part

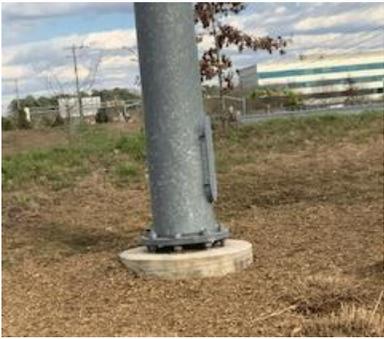
A25
2	Double Roadway	HL_117	Rodent Screen

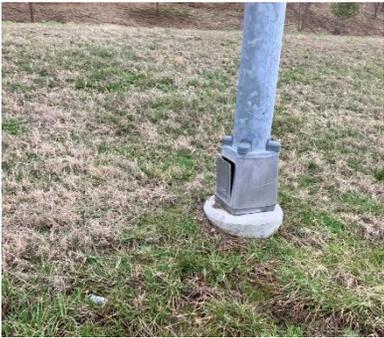
A34
3	Single Roadway	HL_163	Pole Damage

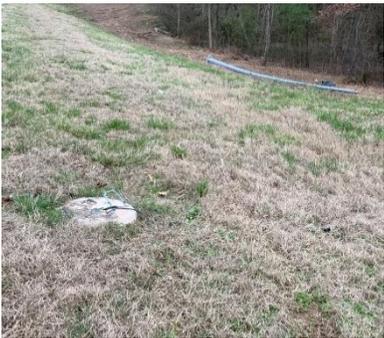
A3
4	Double Roadway	HL_168	Part Damage, Missing Parts

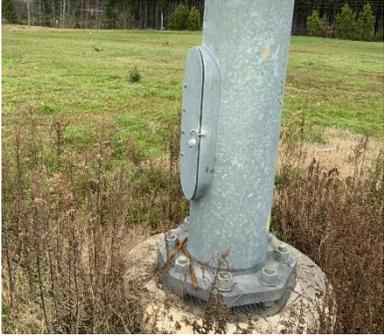
#	Material Type	Object ID	Failure Type	Photo	GIS Reference Page
5	High Mast	HL_318	Part Damage

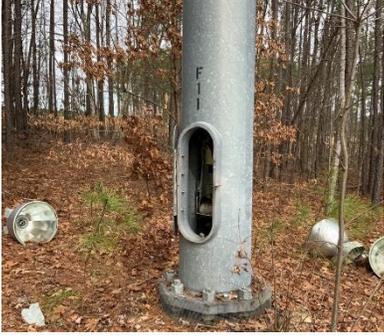
A18, A19
6	High Mast	HL_328	Part Damage

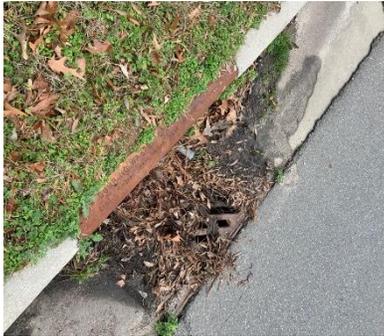
#	Material Type	Object ID	Failure Type	Photo	GIS Reference Page
1	Inlet	IN_544	Obstruction

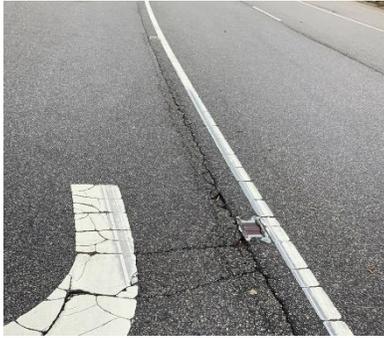
#	Material Type	Object ID	Failure Type	Photo	GIS Reference Page
1	Asphalt	LS_207	Unsealed Cracks

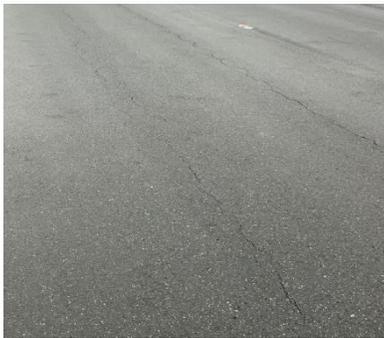
A35
2	Asphalt	LS_765	Unsealed Cracks

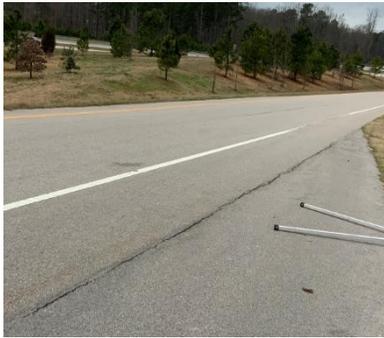
#	Material Type	Object ID	Failure Type	Photo	GIS Reference Page
1	Asphalt	LS_489	Unsealed Cracks

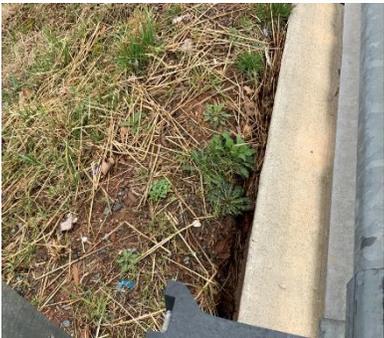
#	Material Type	Object ID	Failure Type	Photo	GIS Reference Page
1	Concrete	LS_472	Elevation Deviation

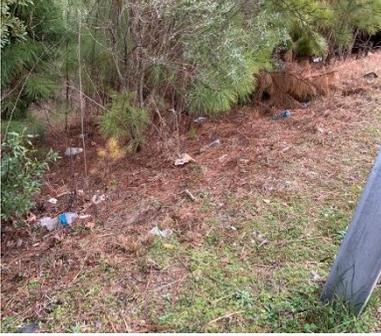
#	Material Type	Object ID	Failure Type	Photo	GIS Reference Page
1	Concrete	LS_42	Litter

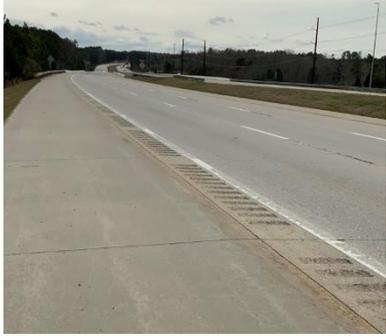
#	Material Type	Object ID	Failure Type	Photo	GIS Reference Page
1	Asphalt	LS_23	Nighttime Reflectivity	Not Available for Nighttime Failure	A27
2	Concrete	LS_42	Line Width

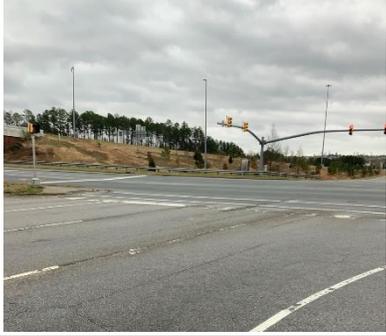
A14
3	Asphalt	LS_207	Line Missing

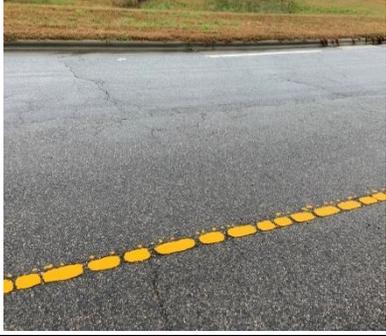
A35
4	Asphalt	LS_733	Line Missing

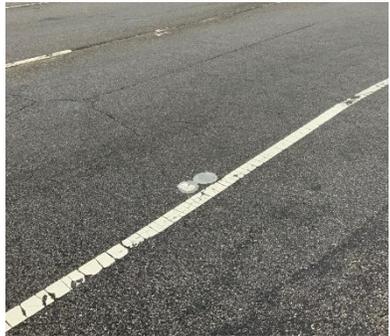
#	Material Type	Object ID	Failure Type	Photo	GIS Reference Page
1	Asphalt	LS_207	Reflective Marker Missing & Nighttime Reflectivity

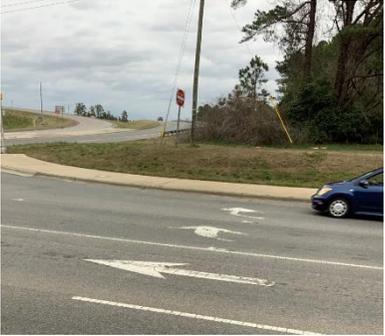
#	Material Type	Object ID	Failure Type	Photo	GIS Reference Page
1	Left Turn	PS_406	Nighttime Reflectivity	Not Available for Nighttime Failure	A1
2	Thru Arrow	PS_412	Nighttime Reflectivity

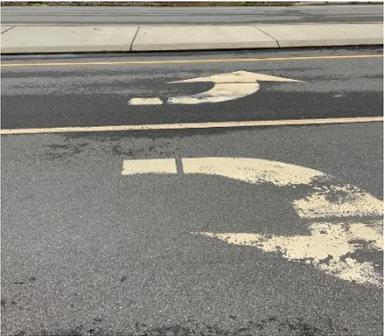
A1
3	Thru Arrow	PS_518	Nighttime Reflectivity	Not Available for Nighttime Failure	A13
4	Left Turn	PS_577	Nighttime Reflectivity

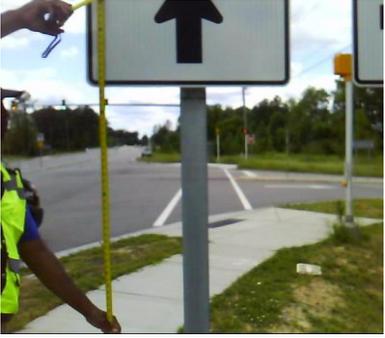
#	Sign Type	Object ID	Failure Type	Photo	GIS Reference Page
1	NC Route	SN_334	Height Requirement

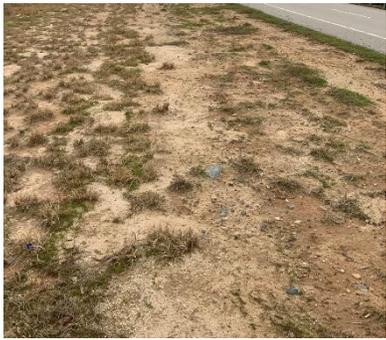
#	Material Type	Object ID	Failure Type	Photo	GIS Reference Page
1	Turf	TF_235	Bare Ground

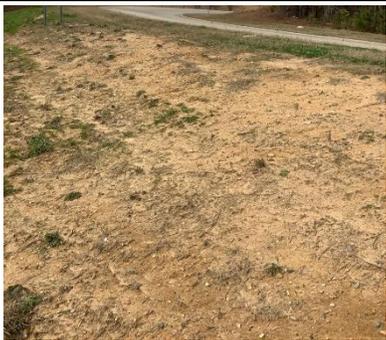
A30
4	Turf	TF_496	Bare Ground

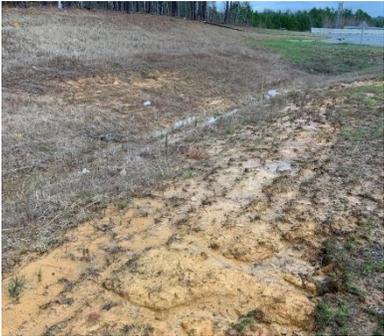
#	Material Type	Object ID	Failure Type	Photo	GIS Reference Page
5	Turf	TF_1028	Bare Ground

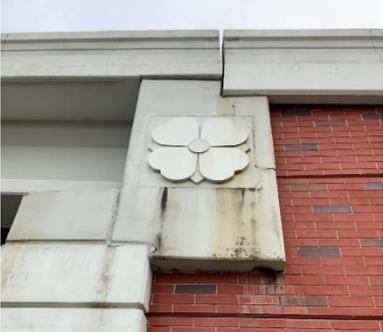
#	Material Type	Object ID	Failure Type	Photo	GIS Reference Page
1	Sound Wall	WL_37	Unsealed Crack
