NORTH CAROLINA
Turnpike Authority

Maintenance Rating Program

Triangle Expressway

2020 Fourth Quarter and Annual Report

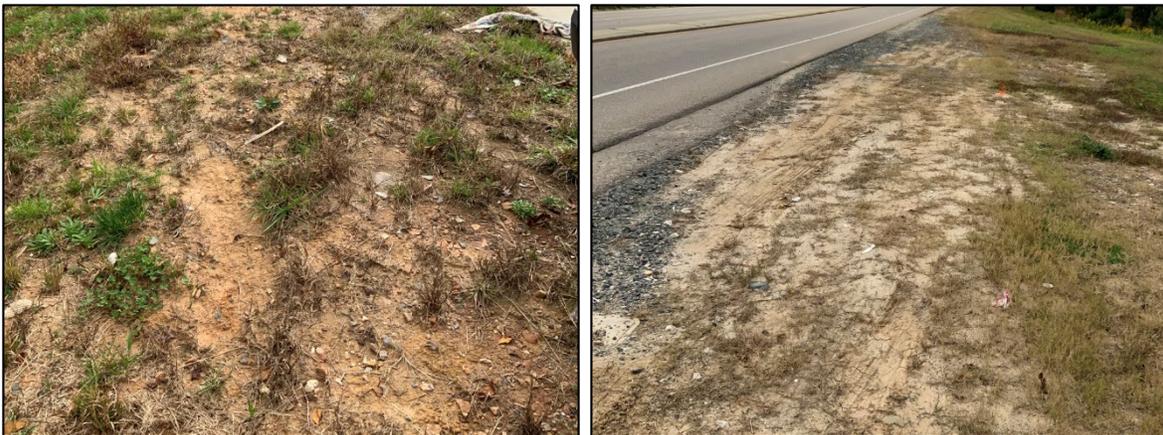
Figure 3: Turf Condition Inspection Results Sample

Turf Condition (62 rating – 32 of the 52 assets did not pass): All the turf sections that did not pass inspection were due to bare ground. Two of the sections that did not pass inspection are presented in **Figure 3**.

To continue to improve the Turf Condition rating, it is recommended that the maintenance provider continue with an aggressive schedule for seeding and fertilization cycles of bare ground areas during the spring and early summer. Some areas will require scarifying of the soil as these areas are heavily compacted and inundated with aggregate.

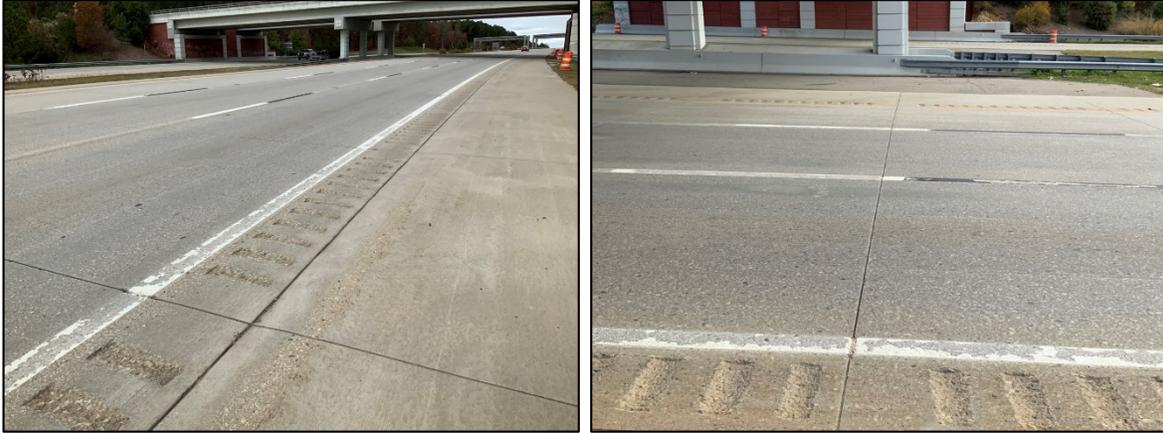
Figure 4: Pavement Striping Inspection Results Sample

Pavement Striping (65 rating – 17 of the 26 assets passed): There were 9 pavement striping/marketing segments that did not pass inspection, these segments were identified as missing sections, not meeting the required line width, or not reflecting during the nighttime inspection. Two of the pavement striping and marking segments that did not pass inspection are presented in **Figure 4**.

To maintain a well-defined lane delineation throughout the Triangle Expressway, it is recommended that the maintenance provider consider scheduling pavement striping/marketing replacement cycles in accordance with the *NCTA Roadway and Facility Maintenance Standards V6*, referenced below.

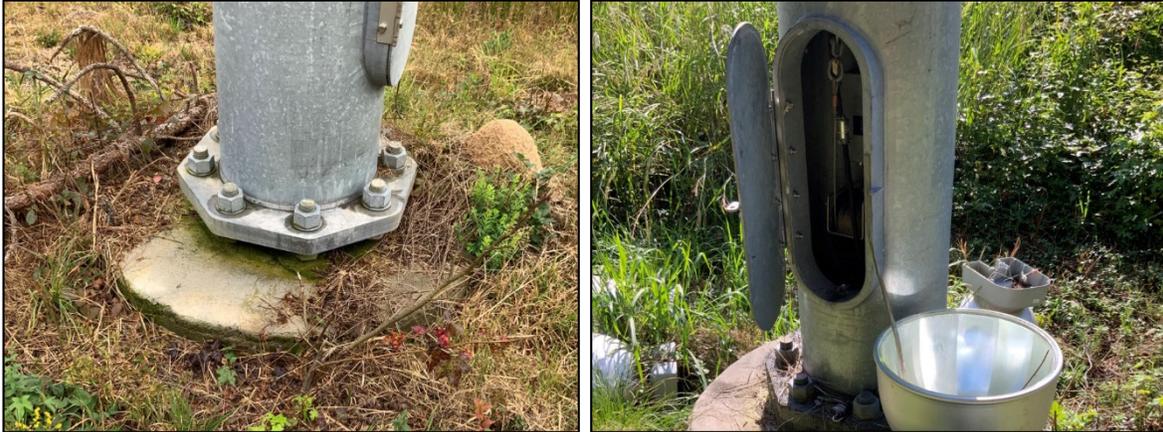
Figure 5: Highway Lighting Inspection Results Sample

Highway Lighting (78 rating – 25 of the 32 assets failed). Out of the 7 highway lights that did not pass inspection, 6 had damaged or open electrical access and 1 had a missing rodent screen. Two of these highway lights are presented in **Figure 5**.

To increase future highway lighting ratings, it is recommended that all damaged highway lights noted during the inspection be repaired and/or replaced in accordance with the *NCTA Roadway and Facility Maintenance Standards V6*, referenced below. Additional care should be taken to ensure all access panels are properly secured to prevent rodent and other animal intrusion.

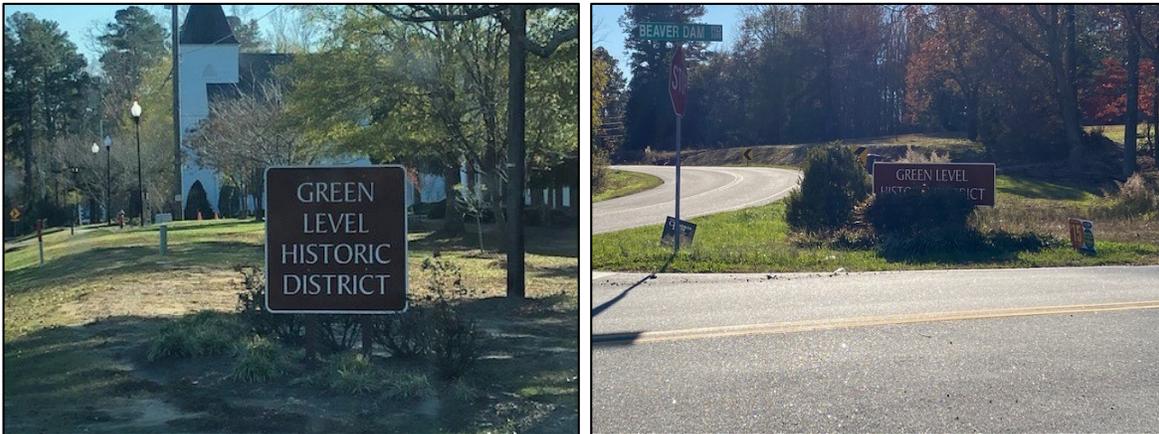
Figure 7: Green Level West Historic District Signs, Landscape Areas

As part of each quarterly inspection, an assessment team visits the three Green Level Historic District signs to conduct a visual inspection of each sign and ensure they are in good standing. Two of the three signs included in the inspection inventory were found to be in good condition, with the landscaped areas being well maintained. The third sign had been temporarily removed due to nearby construction activities. **Figure 7** shows the two signs assessed and the area of the third sign.

This quarter, the two Green Level Historic District signs inspected were found to be in good condition while the third sign was identified to have been removed for a Town of Cary development project near Green Level West Road. Additionally, the landscaped areas surrounding the signs were found to be well maintained.

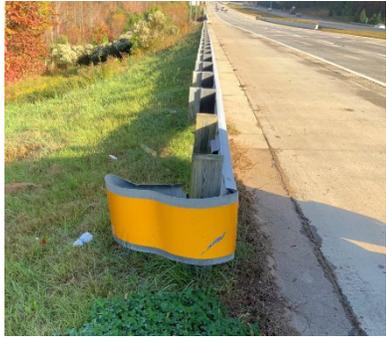
#	Material Type	Object ID	Failure Type	Photo	GIS Reference Page
1	Guardrail	BR_86	Functional Damage

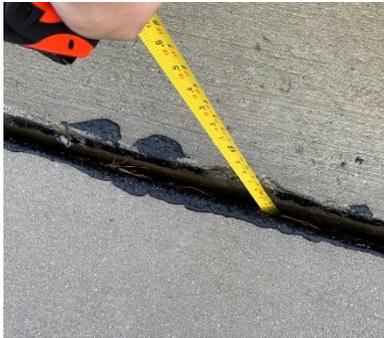
#	Material Type	Object ID	Failure Type	Photo	GIS Reference Page
1	Curb and Gutter	CG_8	Settlement

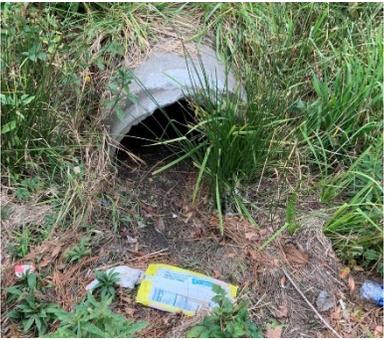
#	Material Type	Object ID	Failure Type	Photo	GIS Reference Page
1	Drain	DP_408	Obstruction

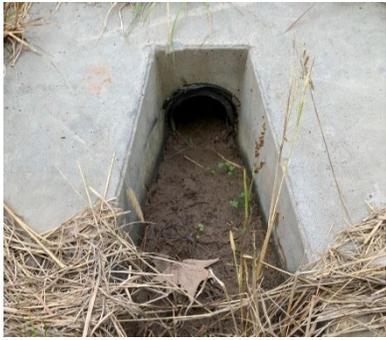
#	Material Type	Object ID	Failure Type	Photo	GIS Reference Page
1	Shoulder Drain	MDP_34	Rodent Screen

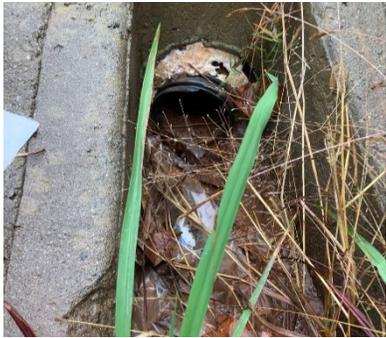
#	Material Type	Object ID	Failure Type	Photo	GIS Reference Page
5	Shoulder Drain	MDP_221	Rodent Screen

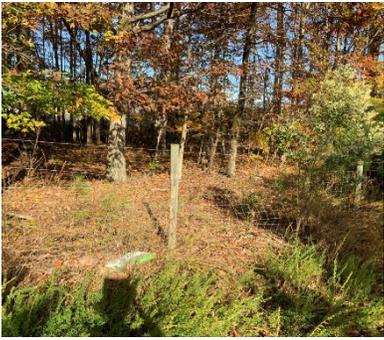
#	Material Type	Object ID	Failure Type	Photo	GIS Reference Page
1	Woven	FN_73	Hole Height

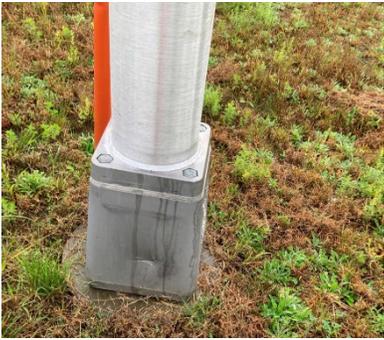
#	Material Type	Object ID	Failure Type	Photo	GIS Reference Page
1	Single Roadway	HL_33	Part Damage

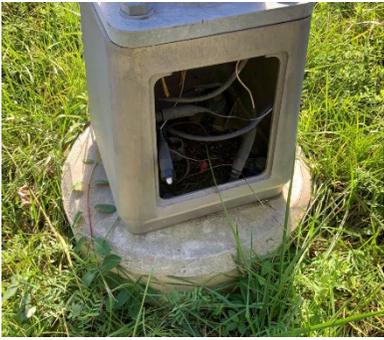
#	Material Type	Object ID	Failure Type	Photo	GIS Reference Page
5	Single Roadway	HL_235	Part Damage

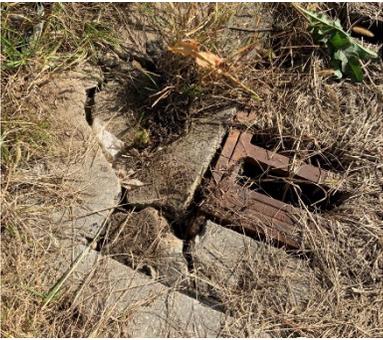
#	Material Type	Object ID	Failure Type	Photo	GIS Reference Page
1	Inlet	IN_3	Obstruction, Surface Damage

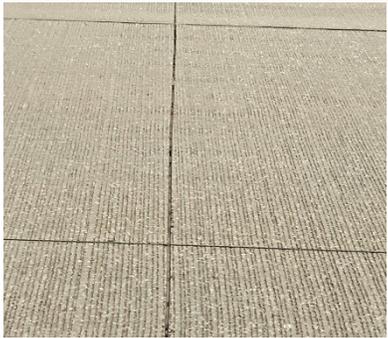
#	Material Type	Object ID	Failure Type	Photo	GIS Reference Page
1	Concrete	LS_342	Joint Seal Damage

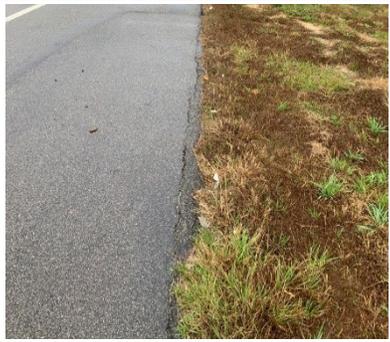
#	Material Type	Object ID	Failure Type	Photo	GIS Reference Page
1	Asphalt	LS_533	Unsealed Cracks

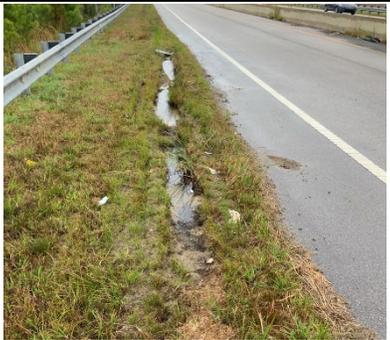
#	Material Type	Object ID	Failure Type	Photo	GIS Reference Page
1	Asphalt	LS_533	Drop-Off

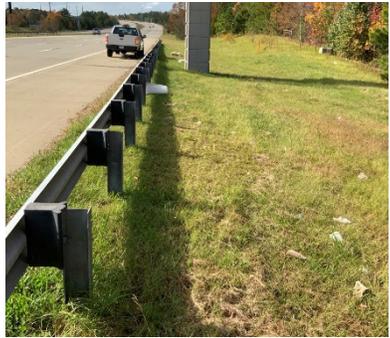
#	Material Type	Object ID	Failure Type	Photo	GIS Reference Page
1	Asphalt	LS_342	Litter – 3CF

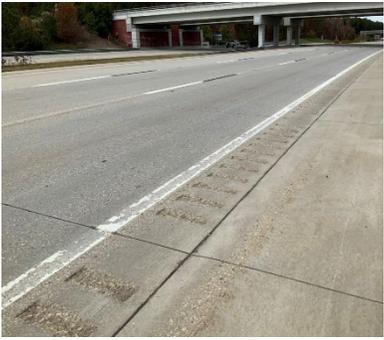
#	Material Type	Object ID	Failure Type	Photo	GIS Reference Page
1	Concrete	LS_65	Line Missing

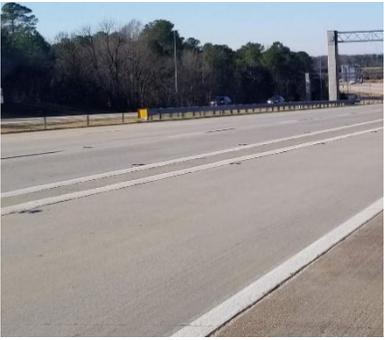
#	Material Type	Object ID	Failure Type	Photo	GIS Reference Page
1	Concrete	LS_588	Nighttime Reflectivity

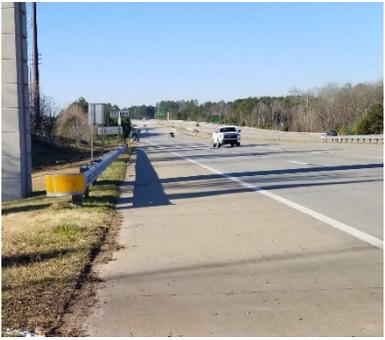
#	Material Type	Object ID	Failure Type	Photo	GIS Reference Page
1	Concrete	LS_351	Missing & Nighttime Reflectivity

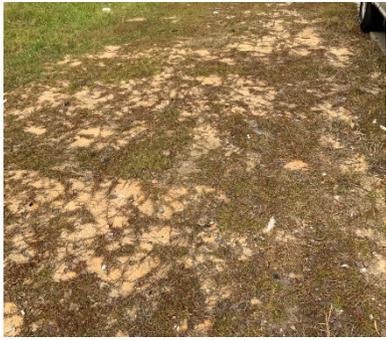
#	Material Type	Object ID	Failure Type	Photo	GIS Reference Page
1	Turf	TF_37	Bare Ground

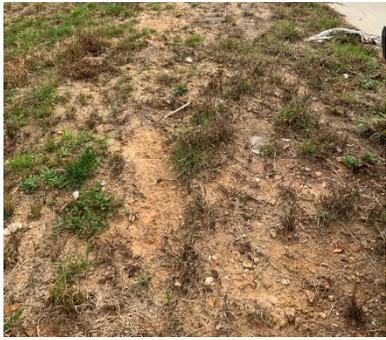
#	Material Type	Object ID	Failure Type	Photo	GIS Reference Page
5	Turf	TF_150	Bare Ground

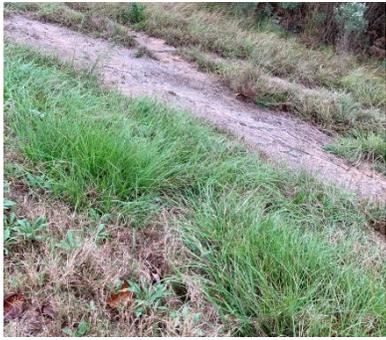
#	Material Type	Object ID	Failure Type	Photo	GIS Reference Page
9	Turf	TF_306	Bare Ground

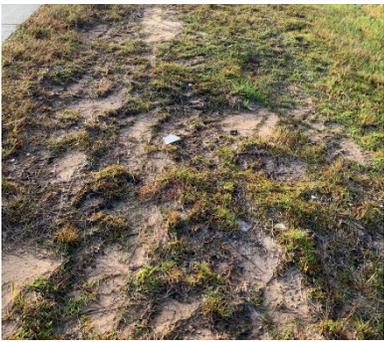
#	Material Type	Object ID	Failure Type	Photo	GIS Reference Page
17	Turf	TF_601	Bare Ground
