NORTH CAROLINA  
**Turnpike Authority**

## Maintenance Rating Program

Triangle Expressway

## 2021 First Quarter and Annual Report

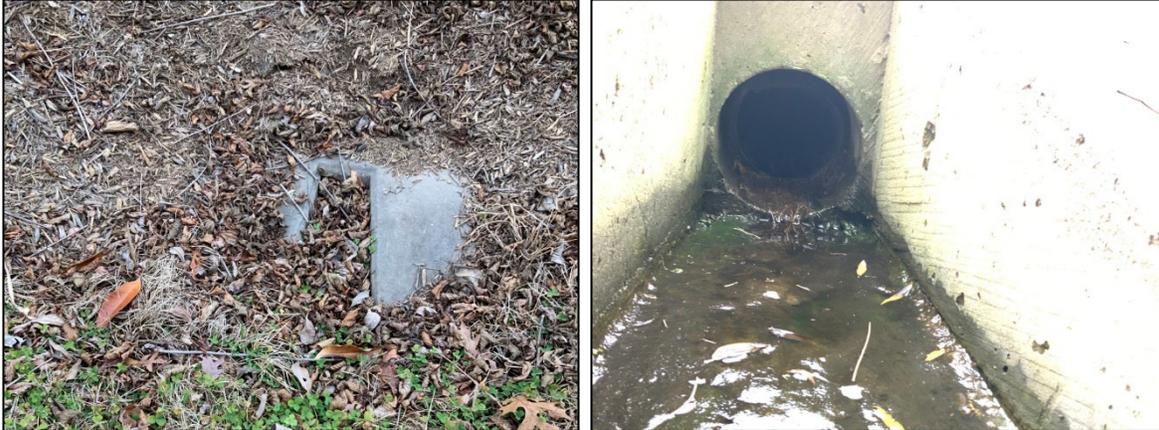
**Figure 3: Miscellaneous Drainage Structure Inspection Results Sample**

Miscellaneous Drainage Structures (75 rating – 21 of the 28 assets passed): Out of the 7 structures that did not pass inspection, 2 were obstructed and 5 had a missing or damaged rodent screen at the outlet. Two of the miscellaneous drainage structures (shoulder underdrains) that did not pass inspection are presented in **Figure 3**.

To avoid affecting the natural flow of water near the drainage features and reducing the design life of pavement performance, it is recommended that outlet elevations be checked against the outflow ditch elevations to ensure positive drainage. Appropriate grading of the ditch line may be necessary to provide positive flow.

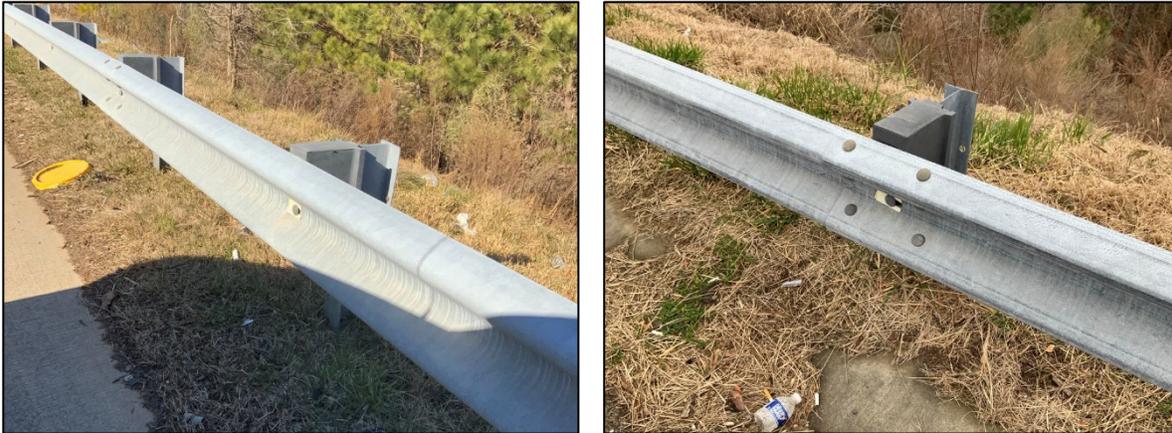
**Figure 4: Delineator Inspection Results Sample**

Delineators (75 rating – 30 of the 40 assets passed): The delineator segments that did not pass inspection were identified as missing more than 10% of the required markers along guardrail segments or not reflecting during nighttime inspection. Two of the delineator segments that did not pass inspection are presented in **Figure 4**.

To maintain a well-defined delineation throughout the Triangle Expressway, it is recommended that the maintenance provider consider scheduling replacement cycles in accordance with the *NCTA Roadway and Facility Maintenance Standards V6*, referenced below.

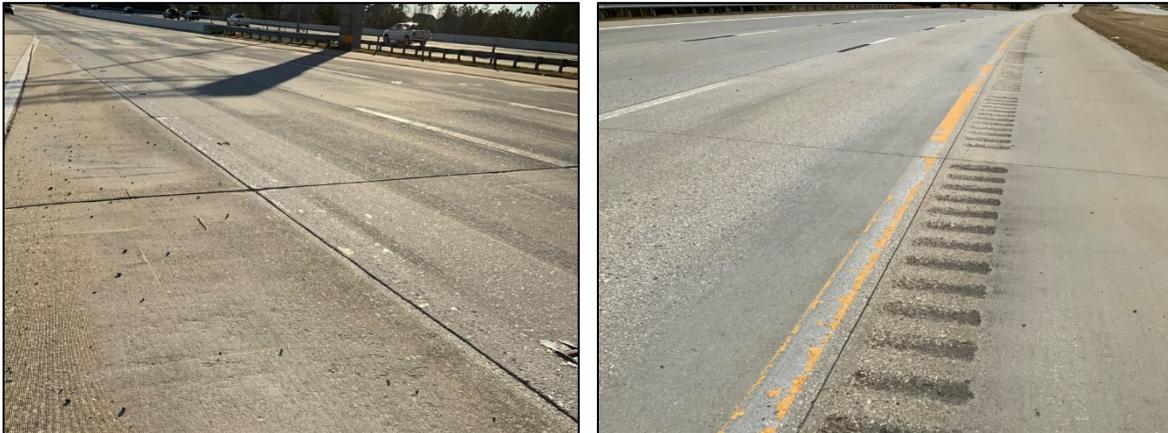
**Figure 5: Pavement Striping Inspection Results Sample**

Pavement Striping (74 rating – 20 of the 27 assets passed): There were 7 pavement striping/markings segments that did not pass inspection, these segments were identified as missing more than 10% of any line segment in the sections, not meeting the required line width, or not reflecting during the nighttime inspection. Two of the pavement striping and marking segments that did not pass inspection are presented in **Figure 5**.

To maintain a well-defined lane delineation throughout the Triangle Expressway, it is recommended that the maintenance provider consider scheduling pavement striping/markings replacement cycles in accordance with the *NCTA Roadway and Facility Maintenance Standards V6*, referenced below.

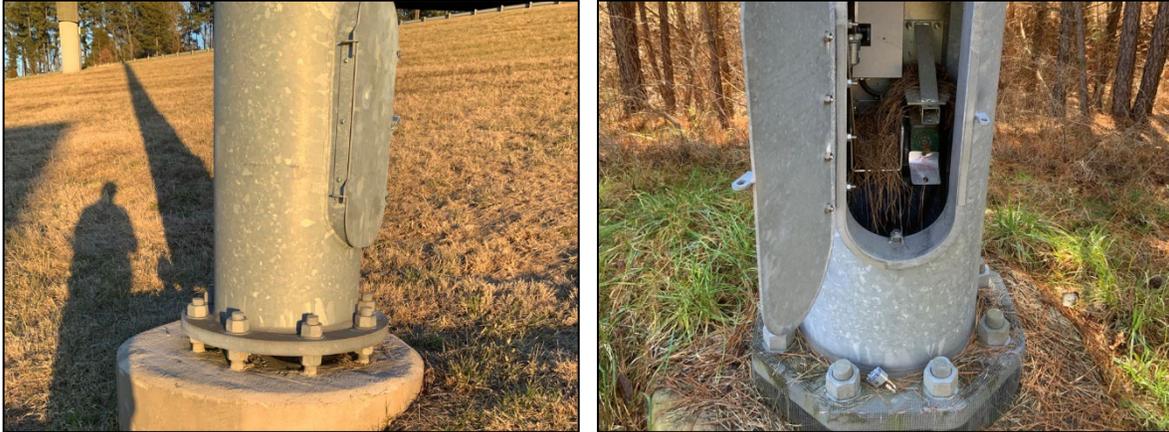
**Figure 6: Highway Lighting Inspection Results Sample**

Highway Lighting (78 rating – 32 of the 41 assets failed). Out of the 9 highway lights that did not pass inspection, 7 had damaged or open electrical access and 2 had a missing rodent screen at the base. Two of these highway lights are presented in **Figure 6**.

To increase future highway lighting ratings, it is recommended that all damaged highway lights noted during the inspection be repaired and/or replaced in accordance with the *NCTA Roadway and Facility Maintenance Standards V6*, referenced below. Additional care should be taken to ensure all access panels are properly secured to prevent rodent and other animal intrusion.

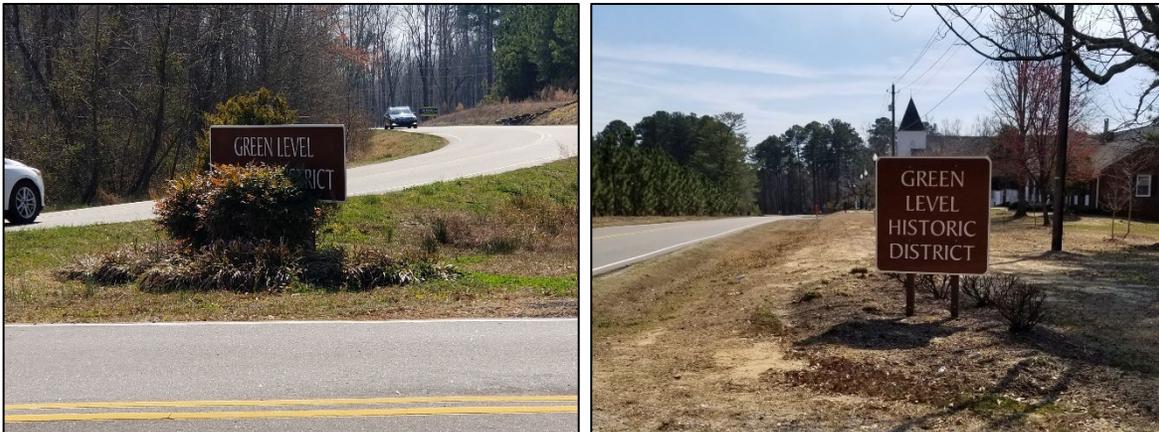
**Figure 7: Green Level West Historic District Signs, Landscape Areas**

As part of each quarterly inspection, an assessment team visits the three Green Level Historic District signs to conduct a visual inspection of each sign and ensure they are in good standing. Two of the three signs included in the inspection inventory were found to be in good condition, with the landscaped areas being well maintained. The landscape area of the sign at intersection of Green Level West Road and Beaver Dam Road did partially obstruct the text of the sign. The third sign had been temporarily removed due to nearby construction activities. **Figure 7** shows the two signs assessed and the area of the third sign.

This quarter, the two Green Level Historic District signs inspected were found to be in good condition while the third sign was identified to have been removed for a Town of Cary development project near Green Level West Road. Additionally, the landscaped areas surrounding the signs were found to be well maintained.

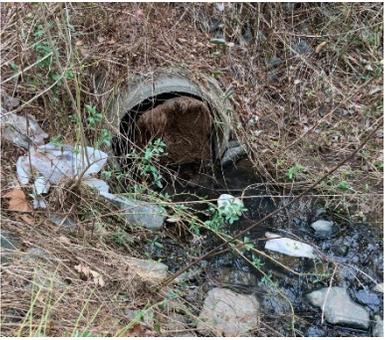
#	Material Type	Object ID	Failure Type	Photo	GIS Reference Page
1	Drain	DP_634	Obstruction

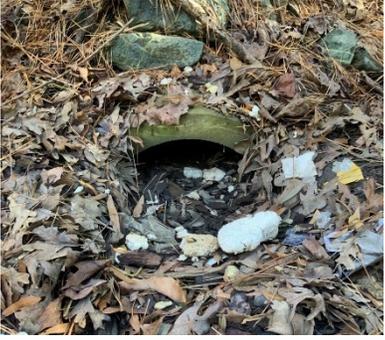
A32
2	Drain	DP_778	Obstruction

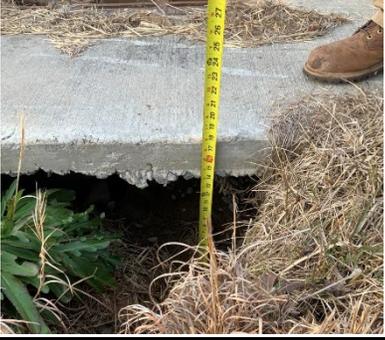
A27
3	Drain	DP_786	Erosion, Water Infiltration

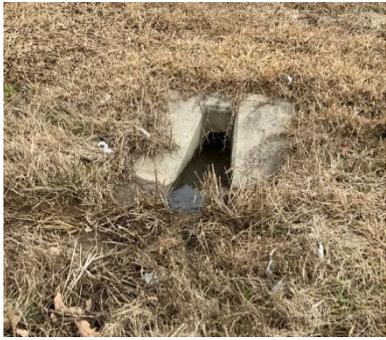
#	Material Type	Object ID	Failure Type	Photo	GIS Reference Page
1	Shoulder Drain	MDP_66	Rodent Screen

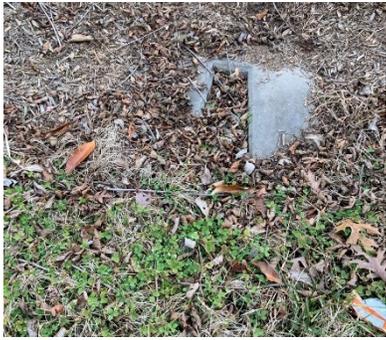
#	Material Type	Object ID	Failure Type	Photo	GIS Reference Page
5	Shoulder Drain	MDP_117	Obstruction

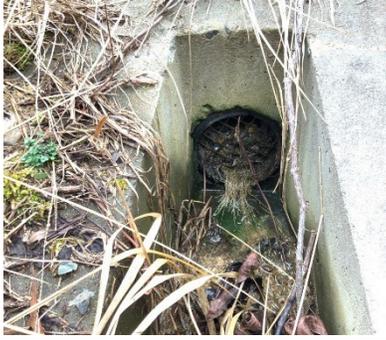
A23
6	Shoulder Drain	MDP_123	Obstruction

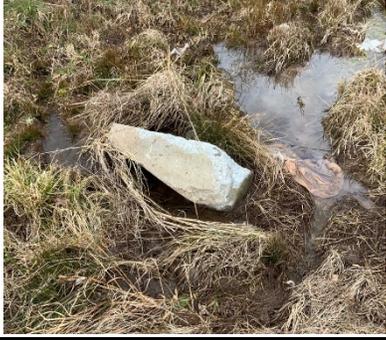
A23
7	Shoulder Drain	MDP_204	Rodent Screen, End Damage

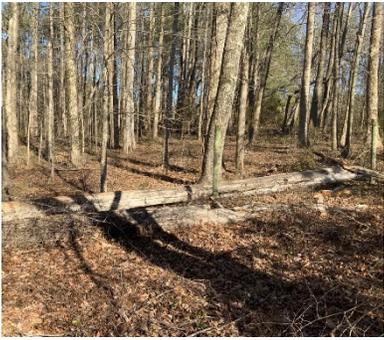
#	Material Type	Object ID	Failure Type	Photo	GIS Reference Page
1	Woven	FN_106	Fence Height

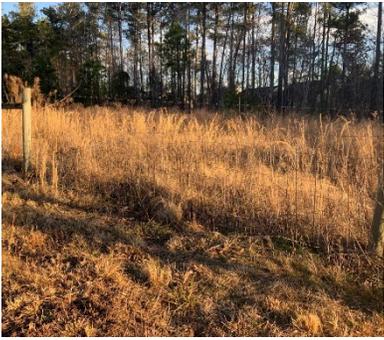
#	Material Type	Object ID	Failure Type	Photo	GIS Reference Page
5	Woven	FN_209	Fence Hole

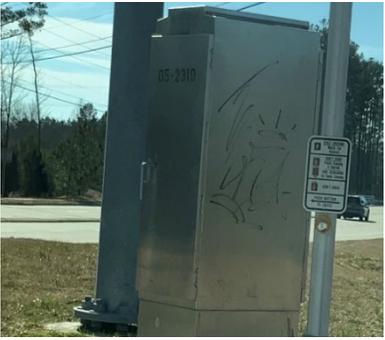
#	Material Type	Object ID	Failure Type	Photo	GIS Reference Page
1	Signal Cabinet	GR_1	Graffiti

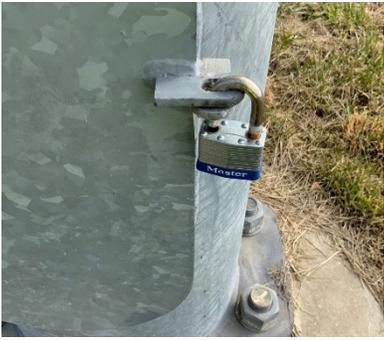
#	Material Type	Object ID	Failure Type	Photo	GIS Reference Page
1	High Mast	HL_1	Part Damage

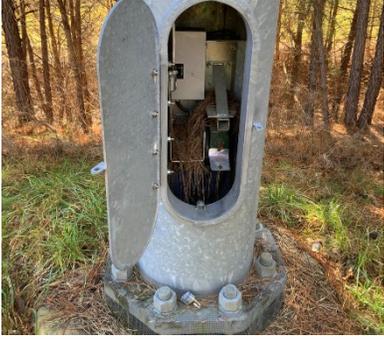
A30
2	High Mast	HL_100	Part Damage

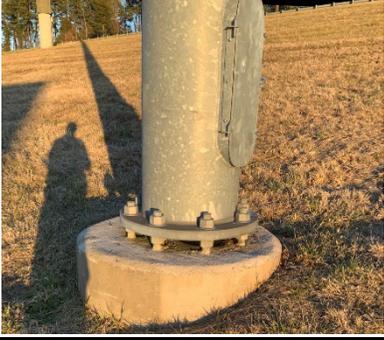
A6
3	High Mast	HL_158	Rodent Screen

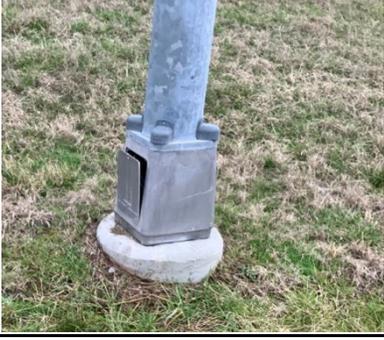
A3
4	Double Roadway	HL_163	Part Damage

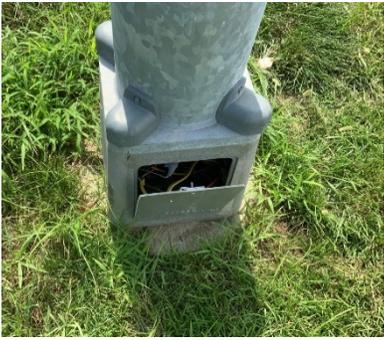
#	Material Type	Object ID	Failure Type	Photo	GIS Reference Page
5	Double Roadway	HL_165	Part Damage

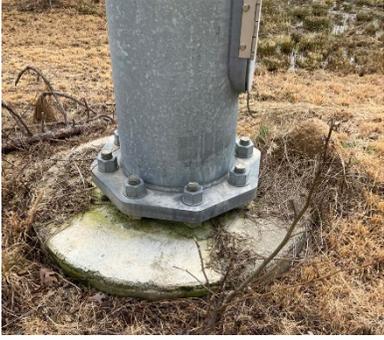
A2
6	High Mast	HL_279	Rodent Screen

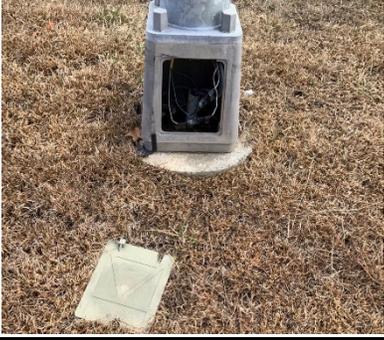
A25
7	Single Roadway	HL_311	Part Damage

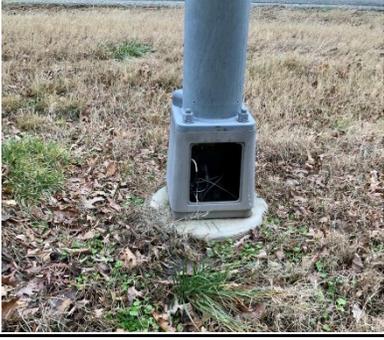
A20
8	Single Roadway	HL_336	Part Damage

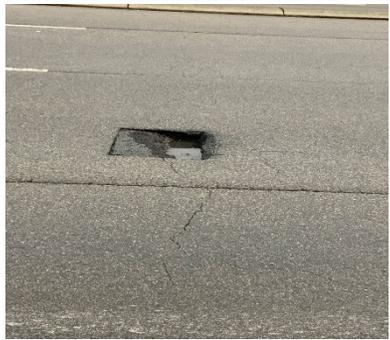
#	Material Type	Object ID	Failure Type	Photo	GIS Reference Page
1	Asphalt	LS_735	Pothole

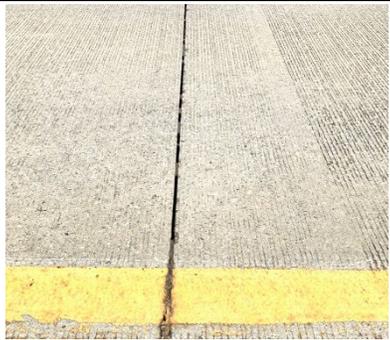
#	Material Type	Object ID	Failure Type	Photo	GIS Reference Page
1	Concrete	LS_316	Joint Malfunction

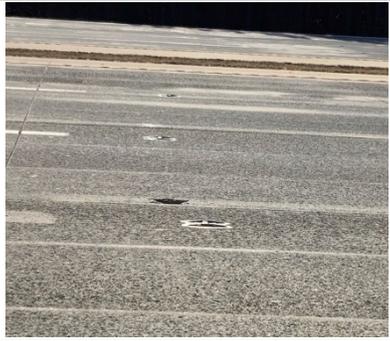
A2
2	Concrete	LS_458	Pothole

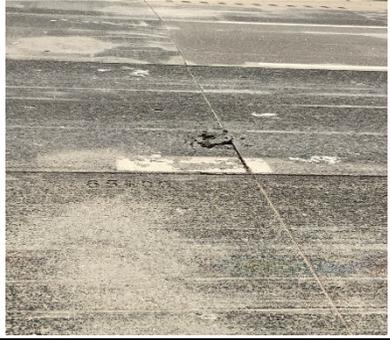
A28
3	Concrete	LS_478	Spalling

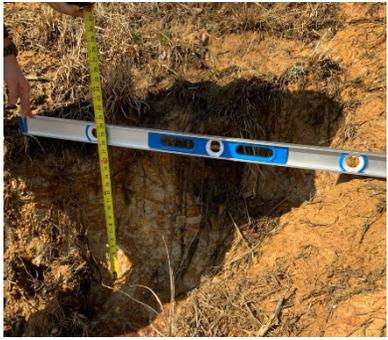
#	Material Type	Object ID	Failure Type	Photo	GIS Reference Page
1	Concrete	LS_476	Slope Deviation

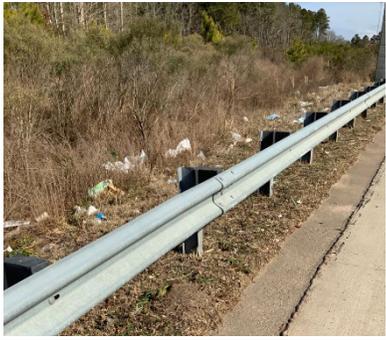
#	Material Type	Object ID	Failure Type	Photo	GIS Reference Page
5	Concrete	LS_480	Litter – 3CF

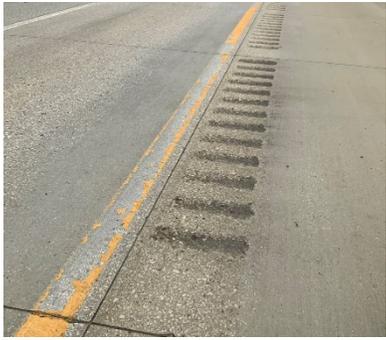
#	Material Type	Object ID	Failure Type	Photo	GIS Reference Page
1	Concrete	LS_71	Line Missing

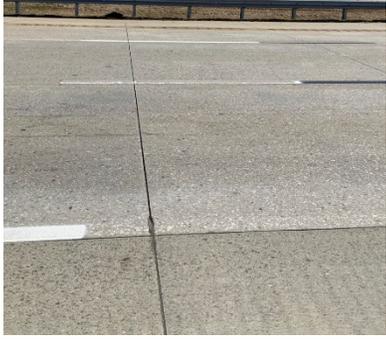
A10
2	Concrete	LS_137	Line Missing

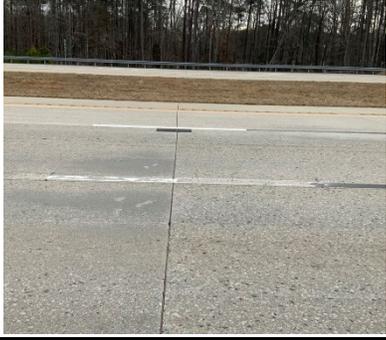
A10
3	Concrete	LS_140	Line Missing

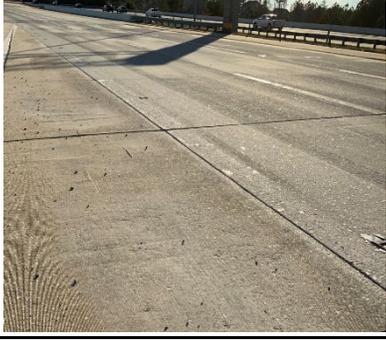
A11
4	Concrete	LS_604	Line Missing

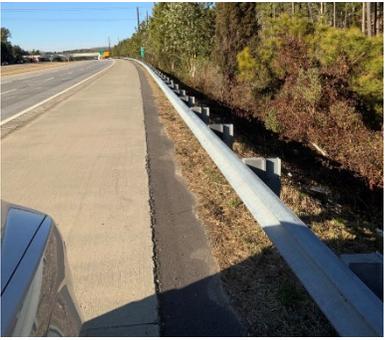
#	Material Type	Object ID	Failure Type	Photo	GIS Reference Page
1	Concrete	LS_71	Missing & Nighttime Reflectivity

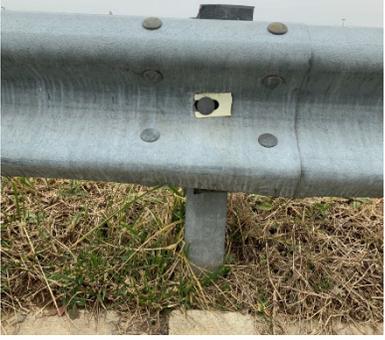
A10
2	Asphalt	LS_214	Missing & Nighttime Reflectivity

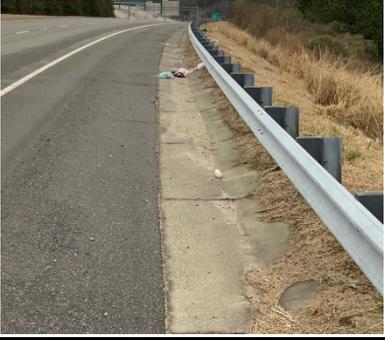
A3
3	Asphalt	LS_314	Missing & Nighttime Reflectivity

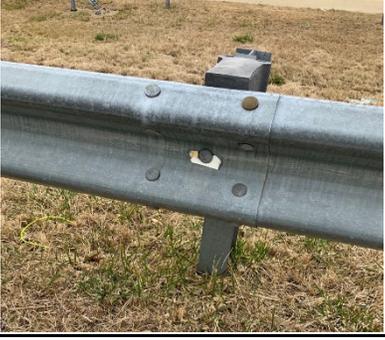
A1
4	Concrete	LS_316	Missing & Nighttime Reflectivity

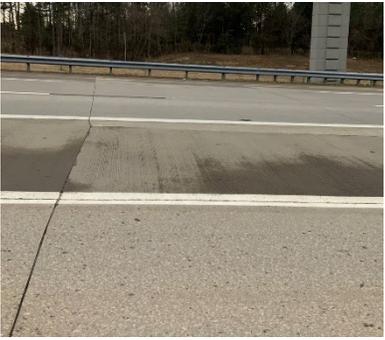
#	Material Type	Object ID	Failure Type	Photo	GIS Reference Page
5	Concrete	LS_326	Missing & Nighttime Reflectivity

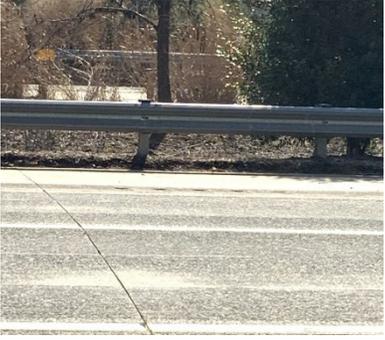
A2
6	Concrete	LS_476	Missing & Nighttime Reflectivity

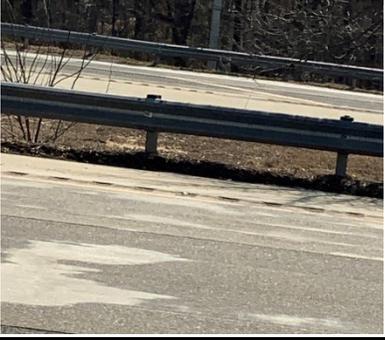
A29
7	Concrete	LS_478	Missing & Nighttime Reflectivity

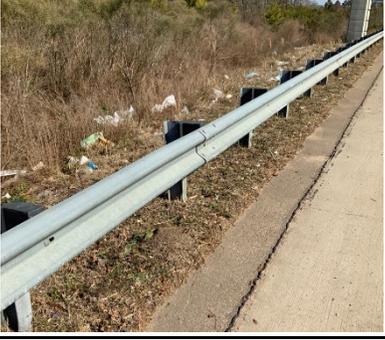
A29, A30
8	Concrete	LS_480	Missing & Nighttime Reflectivity

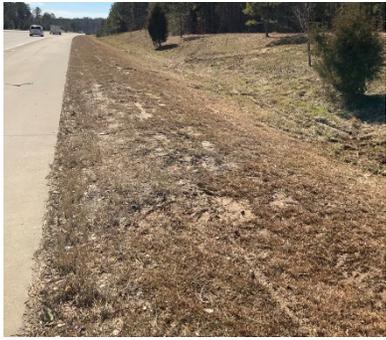
#	Material Type	Object ID	Failure Type	Photo	GIS Reference Page
1	Turf	TF_36	Bare Ground

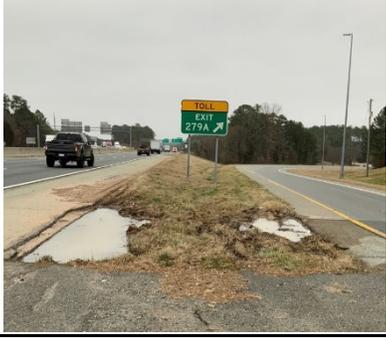
A23
4	Turf	TF_280	Bare Ground
