Maintenance Rating Program

Triangle Expressway

2021 Second Quarter Report

NCTA Triangle Expressway Roadway Maintenance Performance Rating Program; Q2, FY 2021 Rating

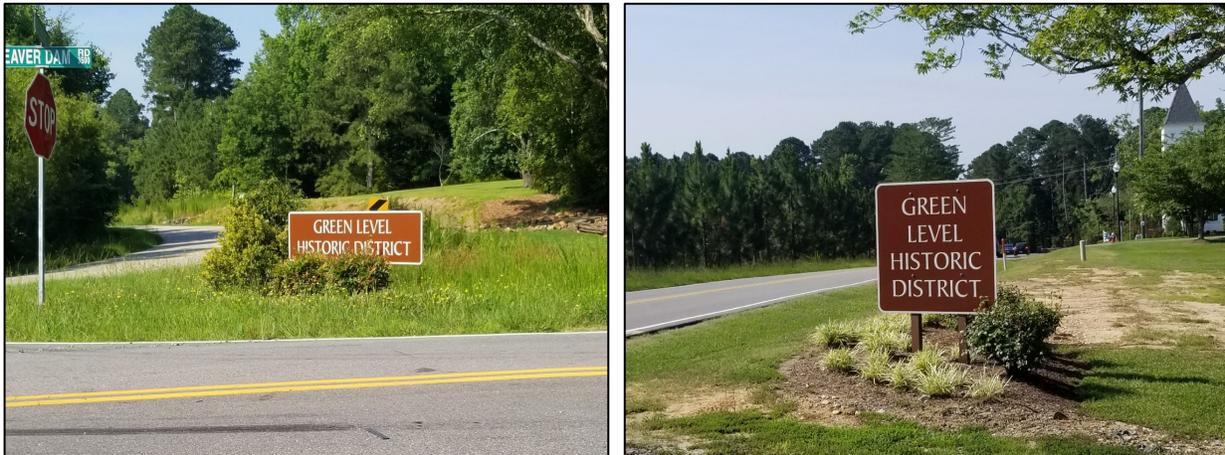
Figure 3: Green Level West Historic District Signs, Landscape Areas

In addition, the report provides findings of the Green Level Historic District signs inspection. This quarter, two signs were inspected. Both signs were found to be in good physical condition, and the landscaped areas around the signs were maintained in accordance with NCTA MRP standards.

This quarter, the two Green Level Historic District signs inspected were found to be in good condition. Additionally, the landscaped areas surrounding the signs were found to be well maintained.

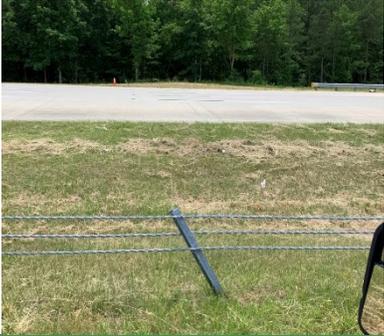
#	Material Type	Object ID	Failure Type	Photo	GIS Reference Page
1	Guardrail	BR_313	Twisted Blocks

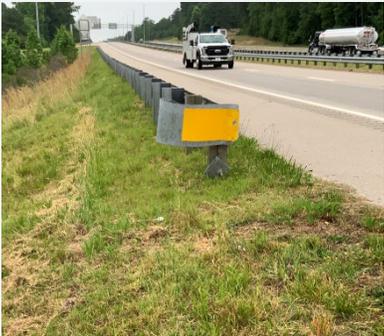
A2
2	Guardrail	BR_452	Functional Damage

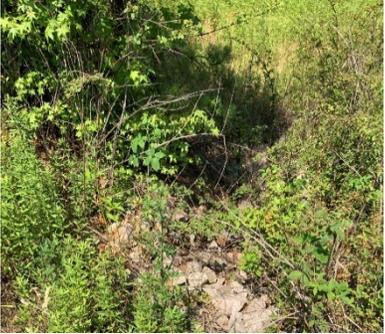
#	Material Type	Object ID	Failure Type	Photo	GIS Reference Page
1	Drain	DP_295	Obstruction

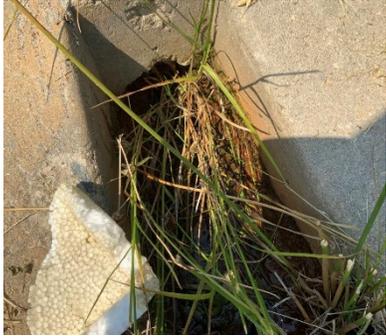
#	Material Type	Object ID	Failure Type	Photo	GIS Reference Page
1	Shoulder Drain	MDP_12	Obstruction

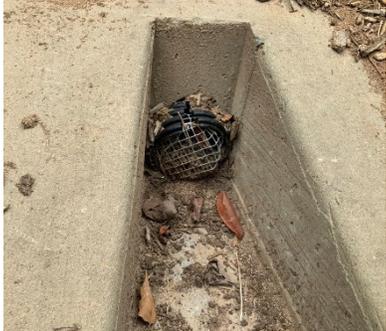
#	Material Type	Object ID	Failure Type	Photo	GIS Reference Page
5	Shoulder Drain	MDP_231	Obstruction

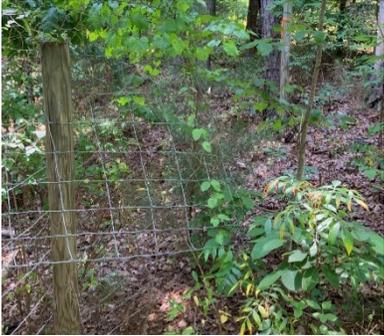
#	Material Type	Object ID	Failure Type	Photo	GIS Reference Page
1	Woven	FN_215	Fence Hole

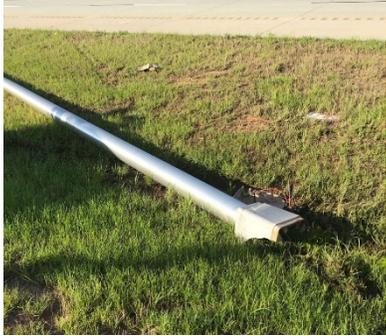
#	Material Type	Object ID	Failure Type	Photo	GIS Reference Page
1	High Mast	HL_25	Part Damage

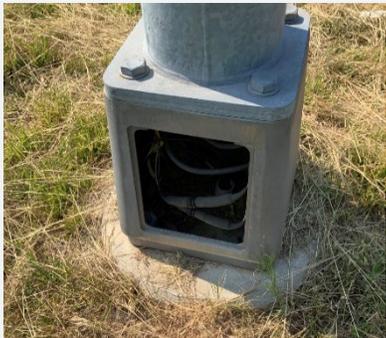
A27
2	High Mast	HL_148	Missing Parts

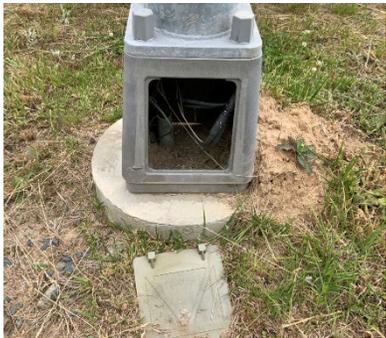
A5
3	High Mast	HL_366	Missing Parts

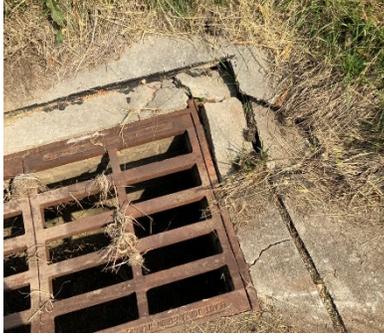
#	Material Type	Object ID	Failure Type	Photo	GIS Reference Page
1	Inlet	IN_3	Surface Damage

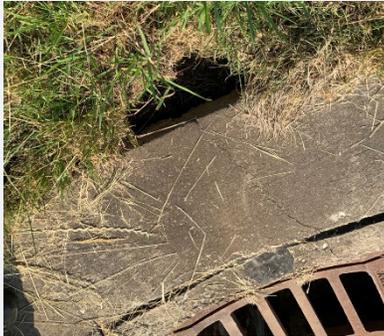
A6
2	Inlet	IN_292	Eroded Area

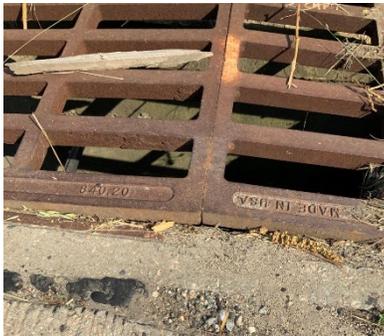
A5
3	Inlet	IN_552	Grate Damage

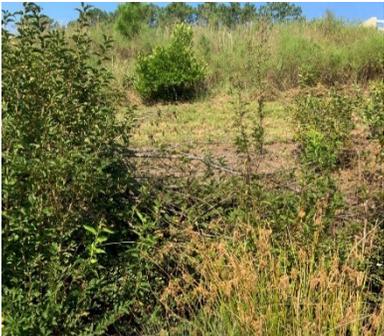
#	Material Type	Object ID	Failure Type	Photo	GIS Reference Page
1	Plant Bed	PB_230	Health

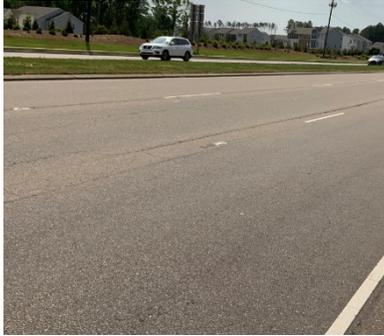
#	Material Type	Object ID	Failure Type	Photo	GIS Reference Page
1	Asphalt	LS_721	Unsealed Cracks

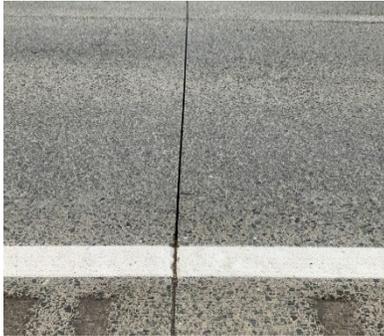
#	Material Type	Object ID	Failure Type	Photo	GIS Reference Page
1	Concrete	LS_396	Joint Malfunction

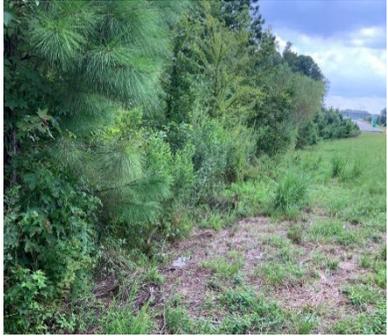
#	Material Type	Object ID	Failure Type	Photo	GIS Reference Page
1	Concrete	LS_421	Obstruction

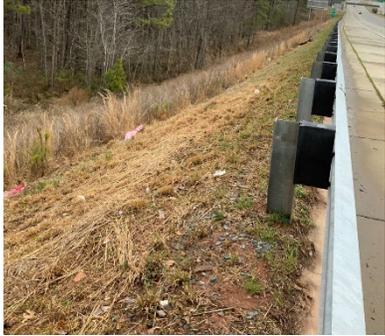
#	Material Type	Object ID	Failure Type	Photo	GIS Reference Page
1	Concrete	LS_472	Litter – 3CF

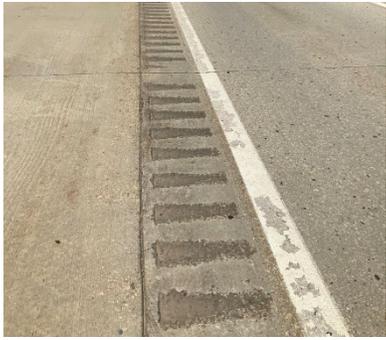
#	Material Type	Object ID	Failure Type	Photo	GIS Reference Page
1	Concrete	LS_164	Line Missing & Nighttime Reflectivity

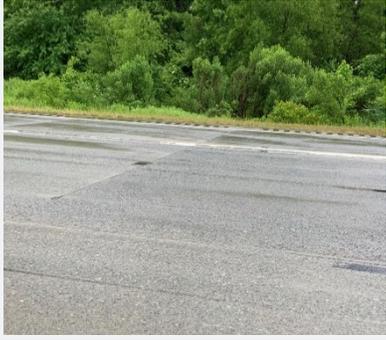
A14
2	Concrete	LS_399	Line Missing & Nighttime Reflectivity

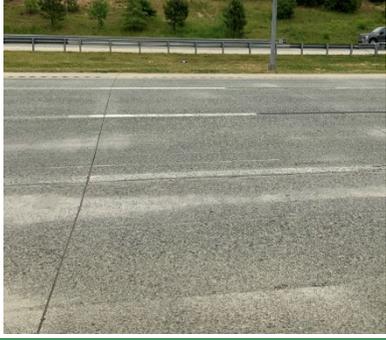
A18
3	Concrete	LS_401	Line Missing & Nighttime Reflectivity

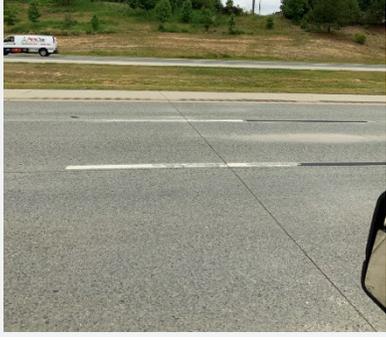
A18
4	Concrete	LS_421	Line Missing

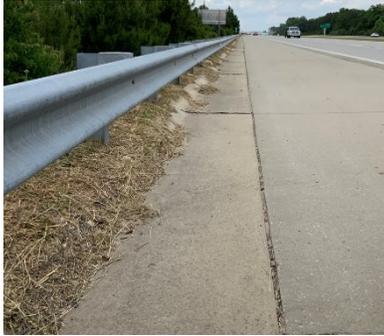
#	Material Type	Object ID	Failure Type	Photo	GIS Reference Page
1	Concrete	LS_150	Missing & Nighttime Reflectivity

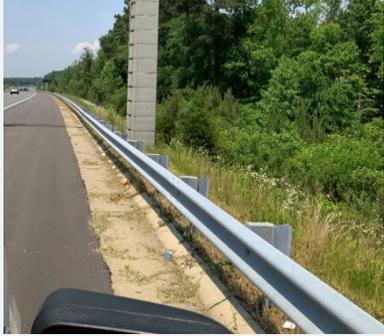
A12
2	Asphalt	LS_252	Missing & Nighttime Reflectivity

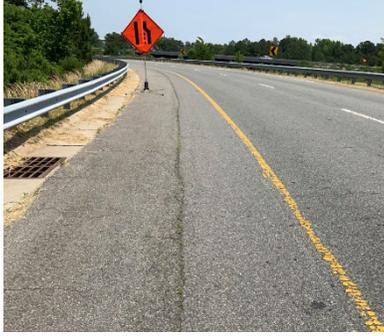
A32
3	Asphalt	LS_743	Missing & Nighttime Reflectivity

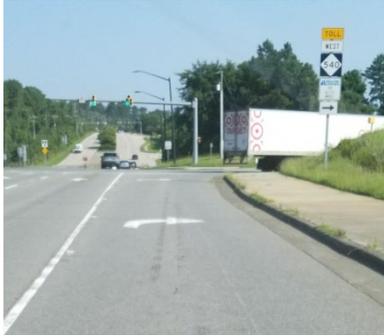
#	Material Type	Object ID	Failure Type	Photo	GIS Reference Page
1	Right Turn	PS_398	Nighttime Reflectivity

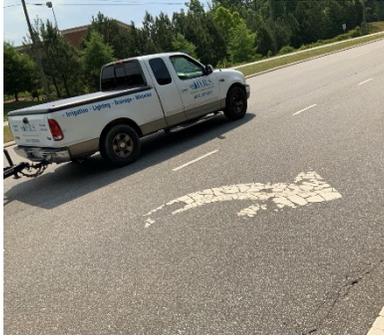
#	Material Type	Object ID	Failure Type	Photo	GIS Reference Page
5	Only	PS_509	Daytime Assessment & Nighttime Reflectivity

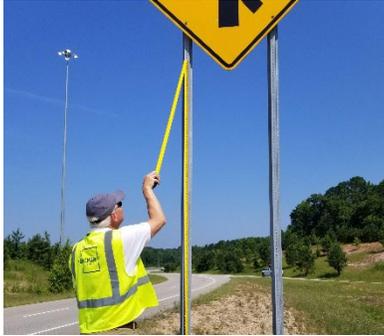
#	Sign Type	Object ID	Failure Type	Photo	GIS Reference Page
1	Merge	SN_778	Height Requirement

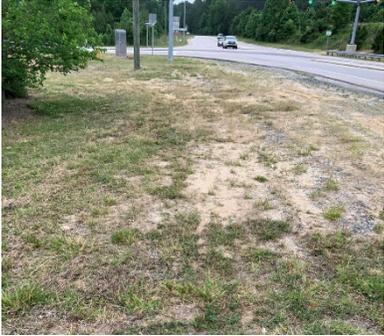
#	Material Type	Object ID	Failure Type	Photo	GIS Reference Page
1	Turf	TF_93	Bare Ground

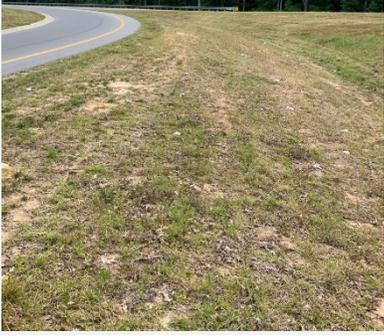
A28
4	Turf	TF_1056	Bare Ground

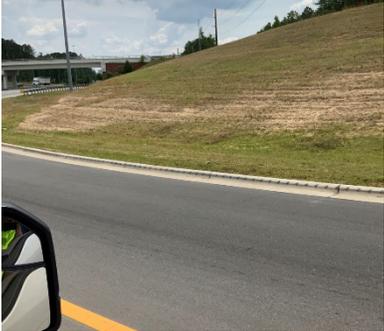
#	Material Type	Object ID	Failure Type	Photo	GIS Reference Page
5	Turf	TF_1069	Bare Ground

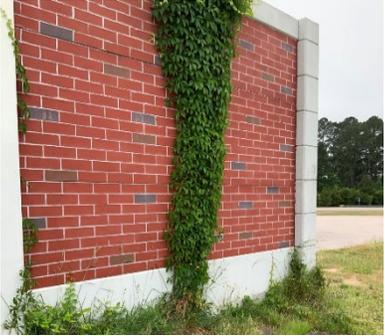
#	Material Type	Object ID	Failure Type	Photo	GIS Reference Page
1	Screen Wall	WL_57	Vegetation
