# Maintenance Rating Program

Triangle Expressway

2021 Third Quarter Report

### NCTA Triangle Expressway Roadway Maintenance Performance Rating Program; Q3, FY 2021 Rating

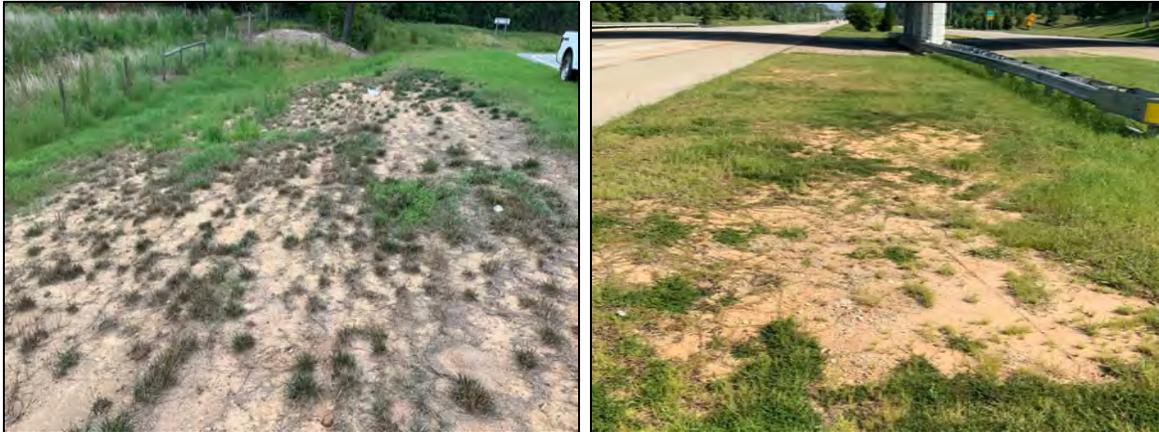
**Figure 3: Turf Condition Inspection Results Sample**

Turf Condition (75 rating – 44 of the 59 assets passed): All 15 of the turf sections that did not pass inspection were due to bare ground. Two of the sections that did not pass inspection are presented in *Figure 3*.

To continue to improve the Turf Condition rating, it is recommended that the maintenance provider continue with an aggressive schedule for seeding and fertilization cycles of bare ground areas during the spring and early summer. Some areas will require scarifying of the soil as these areas are heavily compacted and inundated with aggregate.

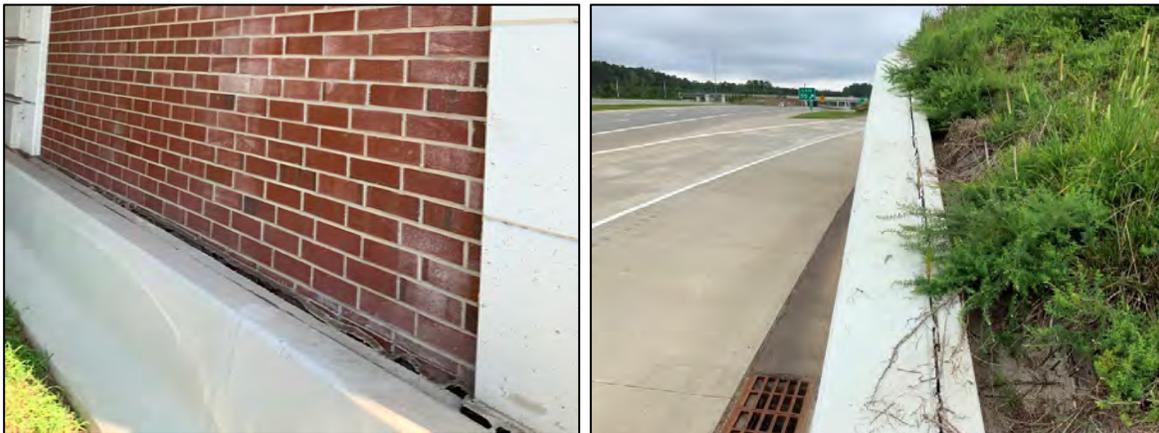
**Figure 4: Retaining and Sound Barrier Walls Inspection Results Sample**

Retaining Walls and Sound Barrier Walls (69 rating – 11 of the 16 assets passed): Out of the 5 retaining wall and sound barrier wall structures that did not pass inspection, 4 had unsealed joints and 1 exhibited spalling and unwanted vegetation growth. Two of the wall segments that did not pass inspection are presented in **Figure 4**.

In accordance with NCTA Roadway and Facility Maintenance Standards V6, referenced below, it is recommended that the maintenance provider plan for and schedule joint repairs within the annual work program and that unwanted vegetation is removed upon observation.

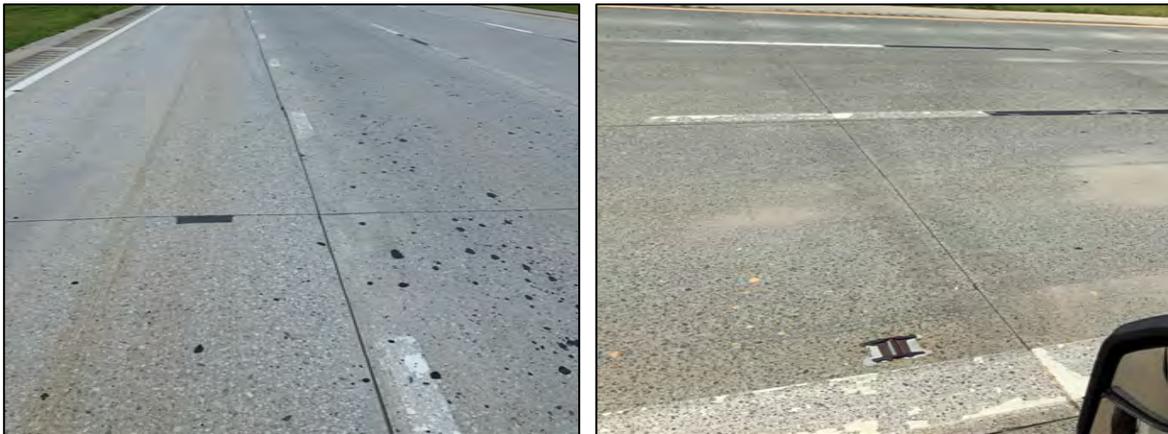
**Figure 5: Pavement Striping Inspection Results Sample**

Pavement Striping (70 rating – 23 of the 33 assets passed): There were 10 pavement striping/marketing segments that did not pass inspection, these segments were identified as missing more than 10% of any line segment in the sections, not meeting the required line width, or not reflecting during the nighttime inspection. Two of the pavement striping and marking segments that did not pass inspection are presented in **Figure 5**.

To maintain a well-defined lane delineation throughout the Triangle Expressway, it is recommended that the maintenance provider consider scheduling pavement striping/marketing replacement cycles in accordance with the NCTA Roadway and Facility Maintenance Standards V6, referenced below.

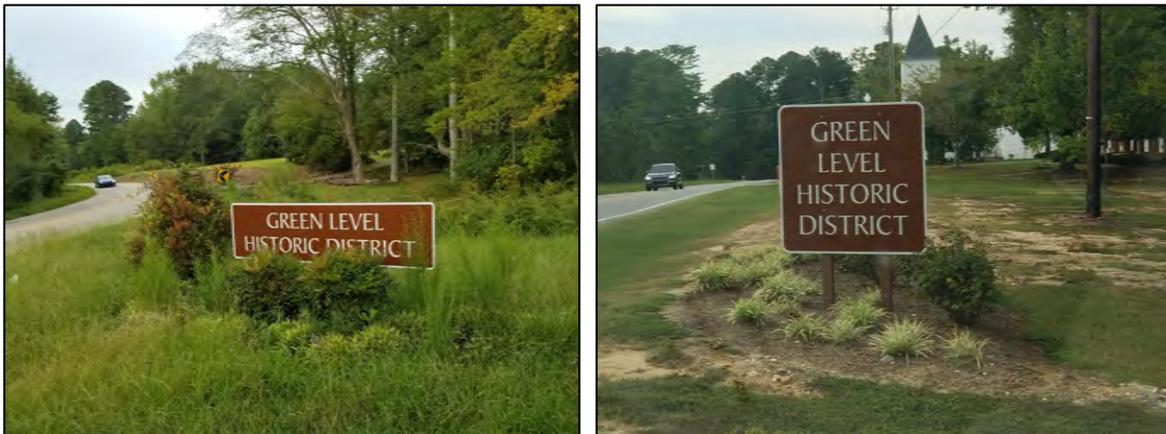
Figure 6: Green Level West Historic District Signs, Landscape Areas

As part of each quarterly inspection, an assessment team visits the two remaining Green Level Historic District signs to conduct a visual inspection of each sign and ensure they are in good standing. The two signs included in the inspection inventory were found to be in good condition. One of the two landscaped areas were well maintained while the other appeared overgrown, partially obscuring the sign text. **Figure 6** shows the two signs assessed.

This quarter, the two Green Level Historic District signs inspected were found to be in good condition. The landscaped area surrounding one of the two signs was found to be overgrown and in need of maintenance. The landscape area around the other sign on Green Level Church Road was found to be well maintained.

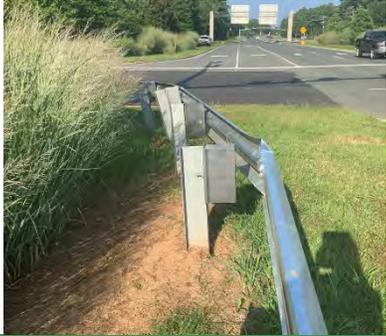
#	Material Type	Object ID	Failure Type	Photo	GIS Reference Page
1	Guardrail	BR_230	Functional Damage

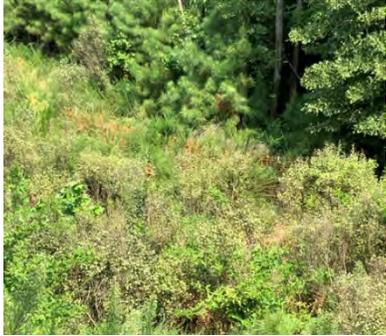
#	Material Type	Object ID	Failure Type	Photo	GIS Reference Page
1	Woven	FN_43	Fence Hole

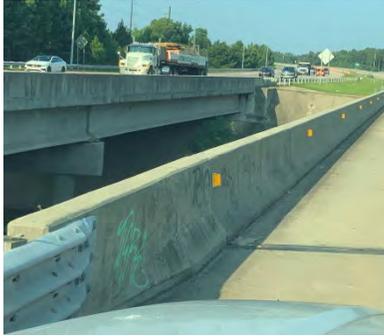
#	Material Type	Object ID	Failure Type	Photo	GIS Reference Page
1	Concrete Barrier	GR_1	Graffiti

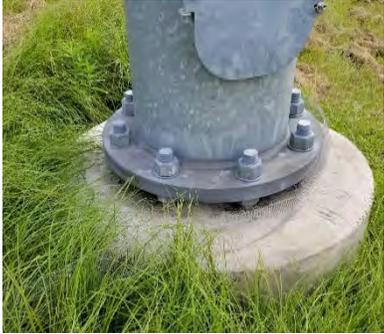
#	Material Type	Object ID	Failure Type	Photo	GIS Reference Page
1	High Mast	HL_217	Rodent Screen

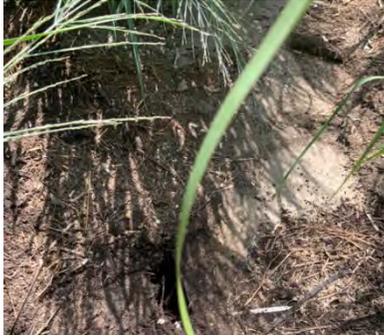
#	Material Type	Object ID	Failure Type	Photo	GIS Reference Page
1	Inlet	IN_53	Obstruction

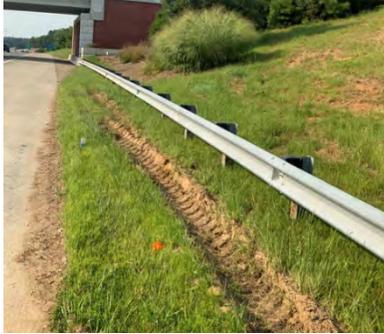
#	Material Type	Object ID	Failure Type	Photo	GIS Reference Page
1	Concrete	LS_419	Elevation Deviation

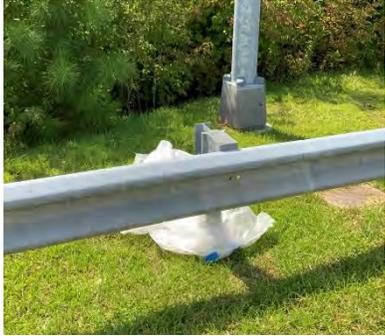
#	Material Type	Object ID	Failure Type	Photo	GIS Reference Page
1	Asphalt	LS_295	Litter – 3CF

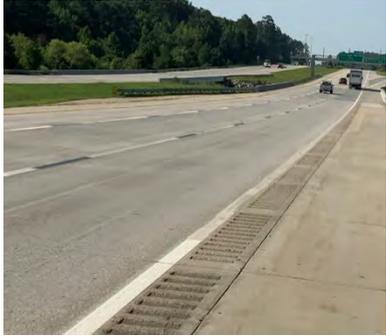
#	Material Type	Object ID	Failure Type	Photo	GIS Reference Page
1	Concrete	LS_41	Line Missing, Nighttime Visibility

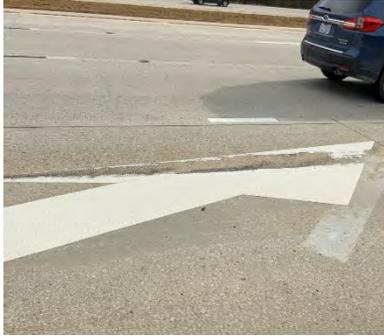
#	Material Type	Object ID	Failure Type	Photo	GIS Reference Page
1	Merge Left	PS_26	Daytime Assessment

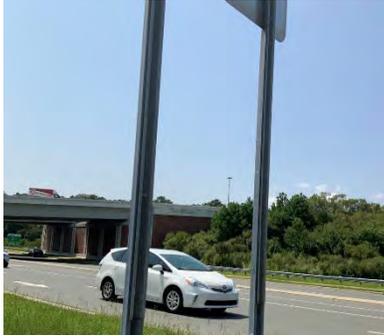
#	Sign Type	Object ID	Failure Type	Photo	GIS Reference Page
1	One Way	SN_521	Height Requirement, Sign Support

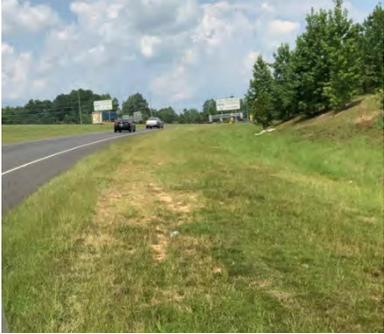
#	Material Type	Object ID	Failure Type	Photo	GIS Reference Page
1	Turf	TF_82	Bare Ground

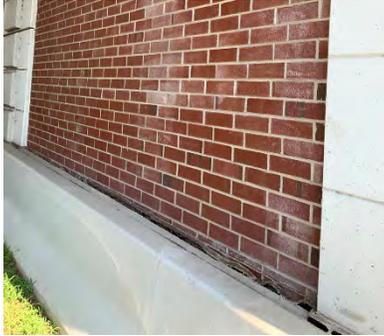
#	Material Type	Object ID	Failure Type	Photo	GIS Reference Page
1	Bridge Wall	WL_11	Unsealed Cracks/Joints
