# Maintenance Rating Program

Triangle Expressway

2021 Fourth Quarter Report

### NCTA Triangle Expressway Roadway Maintenance Performance Rating Program; Q4, FY 2021 Rating

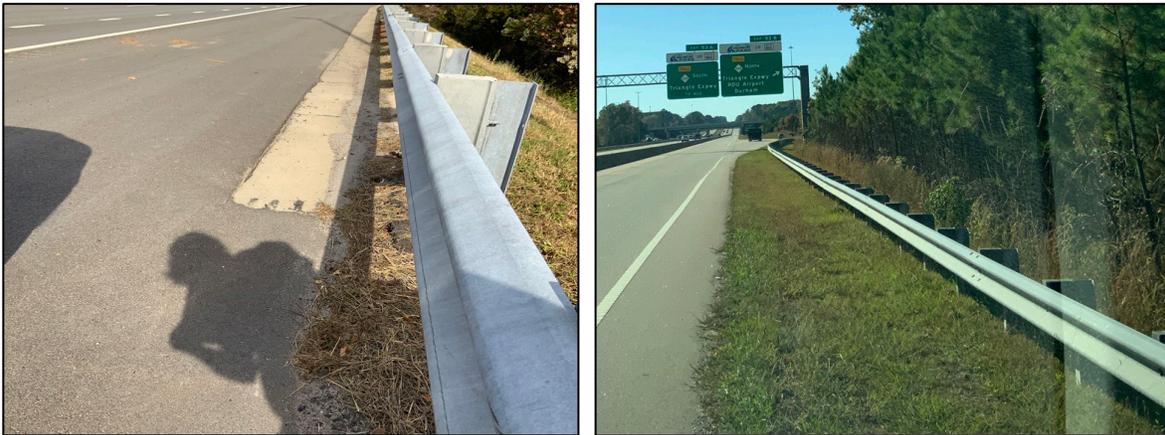
**Figure 3: Delineators Condition Inspection Results Sample**

Delineators (77 rating –30 of the 39 assets passed): All 9 of the linear sections that did not pass inspection had more than 10% of delineators that were not visible during nighttime observation. Two of the sections that did not pass inspection are presented in **Figure 3**.

Delineator Maintenance Program:

- 1) Object markers and delineators are inspected by routine patrols and specifically after each mowing cycle for damage.
- 2) Missing and non-reflective object markers are replaced within the annual work program.
- 3) Missing and non-reflective delineators are replaced within 14 calendar days.

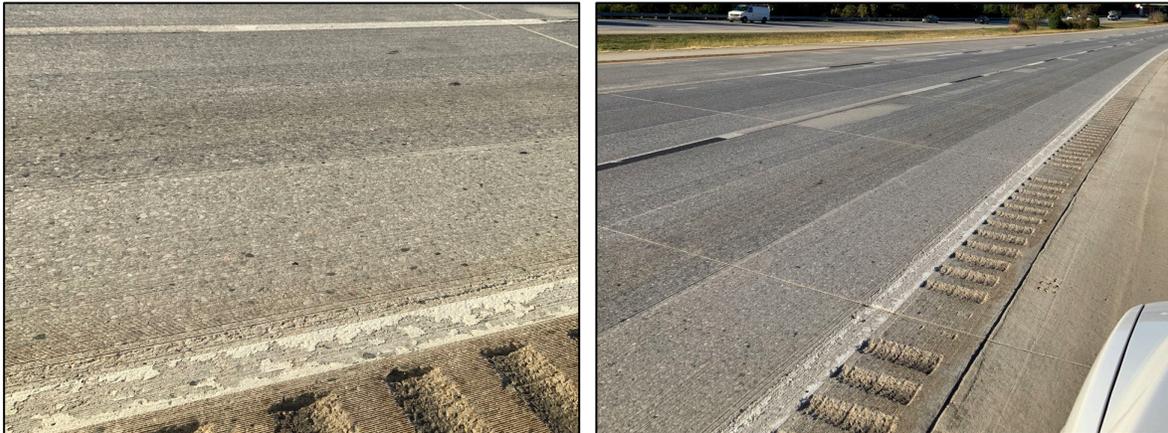
**Figure 4: Pavement Striping Inspection Results Sample**

Pavement Striping (69 rating – 27 of the 39 assets passed): There were 12 pavement striping/markings segments that did not pass inspection, these segments were identified as missing more than 10% of any line segment in the sections, not meeting the required line width, or not reflecting during the nighttime inspection. Two of the pavement striping and marking segments that did not pass inspection are presented in **Figure 4**.

To maintain a well-defined lane delineation throughout the Triangle Expressway, it is recommended that the maintenance provider consider scheduling pavement striping/markings replacement cycles in accordance with the NCTA Roadway and Facility Maintenance Standards V6, referenced below.

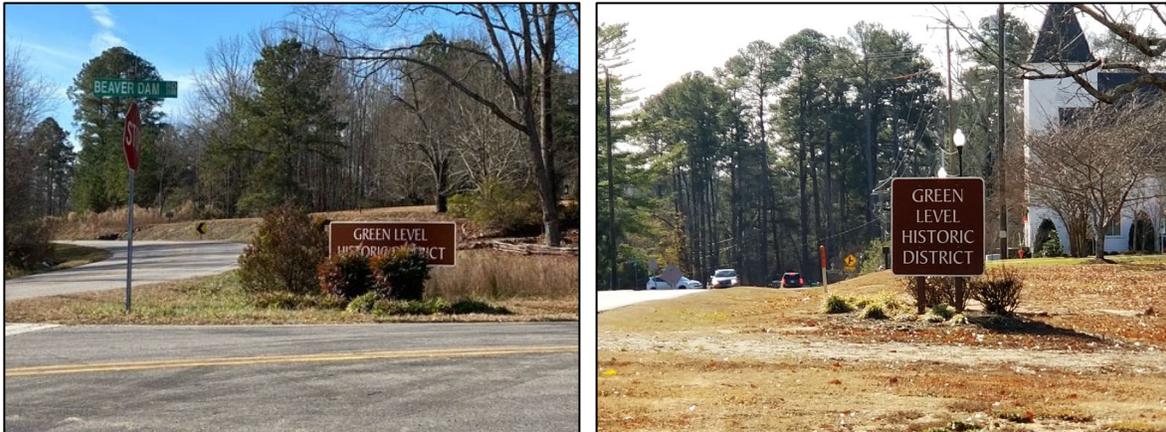
Figure 5: Green Level West Historic District Signs, Landscape Areas

As part of each quarterly inspection, an assessment team visits the two remaining Green Level Historic District signs to conduct a visual inspection of each sign and ensure they are in good standing. The two signs included in the inspection inventory were found to be in good condition. One of the two landscaped areas were well maintained while the other appeared overgrown, partially obscuring the sign text. *Figure 5* shows the two signs assessed.

This quarter, the two Green Level Historic District signs inspected were found to be in good condition. The landscaped area surrounding one of the two signs was found to be overgrown and in need of maintenance. The landscape area around the other sign on Green Level Church Road was found to be well maintained.

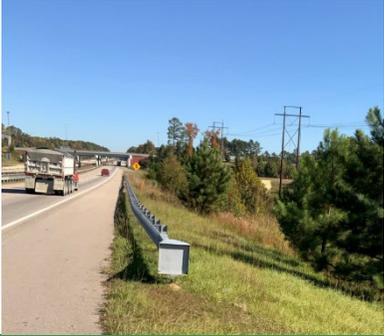
#	Material Type	Object ID	Failure Type	Photo	GIS Reference Page
1	Guardrail	BR_498	Missing Parts

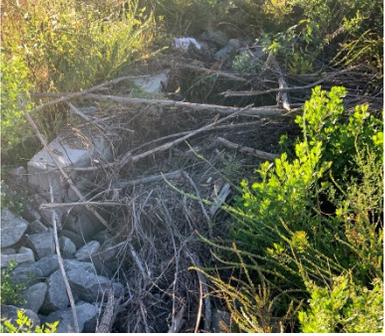
#	Material Type	Object ID	Failure Type	Photo	GIS Reference Page
1	Drain	DP_181	Obstruction

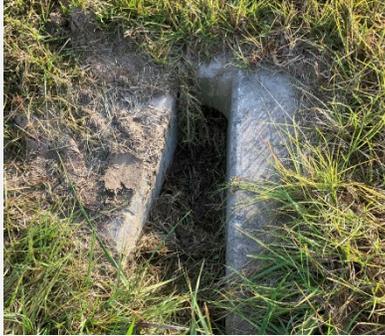
#	Material Type	Object ID	Failure Type	Photo	GIS Reference Page
1	Shoulder Drain	MDP_67	Obstruction

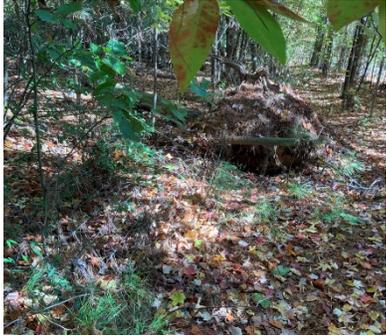
#	Material Type	Object ID	Failure Type	Photo	GIS Reference Page
1	Woven	FN_232	Fence Hole

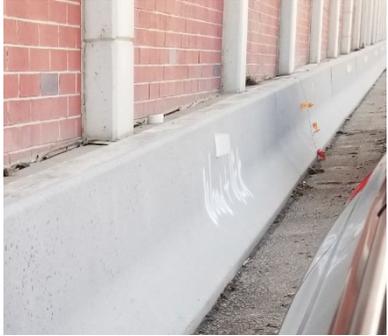
#	Material Type	Object ID	Failure Type	Photo	GIS Reference Page
1	Concrete Barrier	GR_1	Graffiti

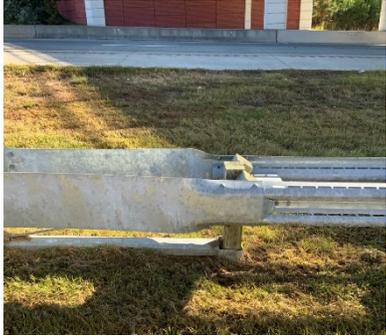
#	Material Type	Object ID	Failure Type	Photo	GIS Reference Page
1	Impact Attenuator	IA_28	Twisted Blocks

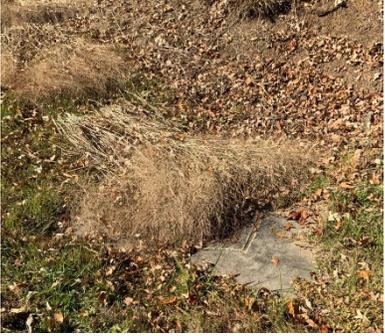
#	Material Type	Object ID	Failure Type	Photo	GIS Reference Page
1	Inlet	IN_573	Obstruction

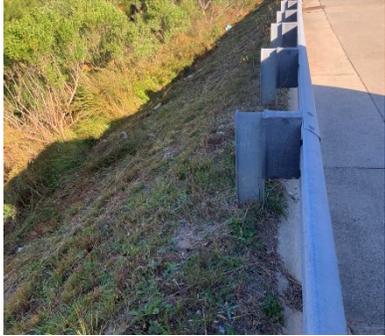
#	Material Type	Object ID	Failure Type	Photo	GIS Reference Page
1	Concrete	LS_162	Litter – 3CF

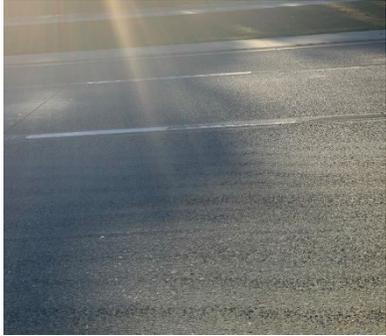
#	Material Type	Object ID	Failure Type	Photo	GIS Reference Page
9	Concrete	LS_417	Line Missing, Nighttime Visibility

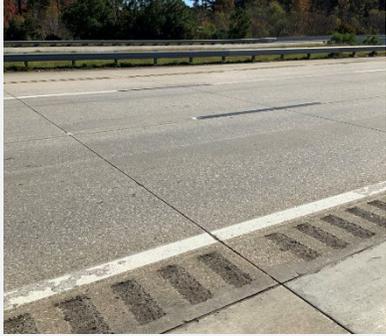
A21
10	Concrete	LS_605	Line Missing, Nighttime Visibility

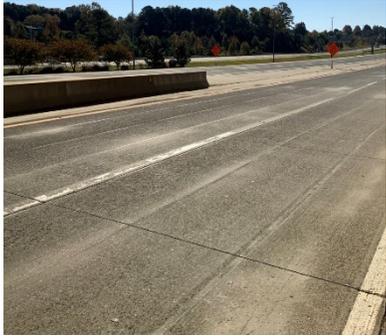
A10
11	Concrete	LS_613	Line Missing, Nighttime Visibility

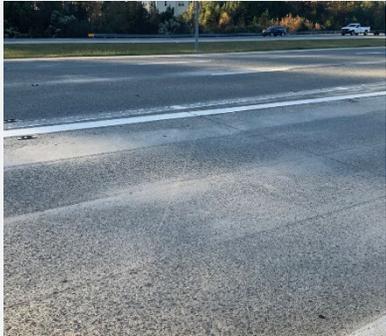
A19
12	Concrete	LS_639	Line Missing

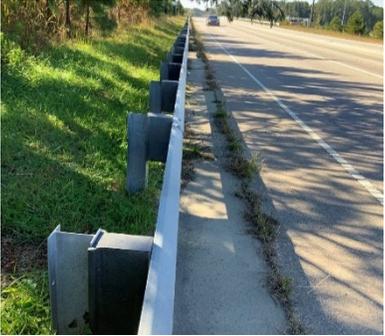
#	Material Type	Object ID	Failure Type	Photo	GIS Reference Page
6	Asphalt	LS_545	Nighttime Reflectivity

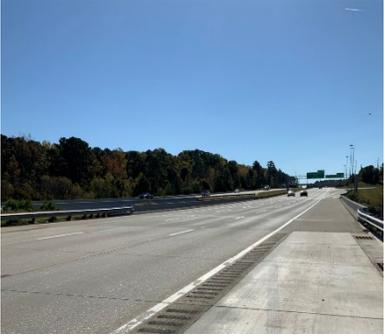
A23
7	Asphalt	LS_605	Missing, Nighttime Reflectivity

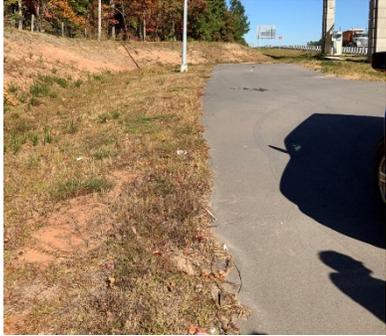
#	Material Type	Object ID	Failure Type	Photo	GIS Reference Page
1	Turf	TF_23	Bare Ground

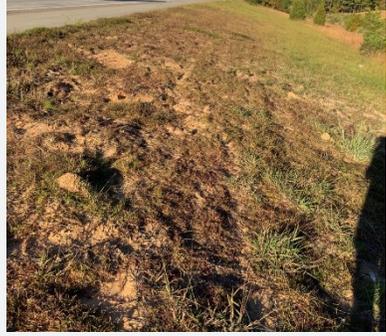
A25
4	Turf	TF_691	Bare Ground

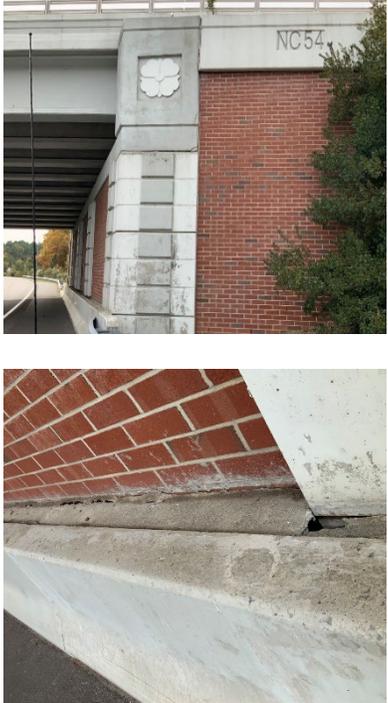
#	Material Type	Object ID	Failure Type	Photo	GIS Reference Page
1	Bridge Wall	WL_5	Unsealed Cracks/Joints

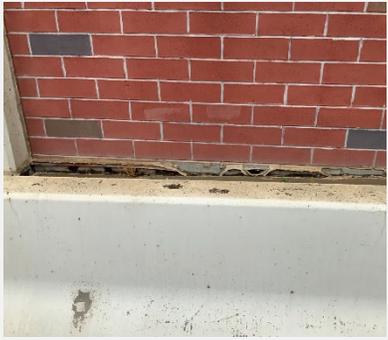
A31
2	Sound Wall	WL_47	Unsealed Cracks/Joints

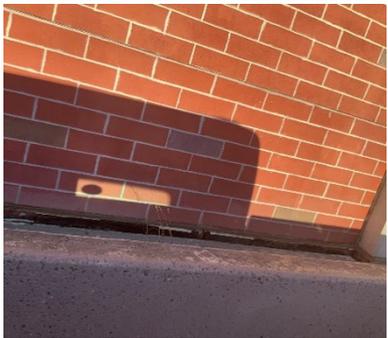
A21
3	Sound Wall	WL_96	Unsealed Cracks/Joints
