Maintenance Rating Program

Triangle Expressway

May 2022

2022 First Quarter Report

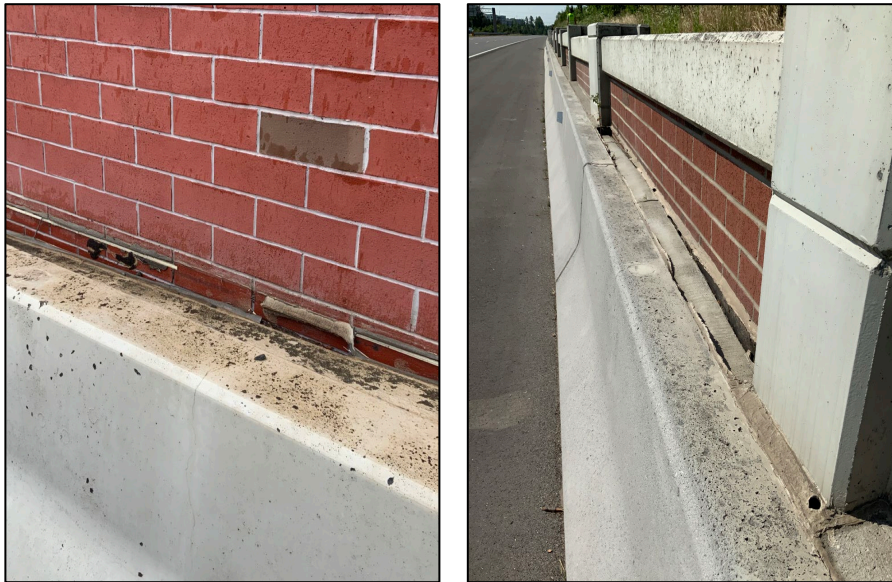
Figure 3: Retaining Walls and Sound Barrier Walls Inspection Results Sample

Retaining Walls and Sound Barrier Walls (75 rating –12 of the 16 assets passed): Three of the four wall sections that did not pass inspection had unsealed joints and scaling. Two of the sections that did not pass inspection are presented in **Figure 3**.

- 1) Walls shall be inspected during daily patrols.
- 2) Unwanted vegetation and graffiti (see graffiti standard) shall be scheduled for removal.
- 3) Minor wall or column damage shall be scheduled for repair within the annual work program.
- 4) Staining damage shall be scheduled for repair within the annual work program.
- 5) Any structural damage that poses a safety risk shall be scheduled immediately upon observation. Mitigate any safety hazard upon observation.

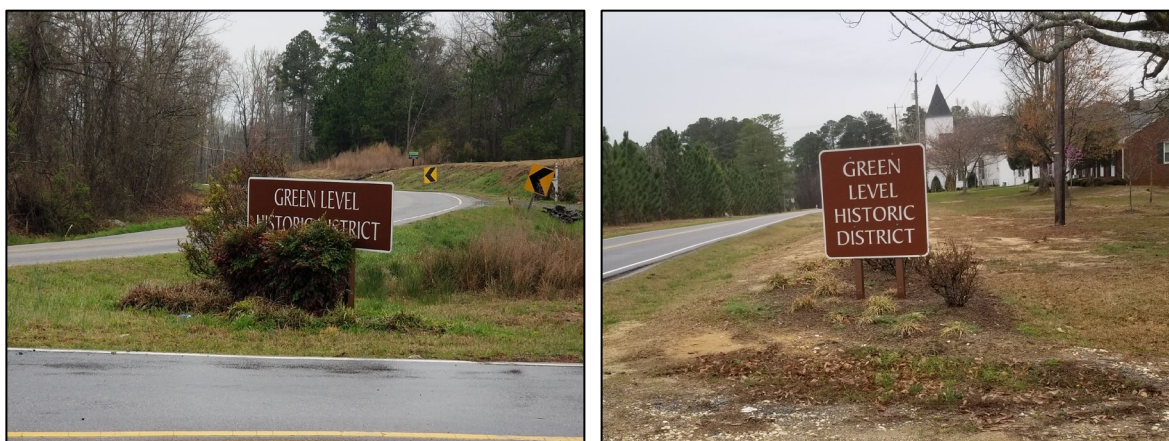
Figure 5: Green Level West Historic District Signs, Landscape Areas

As part of each quarterly inspection, an assessment team visits the two remaining Green Level Historic District signs to conduct a visual inspection of each sign and ensure they are in good standing. The two signs included in the inspection inventory were found to be in good condition. One of the two landscaped areas were well maintained while the other appeared overgrown, partially obscuring the sign text. **Figure 5** shows the two signs assessed.

This quarter, the two Green Level Historic District signs inspected were found to be in good condition. The landscaped area surrounding one of the two signs was found to be overgrown and in need of maintenance. The landscape area around the other sign on Green Level Church Road was found to be well maintained.

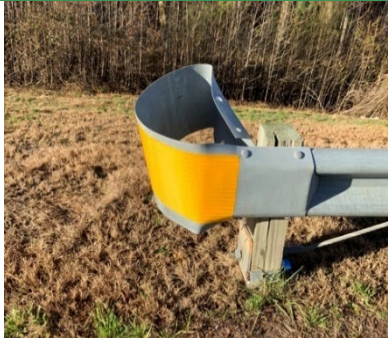
#	Material Type	Object ID	Failure Type	Photo	GIS Reference Page
1	Guardrail	BR_2	Functional Damage

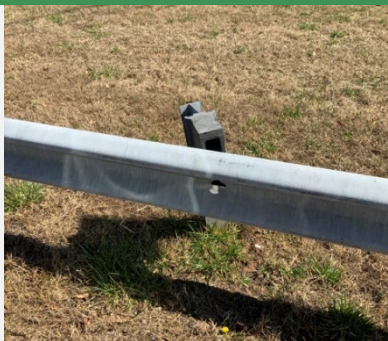
A28
2	Guardrail	BR_223	Functional Damage

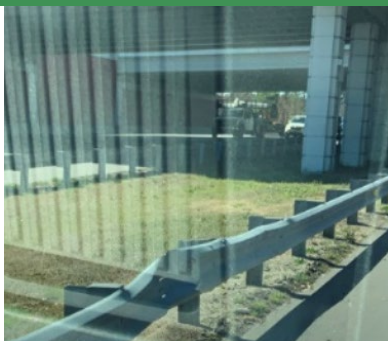
A31
3	Guardrail	BR_405	Functional Damage

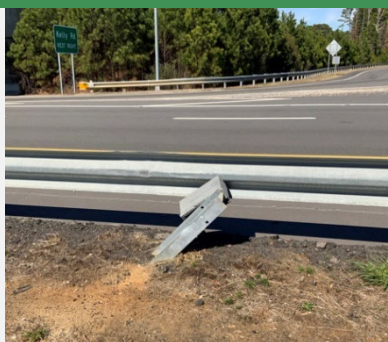
A18
4	Guardrail	BR_512	Functional Damage

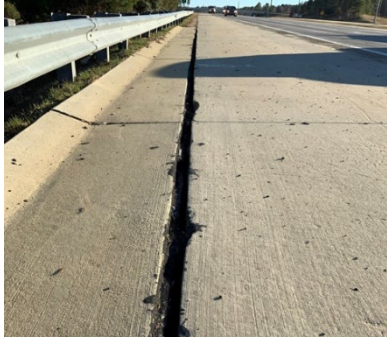
#	Material Type	Object ID	Failure Type	Photo	GIS Reference Page
1	Shoulder Berm Gutter	CG_55	Separation

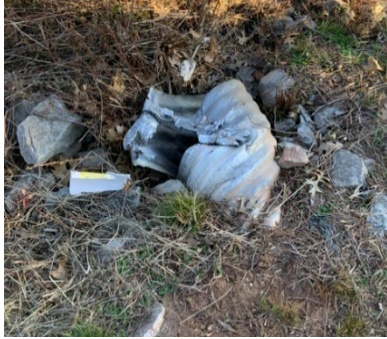
#	Material Type	Object ID	Failure Type	Photo	GIS Reference Page
1	Drain	DP_290	End Protection

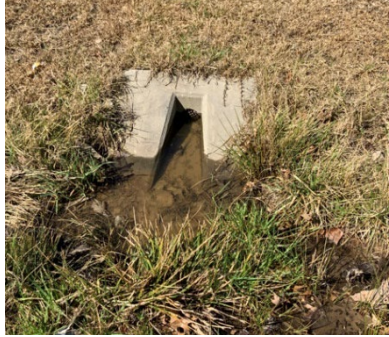
#	Material Type	Object ID	Failure Type	Photo	GIS Reference Page
1	Shoulder Drain	MDP_106	Obstruction

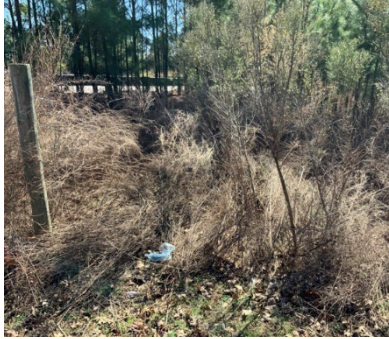
#	Material Type	Object ID	Failure Type	Photo	GIS Reference Page
1	Woven	FN_193	Fence Hole

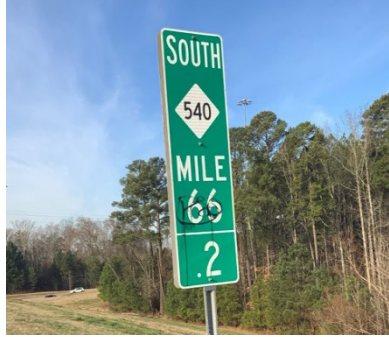
#	Material Type	Object ID	Failure Type	Photo	GIS Reference Page
1	Mile Marker Sign	GR_1	Graffiti

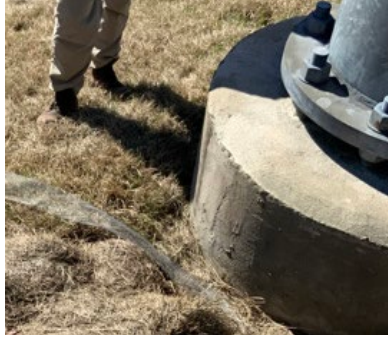
#	Material Type	Object ID	Failure Type	Photo	GIS Reference Page
1	Single Roadway	HL_217	Rodent Screen

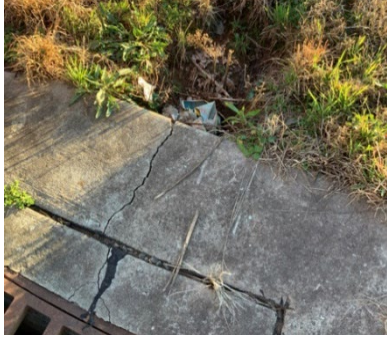
#	Material Type	Object ID	Failure Type	Photo	GIS Reference Page
1	Inlet	IN_470	Eroded Area & Surface Damage

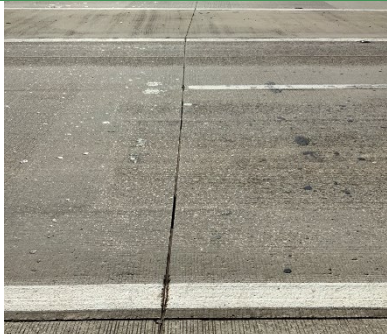
#	Material Type	Object ID	Failure Type	Photo	GIS Reference Page
1	Concrete	LS_590	Joint Malfunction

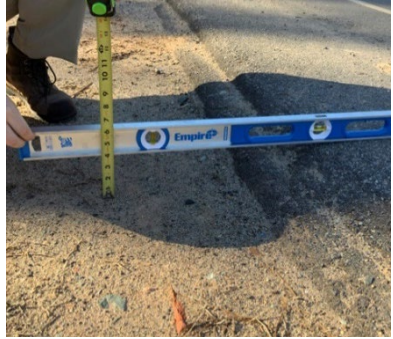
#	Material Type	Object ID	Failure Type	Photo	GIS Reference Page
1	Aaphalt	LS_13	Drop Off

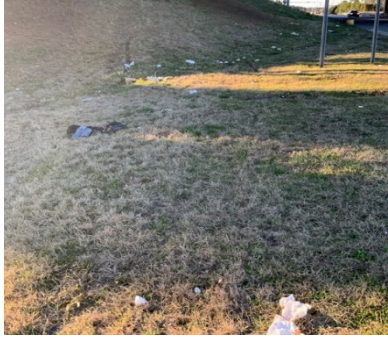
#	Material Type	Object ID	Failure Type	Photo	GIS Reference Page
1	Asphalt	LS_720	Litter – 3CF

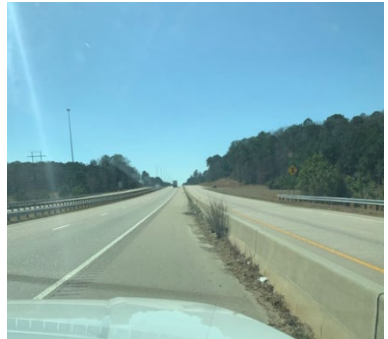
#	Material Type	Object ID	Failure Type	Photo	GIS Reference Page
1	Asphalt	LS_537	Material Accumulation

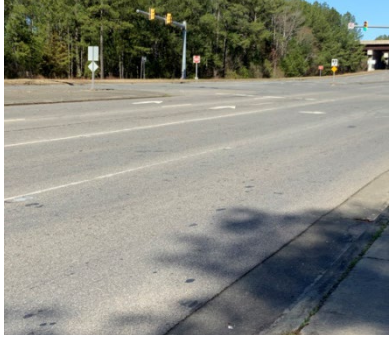
#	Material Type	Object ID	Failure Type	Photo	GIS Reference Page
1	Asphalt	LS_738	Line Missing, Nighttime Visibility

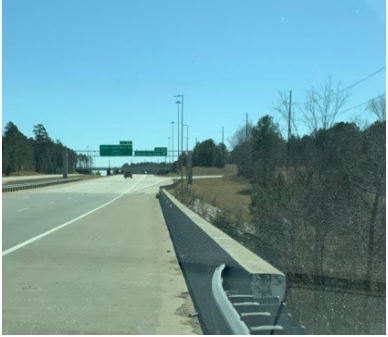
#	Material Type	Object ID	Failure Type	Photo	GIS Reference Page
6	Concrete	LS_605	Missing, Nighttime Reflectivity

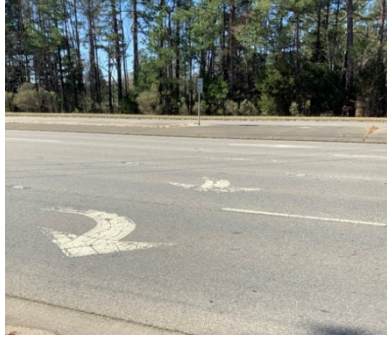
#	Material Type	Object ID	Failure Type	Photo	GIS Reference Page
1	Right Turn	PS_417	Daytime Assessment & Nighttime Reflectivity

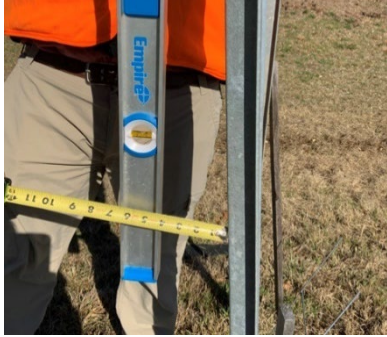
#	Sign Type	Object ID	Failure Type	Photo	GIS Reference Page
1	NC Route	SN_587	Leaning

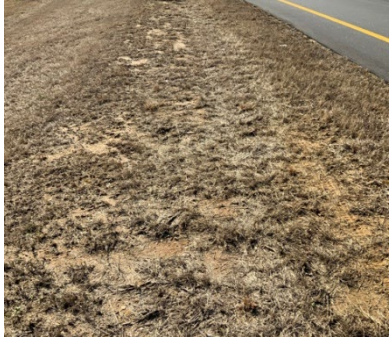
#	Material Type	Object ID	Failure Type	Photo	GIS Reference Page
1	Turf	TF_410	Bare Ground
