# Maintenance Rating Program

## Triangle Expressway

2022 Second Quarter Report

### NCTA Triangle Expressway Roadway Maintenance Performance Rating Program; Q2, FY 2022 Rating

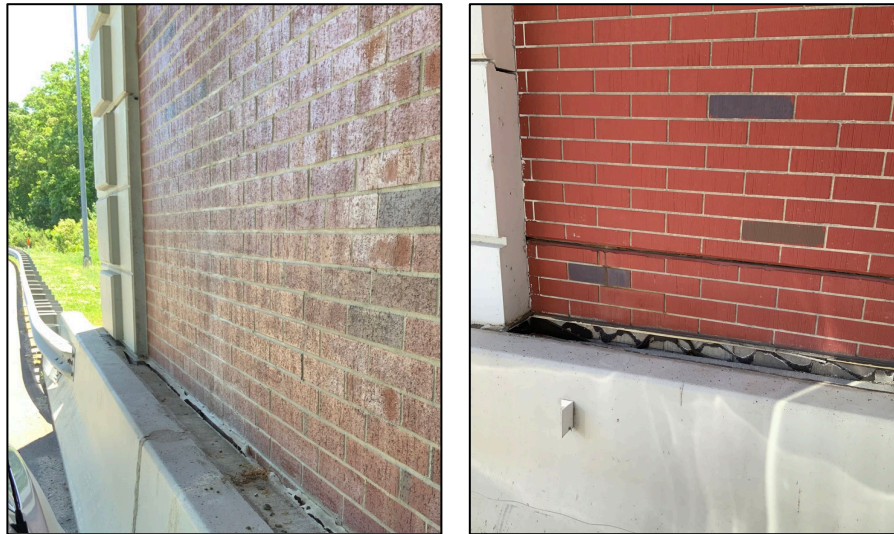
**Figure 3: Retaining Walls and Sound Barrier Walls Inspection Results Sample**

Retaining Walls and Sound Barrier Walls (75 rating –12 of the 16 assets passed): Three of the four wall sections that did not pass inspection had unsealed joints and scaling. Two of the sections that did not pass inspection are presented in **Figure 3**.

- 1) Walls shall be inspected during daily patrols.
- 2) Unwanted vegetation and graffiti (see graffiti standard) shall be scheduled for removal.
- 3) Minor wall or column damage shall be scheduled for repair within the annual work program.
- 4) Staining damage shall be scheduled for repair within the annual work program.
- 5) Any structural damage that poses a safety risk shall be scheduled immediately upon observation. Mitigate any safety hazard upon observation.

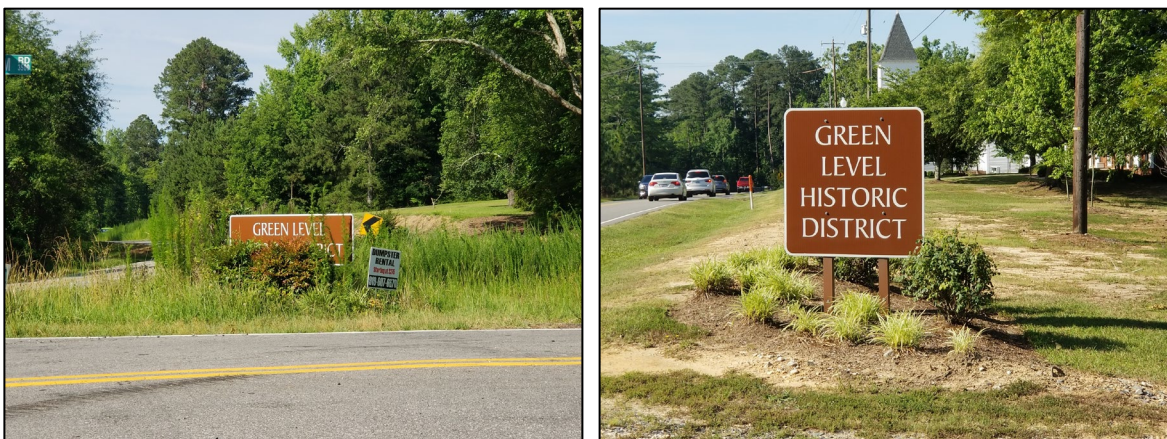
Figure 4: Green Level West Historic District Signs, Landscape Areas

As part of each quarterly inspection, an assessment team visits the two remaining Green Level Historic District signs to conduct a visual inspection of each sign and ensure they are in good standing. The two signs included in the inspection inventory were found to be in good condition. Of the two landscaped areas, one was well maintained while the other was overgrown and partially obstructed the sign text. **Figure 4** shows the two signs assessed.

This quarter, the two Green Level Historic District signs inspected were found to be in good condition. The landscaped area surrounding one of the two signs was found to be overgrown and in need of maintenance. The landscape area around the other sign on Green Level Church Road was found to be well maintained.

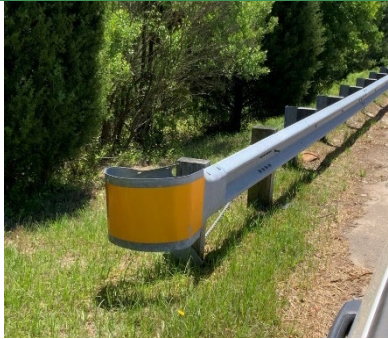
#	Material Type	Object ID	Failure Type	Photo	GIS Reference Page
1	Guardrail	BR_109	Missing Parts

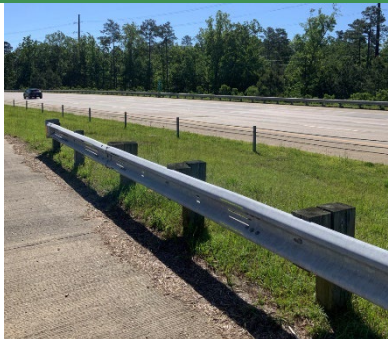
A14
2	Guardrail	BR_248	Twisted Blocks

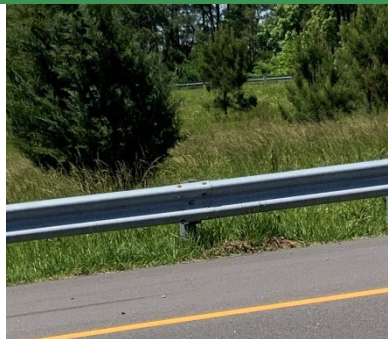
A5
3	Guardrail	BR_269	Missing Parts

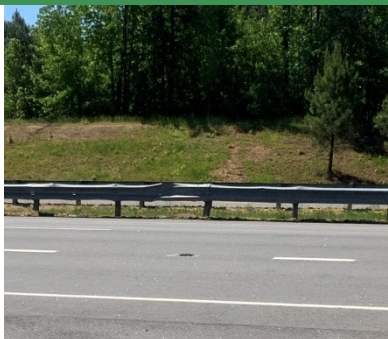
A3
4	Guardrail	BR_475	Functional Damage

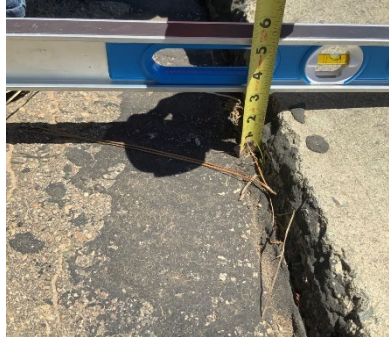
#	Material Type	Object ID	Failure Type	Photo	GIS Reference Page
1	Shoulder Berm Gutter	CG_18	Misalignment

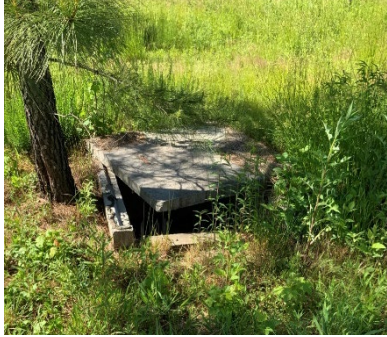
#	Material Type	Object ID	Failure Type	Photo	GIS Reference Page
1	Drain	DP_227	End Protection

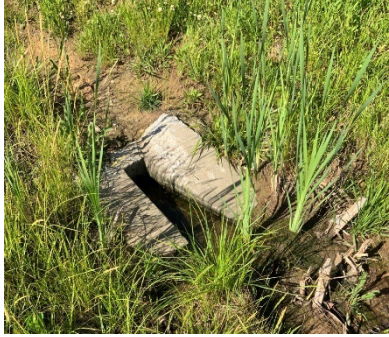
#	Material Type	Object ID	Failure Type	Photo	GIS Reference Page
1	Shoulder Drain	MDP_55	Rodent Screen

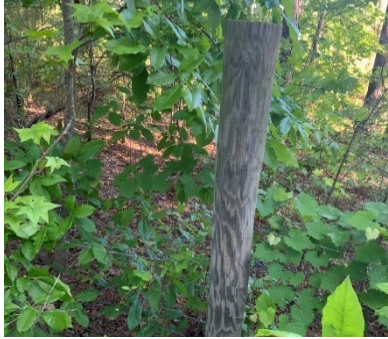
#	Material Type	Object ID	Failure Type	Photo	GIS Reference Page
1	Woven	FN_58	Fence Hole

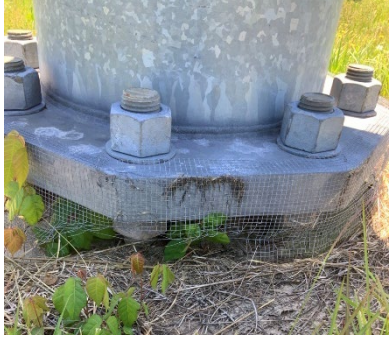
#	Material Type	Object ID	Failure Type	Photo	GIS Reference Page
1	High Mast	HL_48	Rodent Screen

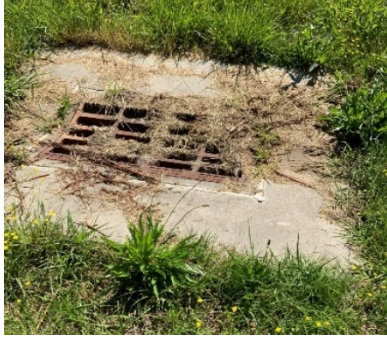
#	Material Type	Object ID	Failure Type	Photo	GIS Reference Page
1	Inlet	IN_713	Obstruction

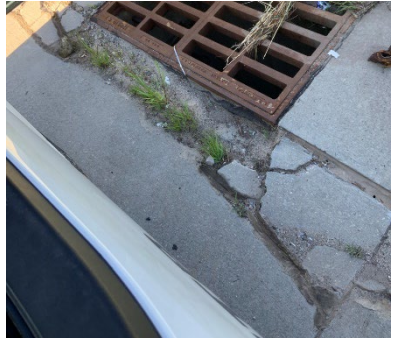
#	Material Type	Object ID	Failure Type	Photo	GIS Reference Page
1	Concrete	LS_136	Paved Shoulder Cracking

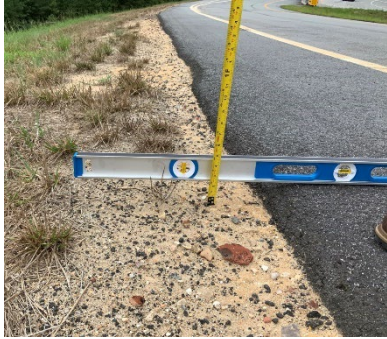
#	Material Type	Object ID	Failure Type	Photo	GIS Reference Page
1	Asphalt	LS_8	Drop Off

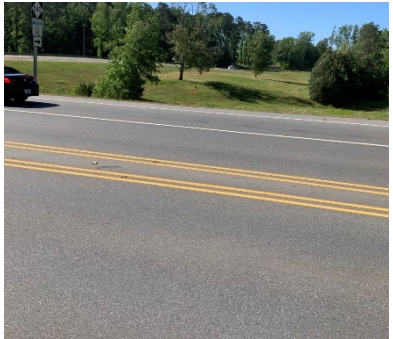
#	Material Type	Object ID	Failure Type	Photo	GIS Reference Page
1	Asphalt	LS_529	Nighttime Visibility	Not Available for Nighttime Failure	A25
2	Asphalt	LS_778	Marker Missing

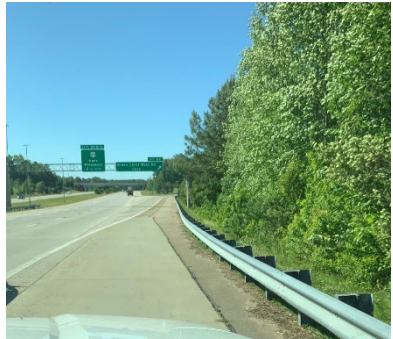
#	Material Type	Object ID	Failure Type	Photo	GIS Reference Page
1	Asphalt	LS_8	Nighttime Visibility	Not Available for Nighttime Failure	A29
2	Concrete	LS_155	Missing

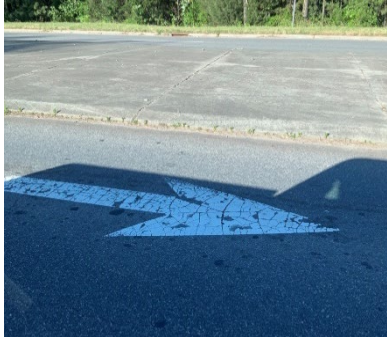
#	Material Type	Object ID	Failure Type	Photo	GIS Reference Page
1	Thru Lane	PS_412	Nighttime Reflectivity

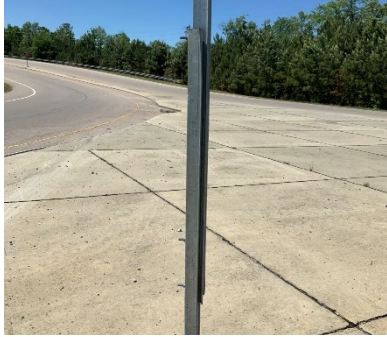
#	Sign Type	Object ID	Failure Type	Photo	GIS Reference Page
1	Merge	SN_857	Sign Support

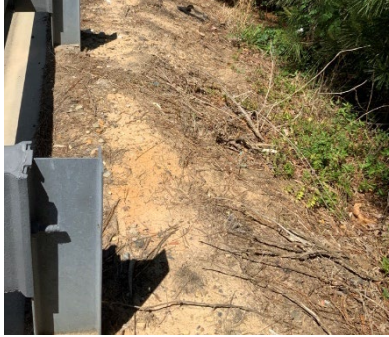
#	Material Type	Object ID	Failure Type	Photo	GIS Reference Page
5	Turf	TF_510	Bare Ground
