Maintenance Rating Program

Triangle Expressway

November 2022

2022 Third Quarter Report

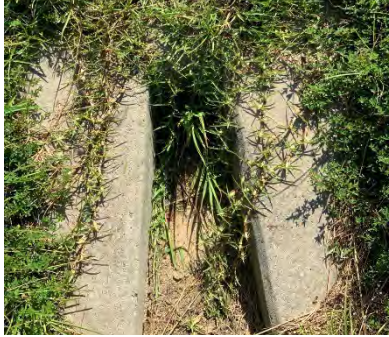
#	Material Type	Object ID	Failure Type	Photo	GIS Reference Page
1	Shoulder Drain	MDP_20	Obstruction

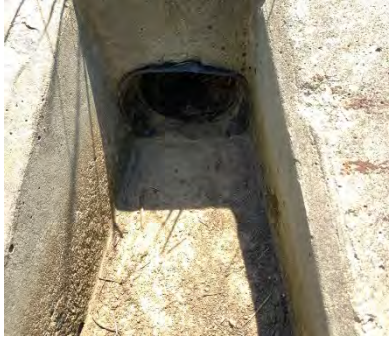
A9
2	Shoulder Drain	MDP_74	Rodent Screen

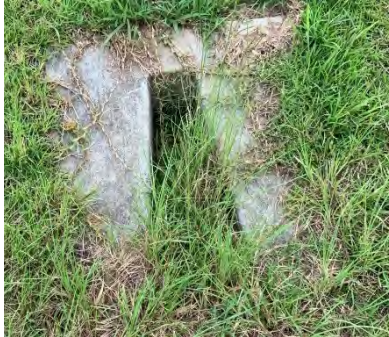
A15
3	Shoulder Drain	MDP_89	Obstruction

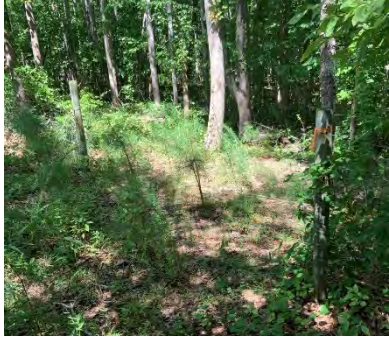
A14
2	Woven	FN_145	Hole Height

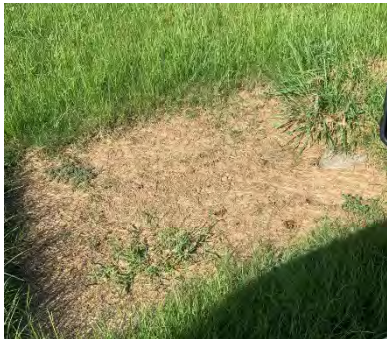
A25
4	Inlet	IN_1061	Obstruction

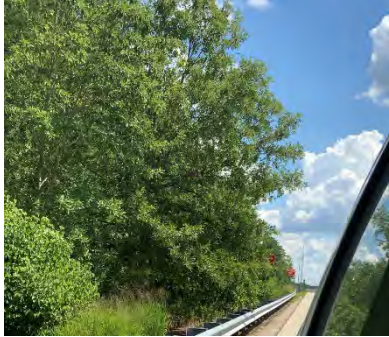
A33
2	Plant Bed	PB_155	Overgrown

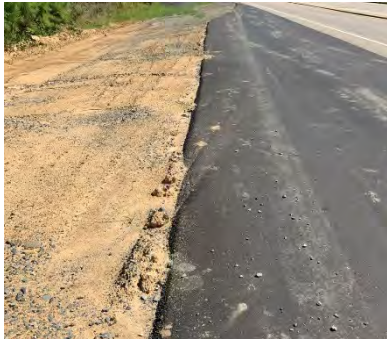
#	Material Type	Object ID	Failure Type	Photo	GIS Reference Page
1	Concrete	LS_148	Drop Off	 	A11
2	Asphalt	LS_563	Drop Off	 	A17
3	Asphalt	LS_679	Drop Off

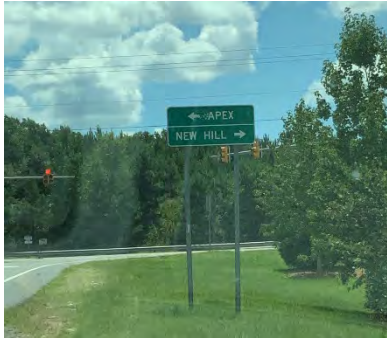
#	Sign Type	Object ID	Failure Type	Photo	GIS Reference Page
1	Mile Post	SN_599	Functional Damage	 	A3
2	Other	SN_819	Height

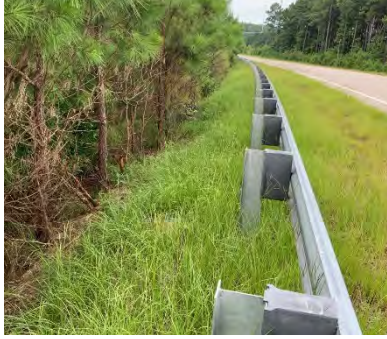
#	Material Type	Object ID	Failure Type	Photo	GIS Reference Page
1	Tree and Brush	TB_130	Barrier Clearance

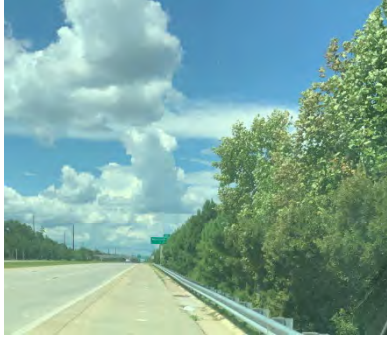
A27
2	Tree and Brush	TB_327	Sign Obstruction

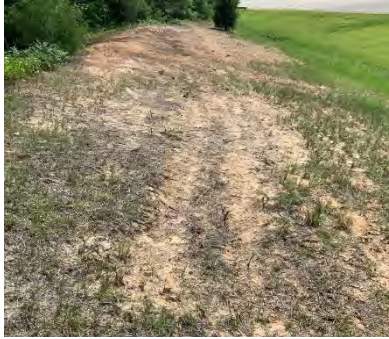
#	Material Type	Object ID	Failure Type	Photo	GIS Reference Page
5	Turf	TF_581	Bare Ground

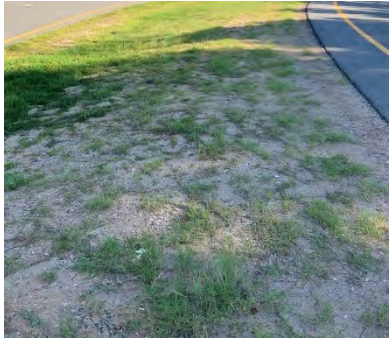
A12
6	Turf	TF_1073	Bare Ground
