Maintenance Rating Program

Triangle Expressway

2022 Fourth Quarter Report

NCTA Triangle Expressway Roadway Maintenance Performance Rating Program; Q4, CY 2022 Rating

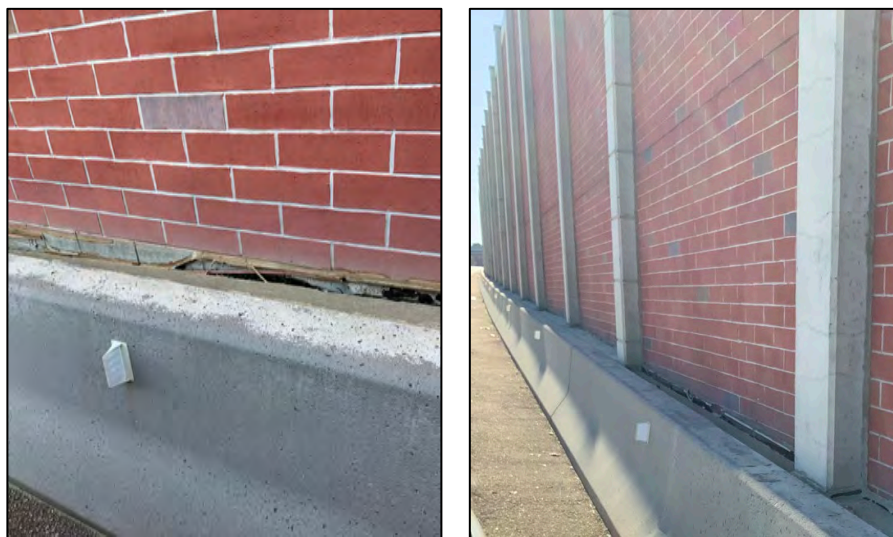
Figure 3: Retaining Walls and Sound Barrier Walls Inspection Results Sample

Retaining Walls and Sound Barrier Walls (75 rating –12 of the 16 assets passed): The four wall sections that did not pass inspection had unsealed joints. Two of the sections that did not pass inspection are presented in *Figure 3*.

- 1) Walls shall be inspected during daily patrols.
- 2) Unwanted vegetation and graffiti (see graffiti standard) shall be scheduled for removal.
- 3) Minor wall or column damage shall be scheduled for repair within the annual work program.
- 4) Staining damage shall be scheduled for repair within the annual work program.
- 5) Any structural damage that poses a safety risk shall be scheduled immediately upon observation. Mitigate any safety hazard upon observation.

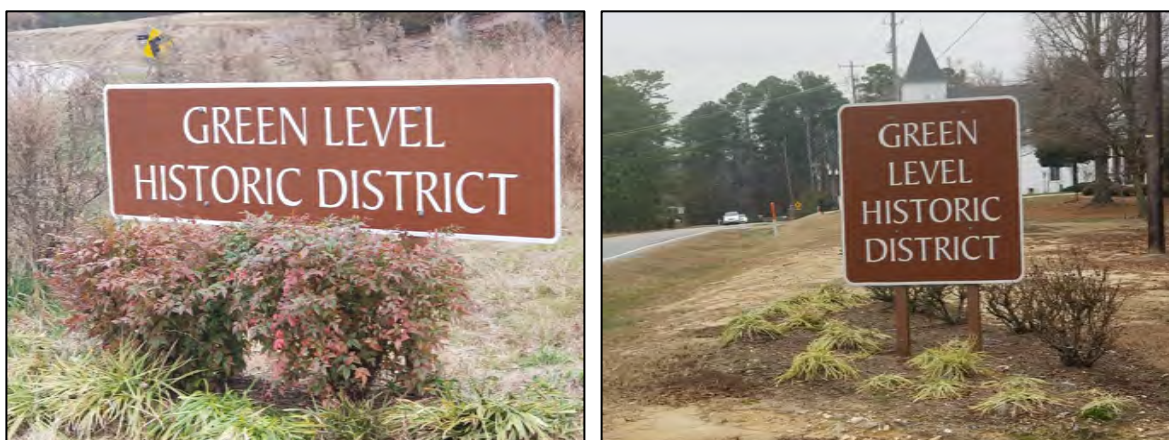
Figure 4: Green Level West Historic District Signs, Landscape Areas

As part of each quarterly inspection, an assessment team visits the two remaining Green Level Historic District signs to conduct a visual inspection of each sign and ensure they are in good standing. The two signs included in the inspection inventory were found to be in good condition. **Figure 4** shows the two signs assessed.

This quarter, the two Green Level Historic District signs inspected were found to be in good condition. Additionally, the landscaped areas surrounding the signs were found to be well maintained.

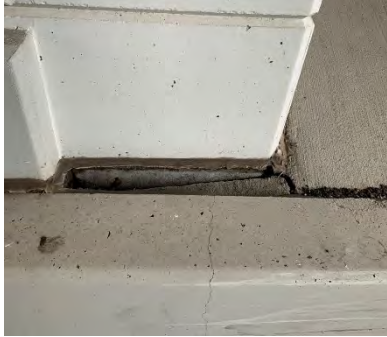
#	Material Type	Object ID	Failure Type	Photo	GIS Reference Page
1	Overpass Support	DS_277	Unsealed Cracks/Joints

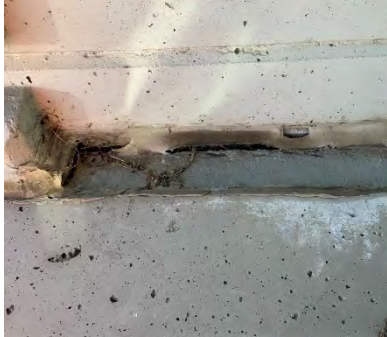
A29
2	Overpass Support	DS_281	Unsealed Cracks/Joints

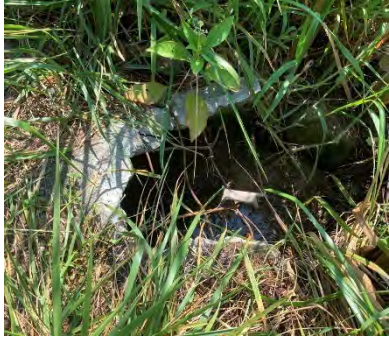
#	Material Type	Object ID	Failure Type	Photo	GIS Reference Page
1	Cross Pipe	DP_380	End Protection Damage

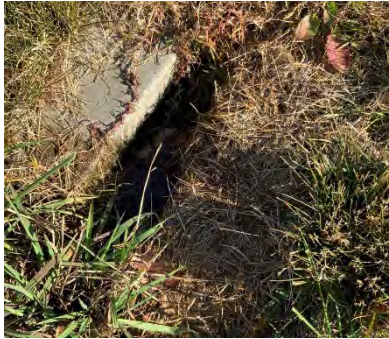
#	Material Type	Object ID	Failure Type	Photo	GIS Reference Page
1	Shoulder Drain	MDP_111	Obstruction

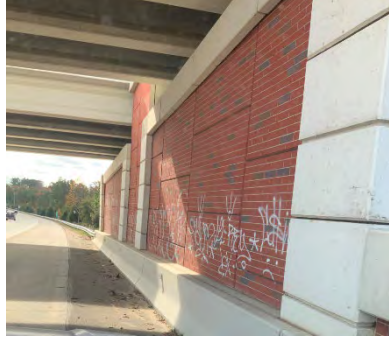
#	Material Type	Object ID	Failure Type	Photo	GIS Reference Page
1	Bridge Wall	GR_1	Graffiti

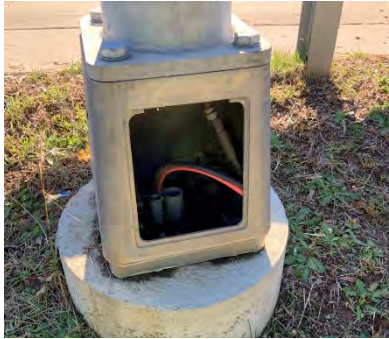
#	Material Type	Object ID	Failure Type	Photo	GIS Reference Page
1	Single Roadway	HL_8	Missing Part

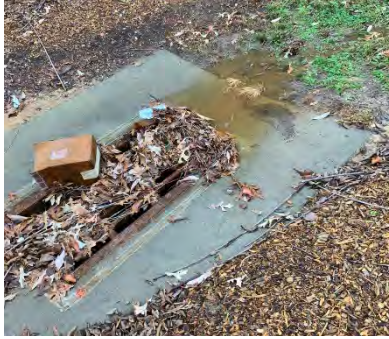
#	Material Type	Object ID	Failure Type	Photo	GIS Reference Page
1	Inlet	IN_52	Obstruction

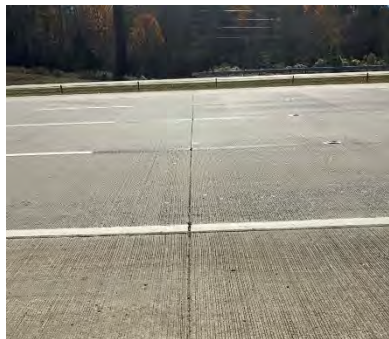
#	Material Type	Object ID	Failure Type	Photo	GIS Reference Page
1	Concrete	LS_342	Joint Malfunction

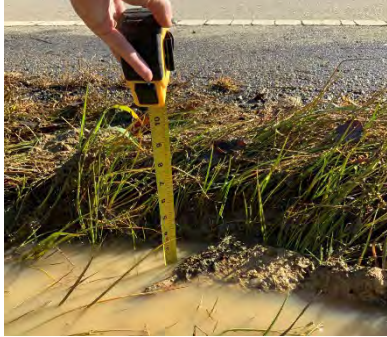
#	Material Type	Object ID	Failure Type	Photo	GIS Reference Page
1	Asphalt	LS_521	Drop-Off

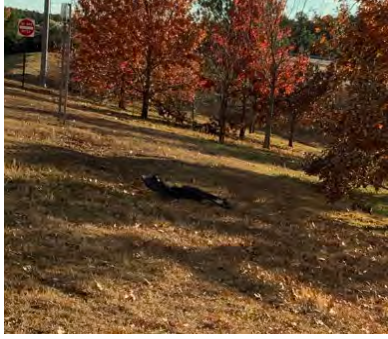
#	Material Type	Object ID	Failure Type	Photo	GIS Reference Page
1	Asphalt	LS_206	Litter

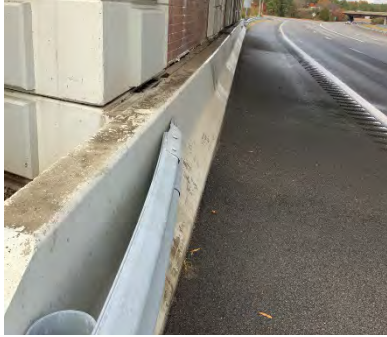
#	Material Type	Object ID	Failure Type	Photo	GIS Reference Page
1	Asphalt	LS_203	Nighttime Reflectivity	Not Available for Nighttime Failures	A3
2	Asphalt	LS_269	Missing

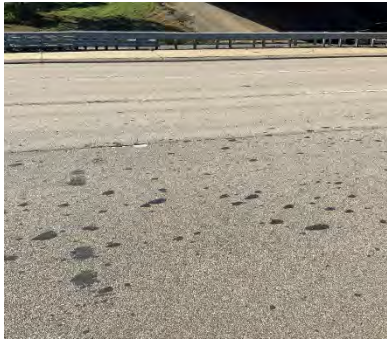
A29
3	Asphalt	LS_725	Missing

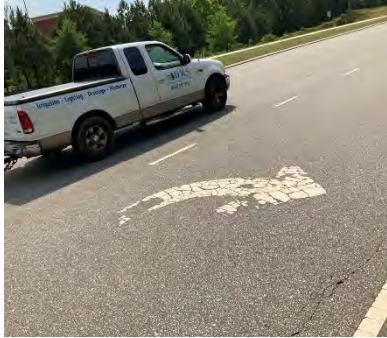
#	Material Type	Object ID	Failure Type	Photo	GIS Reference Page
1	Left Turn	PS_423	Nighttime Reflectivity	Not Available for Nighttime Failures	A1
2	Left Turn	PS_432	Nighttime Reflectivity	Not Available for Nighttime Failures	A5
3	Only	PS_509	Nighttime Reflectivity, Daytime Assessment

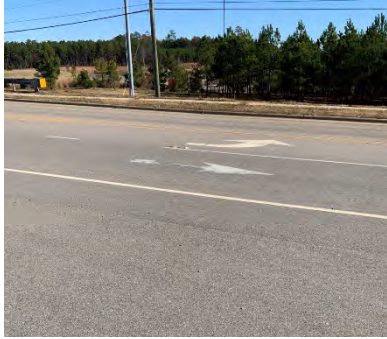
A5
4	Thru and Right	PS_558	Nighttime Reflectivity	Not Available for Nighttime Failures	A27
5	Thru Lane	PS_568	Nighttime Reflectivity, Daytime Assessment

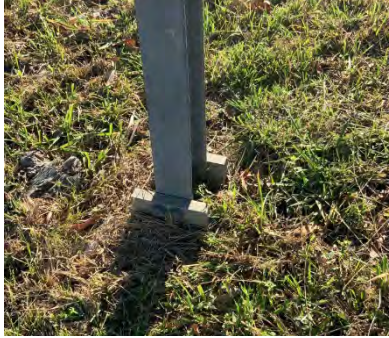
#	Sign Type	Object ID	Failure Type	Photo	GIS Reference Page
1	Exit	SN_405	Slip Base

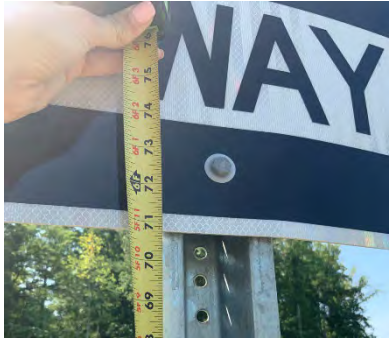
A3
2	Right Lane Ends	SN_564	Night Reflectivity	Not Available for Nighttime Failures	A2
3	One Way	SN_1208	Height

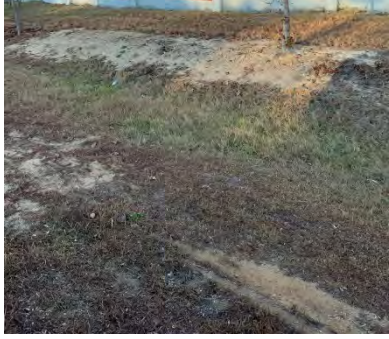
#	Material Type	Object ID	Failure Type	Photo	GIS Reference Page
5	Turf	TF_449	Bare Ground
