# Maintenance Rating Program

Triangle Expressway

2023 First Quarter Report

### NCTA Triangle Expressway Roadway Maintenance Performance Rating Program; Q1, FY 2023 Rating

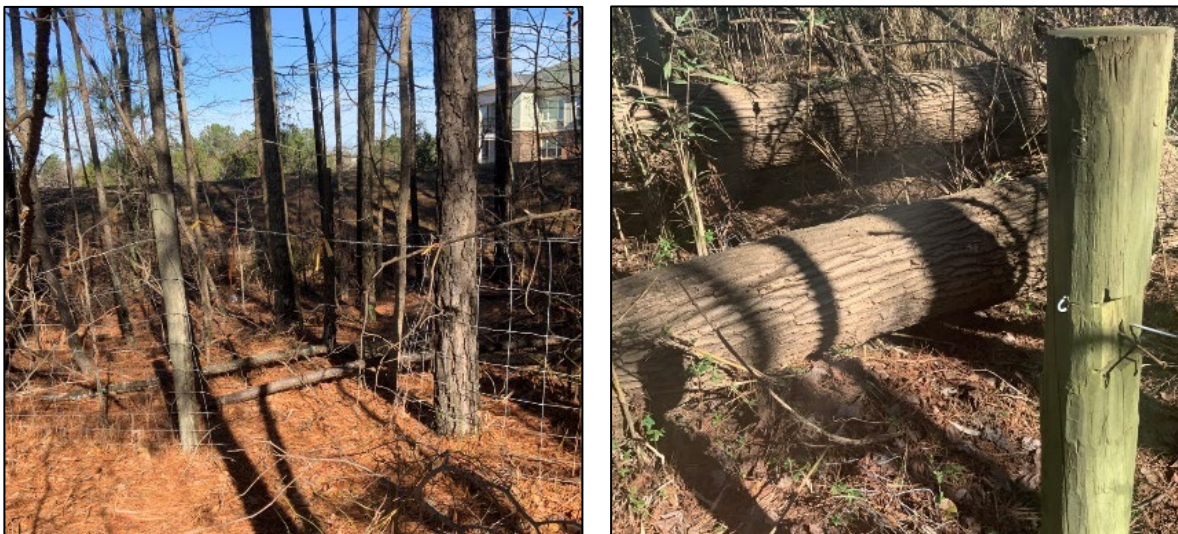
**Figure 3: Fences and Control Access Inspection Results Sample**

Fence and Control Access (71 rating – 20 of the 28 assets passed): Five of the eight wall sections that did not pass had failed for height. Two of the sections that did not pass inspection are presented in **Figure 3**.

Fence repair was ongoing through February and March when the inspection was occurring.

- 1) Fence shall be inspected every 4 months.
- 2) Areas where fence is adjacent to livestock or known pedestrian traffic must be secured until fence is fully restored.
- 3) Schedule and repair or replace damaged sections within the annual work program.

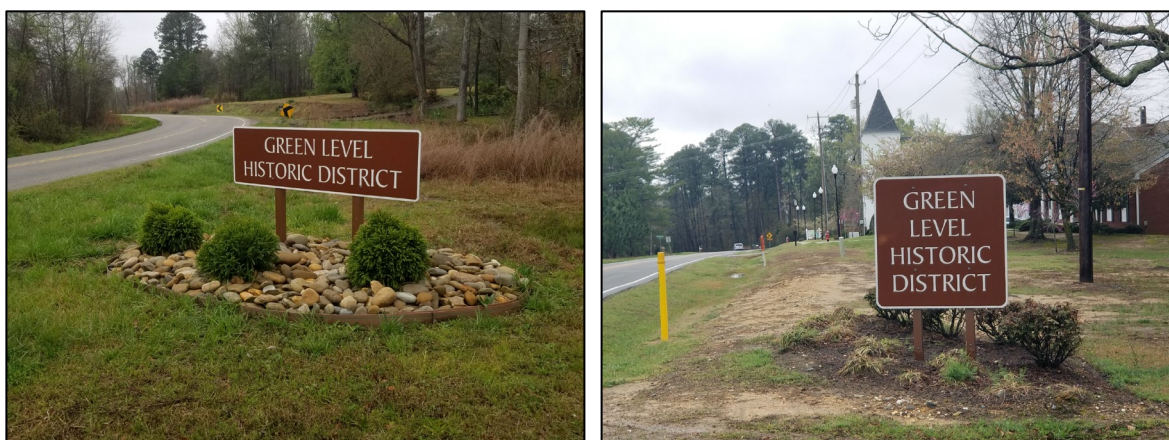
**Figure 4:** Green Level West Historic District Signs, Landscape Areas

As part of each quarterly inspection, an assessment team visits the two remaining Green Level Historic District signs to conduct a visual inspection of each sign and ensure they are in good standing. The two signs included in the inspection inventory were found to be in good condition. **Figure 4** shows the two signs assessed.

This quarter, the two Green Level Historic District signs inspected were found to be in good condition. Additionally, the landscaped areas surrounding the signs were found to be well maintained.

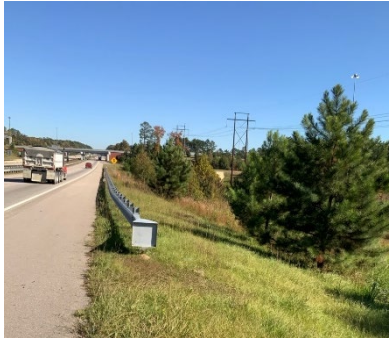
#	Material Type	Object ID	Failure Type	Photo	GIS Reference Page
1	Guardrail	BR_498	Missing Part

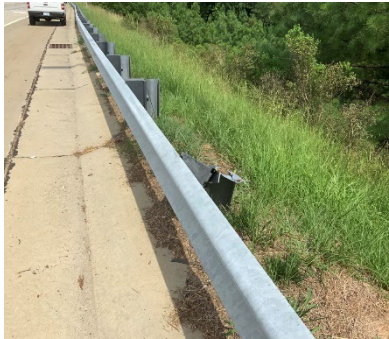
A24
2	Guardrail	BR_657	Post Damage

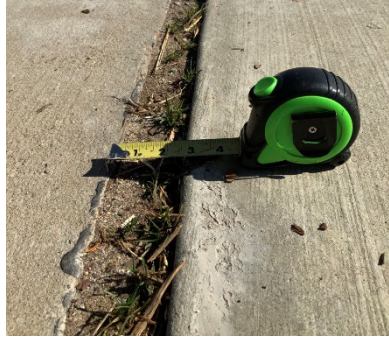
#	Material Type	Object ID	Failure Type	Photo	GIS Reference Page
1	Shoulder Berm Gutter	CG_4	Misalignment

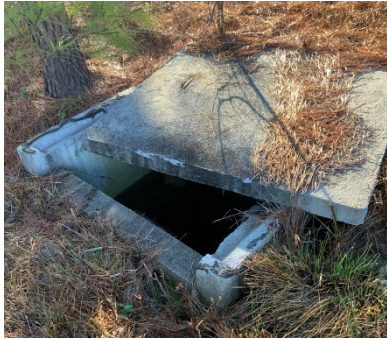
#	Material Type	Object ID	Failure Type	Photo	GIS Reference Page
1	Drain	DP_227	End Protection

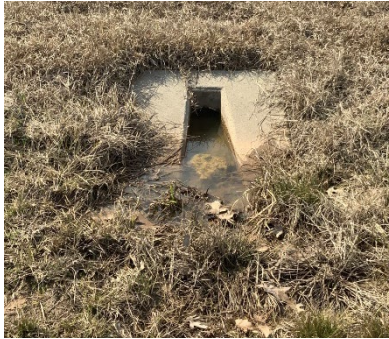
#	Material Type	Object ID	Failure Type	Photo	GIS Reference Page
1	Shoulder Drain	MDP_41	End Damage

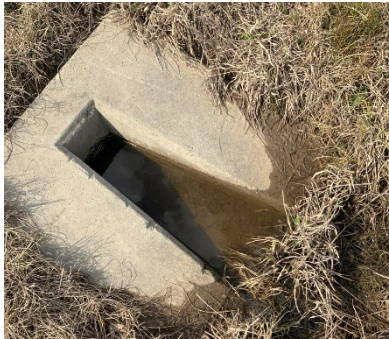
A10
2	Shoulder Drain	MDP_53	End Damage

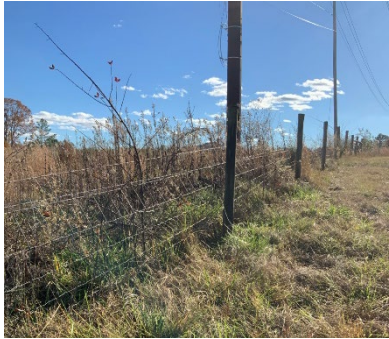
#	Material Type	Object ID	Failure Type	Photo	GIS Reference Page
1	Woven	FN_63	Height

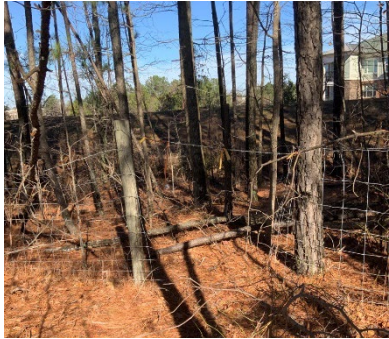
#	Material Type	Object ID	Failure Type	Photo	GIS Reference Page
5	Woven	FN_310	Fence Hole

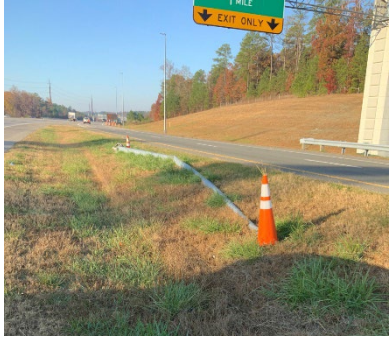
#	Material Type	Object ID	Failure Type	Photo	GIS Reference Page
1	Double Roadway	HL_142	Functional Damage

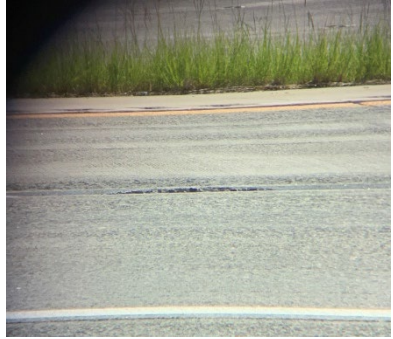
#	Material Type	Object ID	Failure Type	Photo	GIS Reference Page
1	Concrete	LS_462	Pothole

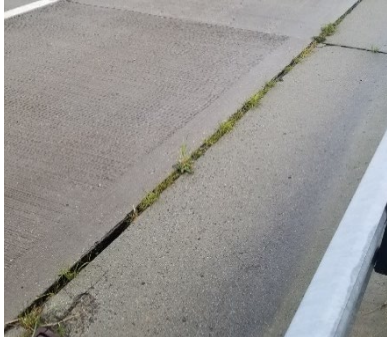
#	Material Type	Object ID	Failure Type	Photo	GIS Reference Page
1	Concrete	LS_318	Joint Separation

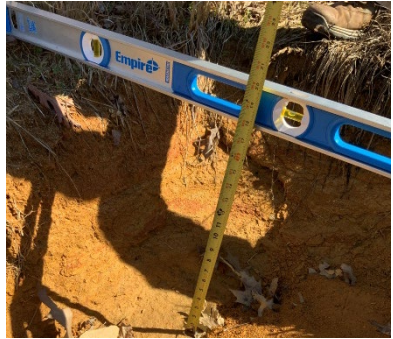
#	Material Type	Object ID	Failure Type	Photo	GIS Reference Page
1	Concrete	LS_456	Ditch Erosion

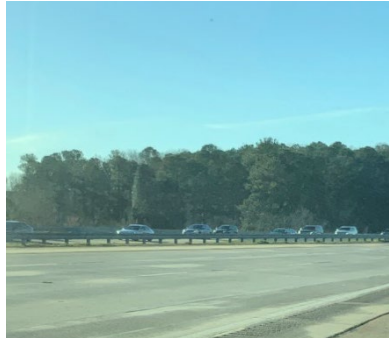
#	Material Type	Object ID	Failure Type	Photo	GIS Reference Page
1	Concrete	LS_43	Missing

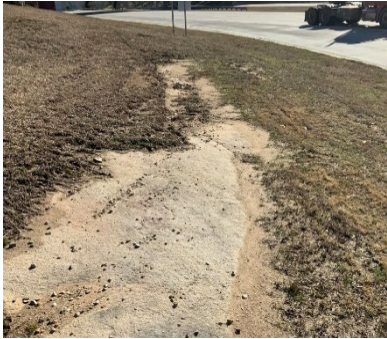
#	Material Type	Object ID	Failure Type	Photo	GIS Reference Page
1	Turf	TF_177	Bare Ground

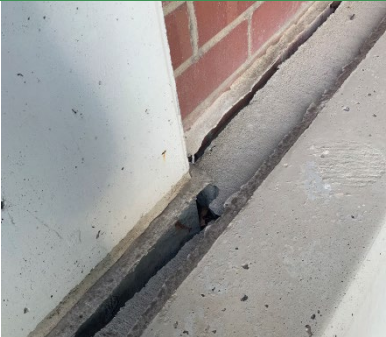
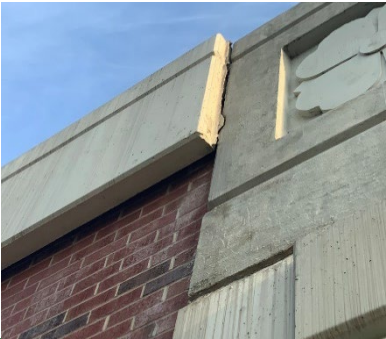
#	Material Type	Object ID	Failure Type	Photo	GIS Reference Page
1	Bridge Wall	WL_5	Unsealed Cracks/Joints

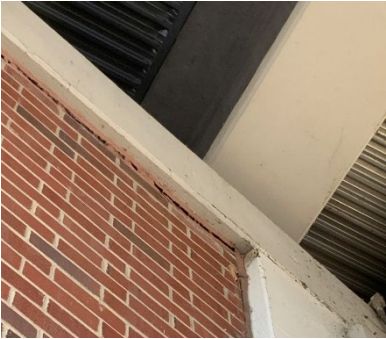
A29
2	Bridge Wall	WL_10	Unsealed Cracks/Joints

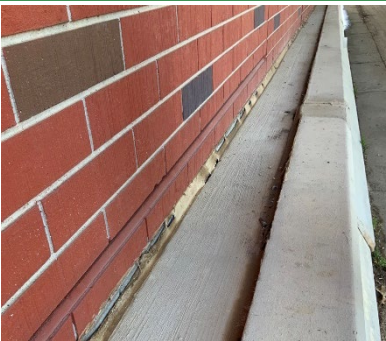
A33
3	Bridge Wall	WL_69	Unsealed Cracks/Joints
