Maintenance Rating Program

Triangle Expressway

2023 Second Quarter Report

NCTA Triangle Expressway Roadway Maintenance Performance Rating Program; Q2, FY 2023 Rating

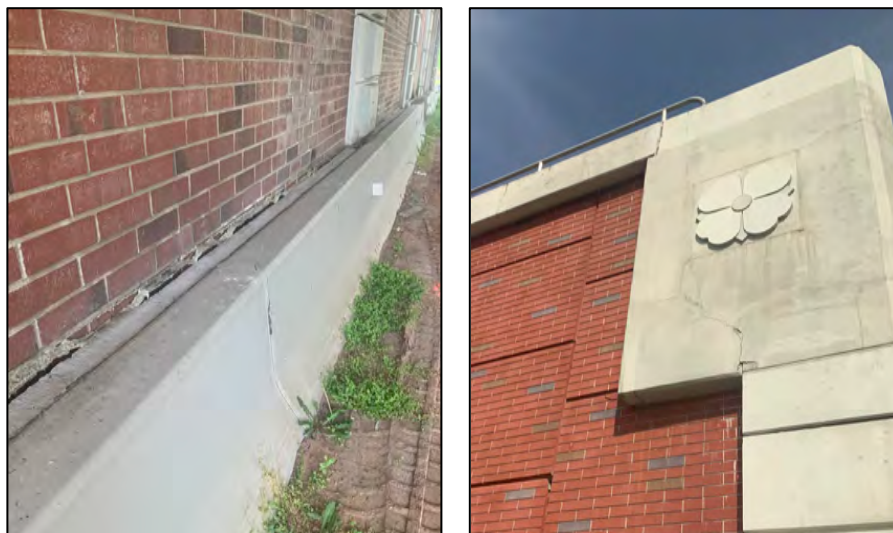
Figure 3: Retaining Walls and Sound Barrier Walls Inspection Results Sample

Retaining Walls and Sound Barrier Walls (78 rating –14 of the 18 assets passed): The four wall sections that did not pass inspection had unsealed cracks/joints. Two of the sections that did not pass inspection are presented in *Figure 3*.

- 1) Walls shall be inspected during daily patrols.
- 2) Unwanted vegetation and graffiti (see graffiti standard) shall be scheduled for removal.
- 3) Minor wall or column damage shall be scheduled for repair within the annual work program.
- 4) Staining damage shall be scheduled for repair within the annual work program.
- 5) Any structural damage that poses a safety risk shall be scheduled immediately upon observation. Mitigate any safety hazard upon observation.

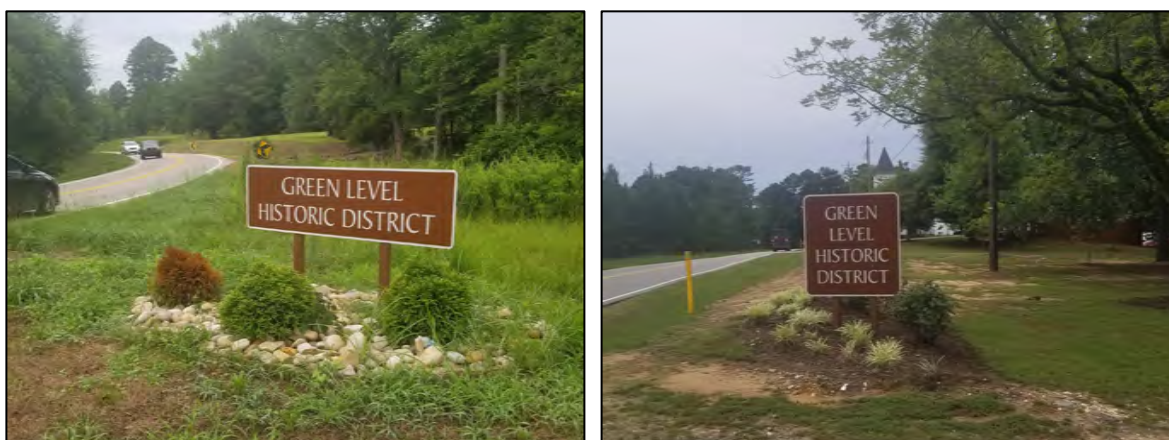
Figure 4: Green Level West Historic District Signs, Landscape Areas

As part of each quarterly inspection, an assessment team visits the two remaining Green Level Historic District signs to conduct a visual inspection of each sign and ensure they are in good standing. The two signs included in the inspection inventory were found to be in good condition. **Figure 4** shows the two signs assessed.

This quarter, the two Green Level Historic District signs inspected were found to be in good condition. Additionally, the landscaped areas surrounding the signs were found to be well maintained.

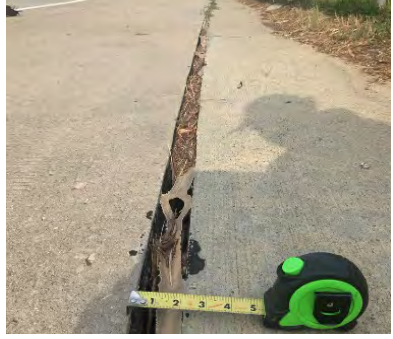
#	Material Type	Object ID	Failure Type	Photo	GIS Reference Page
1	Express-way Gutter	CG_337	Misalignment

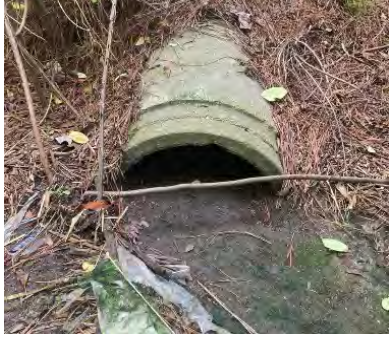
#	Material Type	Object ID	Failure Type	Photo	GIS Reference Page
1	Drain	DP_781	Obstruction

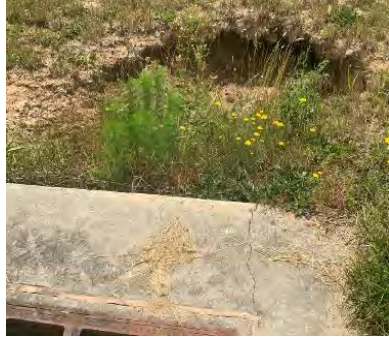
#	Material Type	Object ID	Failure Type	Photo	GIS Reference Page
1	Drop Inlet	IN_787	Eroded Area

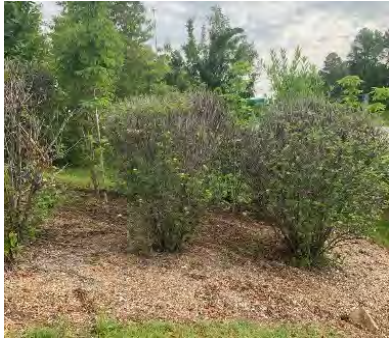
#	Material Type	Object ID	Failure Type	Photo	GIS Reference Page
1	Plant Bed	PB_75	Overgrown

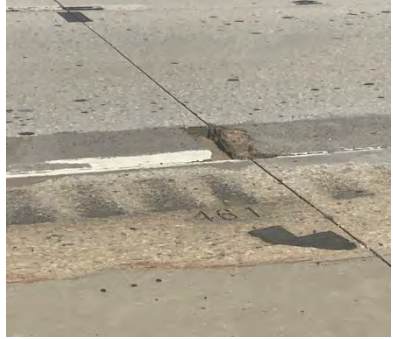
#	Material Type	Object ID	Failure Type	Photo	GIS Reference Page
1	Concrete	LS_608	Joint Malfunction

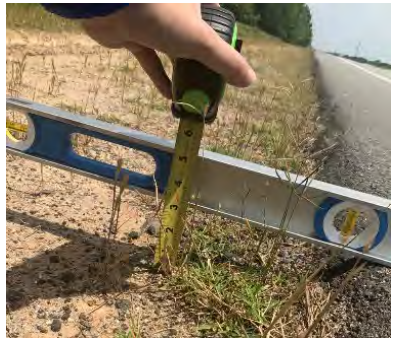
#	Material Type	Object ID	Failure Type	Photo	GIS Reference Page
1	Asphalt	LS_29	Drop off

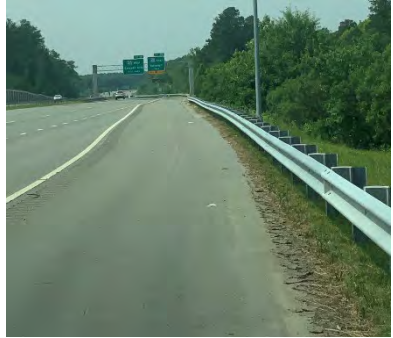
#	Material Type	Object ID	Failure Type	Photo	GIS Reference Page
1	Concrete	LS_100	Nighttime Reflectivity	Not available for nighttime failure	A13
2	Asphalt	LS_250	Missing, Nighttime Reflectivity

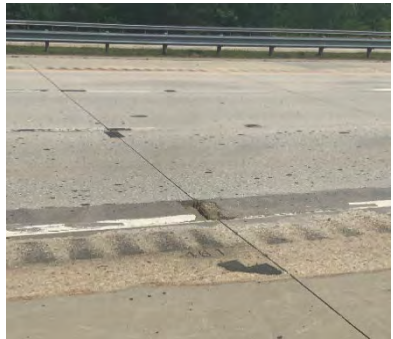
A29
3	Concrete	LS_588	Nighttime Reflectivity	Not available for nighttime failure	A1
4	Concrete	LS_608	Missing, Nighttime Reflectivity

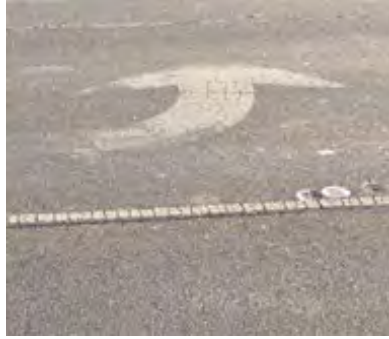
#	Material Type	Object ID	Failure Type	Photo	GIS Reference Page
1	Left Turn	PS_409	Nighttime Reflectivity

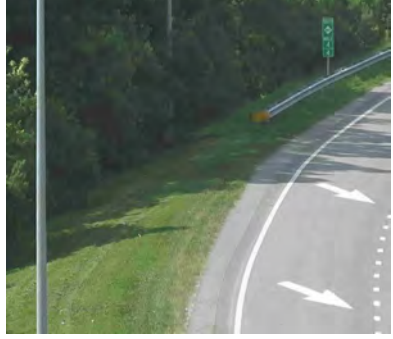
#	Sign Type	Object ID	Failure Type	Photo	GIS Reference Page
1	Speed Limit Interstate	SN_1040	Missing

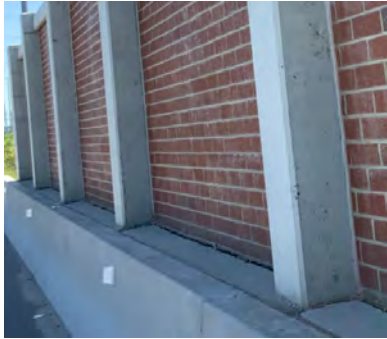
#	Material Type	Object ID	Failure Type	Photo	GIS Reference Page
1	Sound Wall	WL_7	Unsealed Cracks/Joints

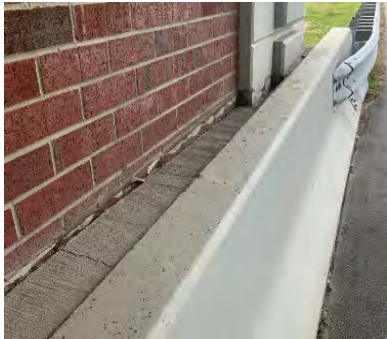
A29
2	Bridge Wall	WL_9	Unsealed Cracks/Joints

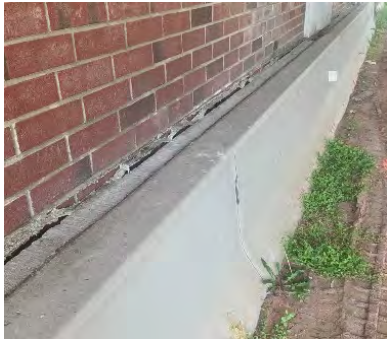
A30
3	Bridge Wall	WL_11	Unsealed Cracks/Joints

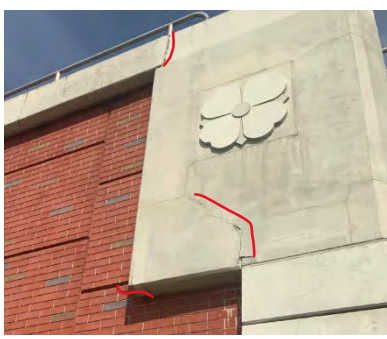
A31
4	Bridge Wall	WL_58	Unsealed Cracks/Joints
