Maintenance Rating Program

Triangle Expressway

2023 Third Quarter Report

NCTA Monroe By-Pass Roadway Maintenance Performance Rating Program; Q3, FY 2023 Rating

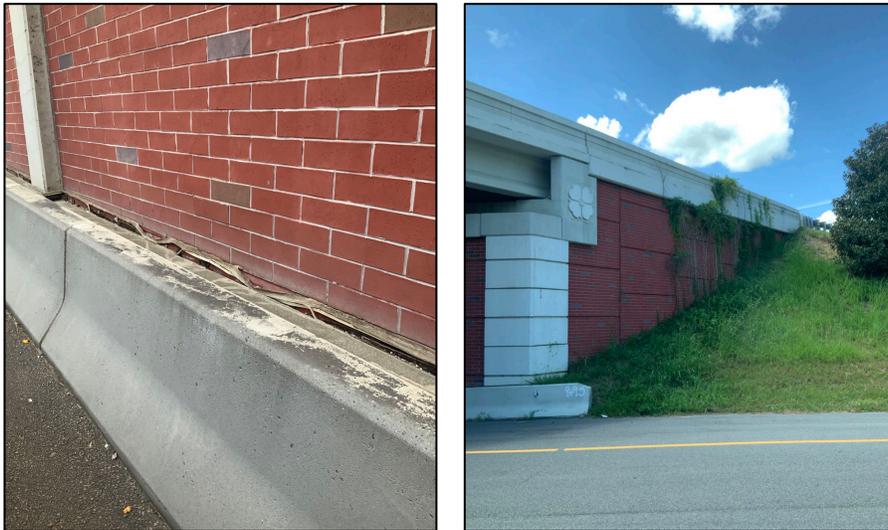
Figure 3: Retaining Walls and Sound Barrier Walls Inspection Results Sample

Retaining Walls and Sound Barrier Walls (72 rating – 13 of the 18 assets passed): Four of the wall sections that did not pass inspection had unsealed cracks/joints and one did not pass due to vegetation. Two of the sections that did not pass inspection are presented in *Figure 3*.

Maintenance Program:

- 1) Walls shall be inspected during daily patrols.
- 2) Unwanted vegetation and graffiti (see graffiti standard) shall be scheduled for removal.
- 3) Minor wall or column damage shall be scheduled for repair within the annual work program.
- 4) Staining damage shall be scheduled for repair within the annual work program.
- 5) Any structural damage that poses a safety risk shall be scheduled immediately upon observation. Mitigate any safety hazard upon observation.

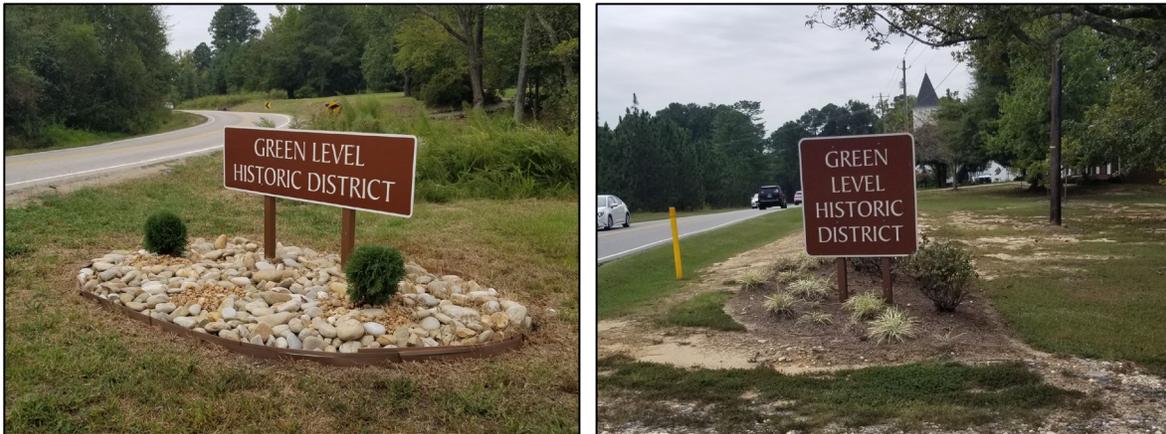
Figure 4: Green Level West Historic District Signs, Landscape Areas

As part of each quarterly inspection, an assessment team visits the two remaining Green Level Historic District signs to conduct a visual inspection of each sign and ensure they are in good standing. The two signs included in the inspection inventory were found to be in good condition. *Figure 4* shows the two signs assessed.

This quarter, the two Green Level Historic District signs inspected were found to be in good condition. Additionally, the landscaped areas surrounding the signs were found to be well maintained.

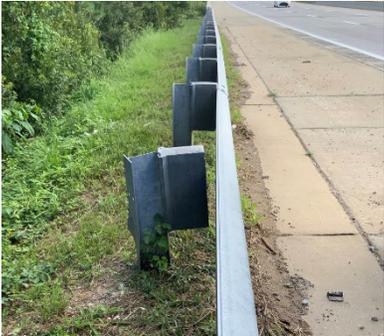
#	Material Type	Object ID	Failure Type	Photo	GIS Reference Page
1	Guardrail	BR_121	Missing Parts

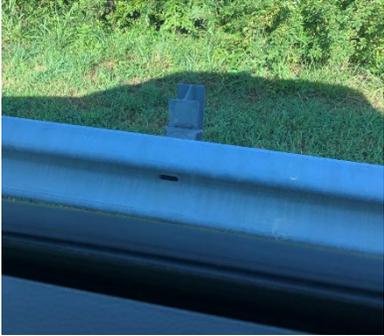
A9
2	Guardrail	BR_724	Missing Parts

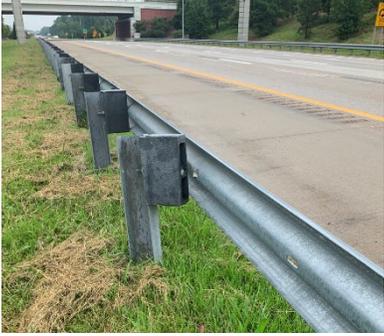
A28
3	Guardrail	BR_807	Missing Parts

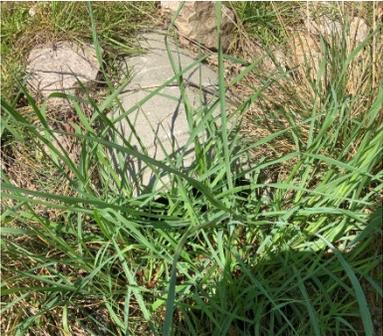
#	Material Type	Object ID	Failure Type	Photo	GIS Reference Page
1	Drain	DP_1201	Obstruction

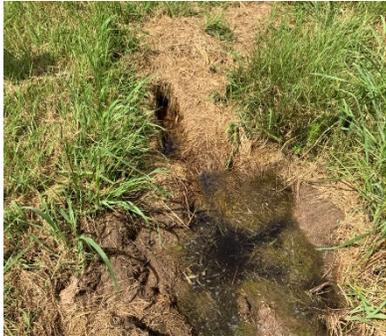
#	Material Type	Object ID	Failure Type	Photo	GIS Reference Page
1	Shoulder Drain	MDP_12	Rodent Screen/ Obstruction

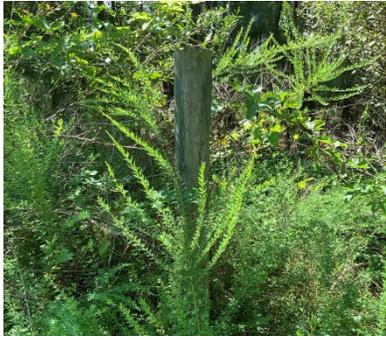
#	Material Type	Object ID	Failure Type	Photo	GIS Reference Page
1	Woven	FN_193	Hole

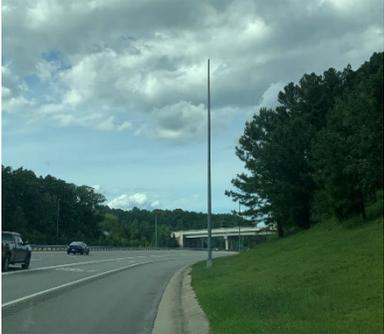
#	Material Type	Object ID	Failure Type	Photo	GIS Reference Page
1	Single Roadway	HL_214	Missing Parts

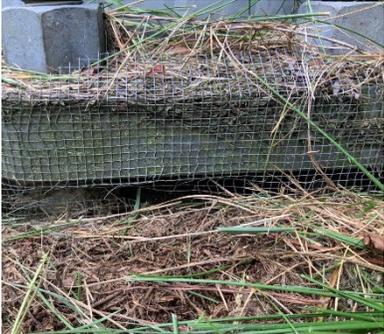
A28
2	High Mast	HL_273	Rodent Screen

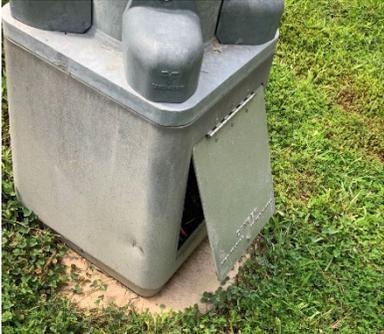
A21
3	Single Roadway	HL_423	Part Damage

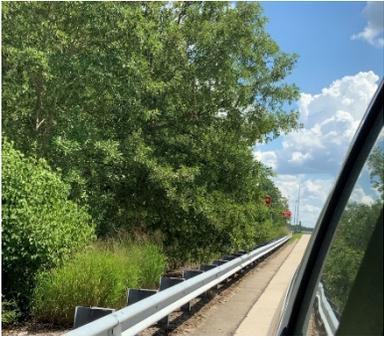
#	Material Type	Object ID	Failure Type	Photo	GIS Reference Page
1	Plant Bed	PB_155	Overgrown

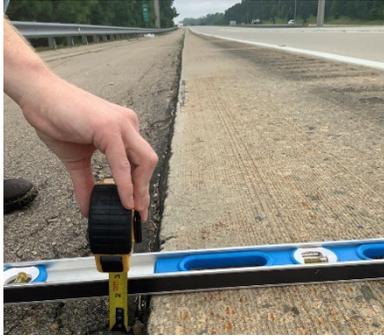
#	Material Type	Object ID	Failure Type	Photo	GIS Reference Page
1	Concrete	LS_680	Drop off

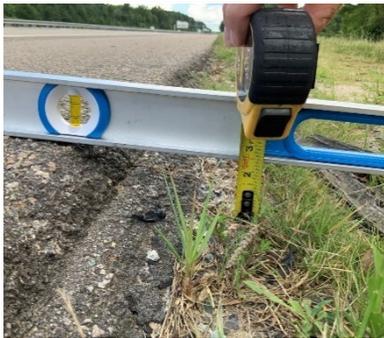
#	Material Type	Object ID	Failure Type	Photo	GIS Reference Page
1	Asphalt	LS_387	Drop off

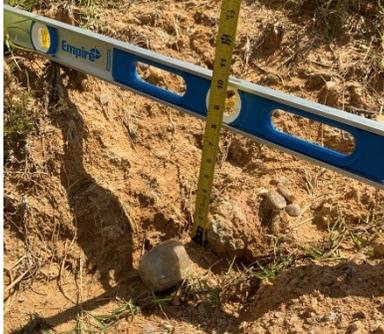
#	Material Type	Object ID	Failure Type	Photo	GIS Reference Page
1	Concrete	LS_618	Slope Deviation

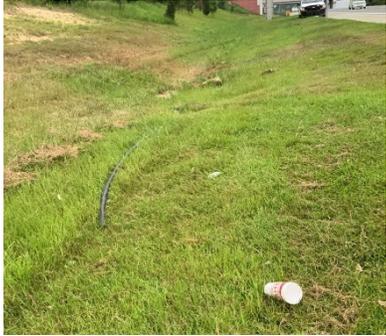
#	Material Type	Object ID	Failure Type	Photo	GIS Reference Page
1	Concrete	LS_442	Litter

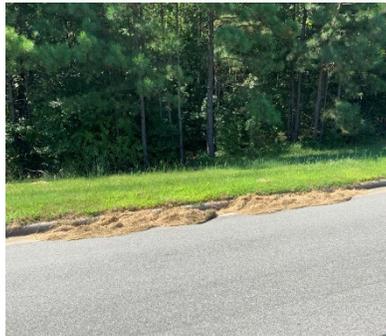
#	Material Type	Object ID	Failure Type	Photo	GIS Reference Page
1	Asphalt	LS_27	Material Accumulation

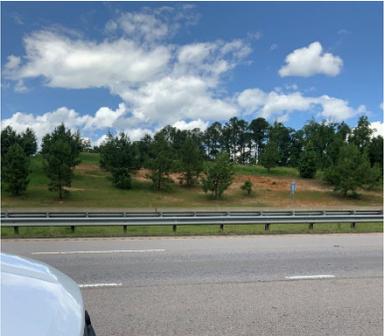
#	Material Type	Object ID	Failure Type	Photo	GIS Reference Page
1	Asphalt	LS_387	Missing, Nighttime Reflectivity

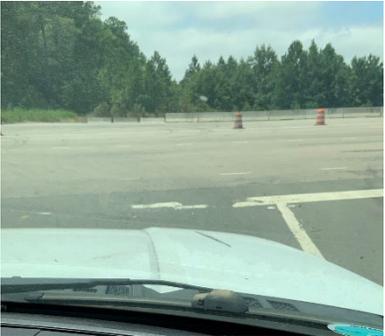
#	Material Type	Object ID	Failure Type	Photo	GIS Reference Page
1	Stop Bar	PS_601	Daytime Assessment

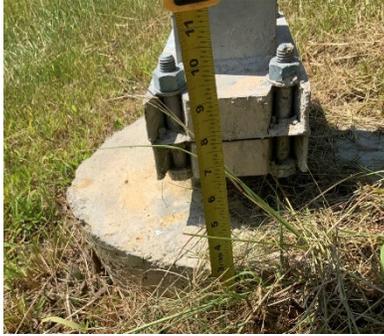
#	Sign Type	Object ID	Failure Type	Photo	GIS Reference Page
1	Hospital	SN_16	Slip Base

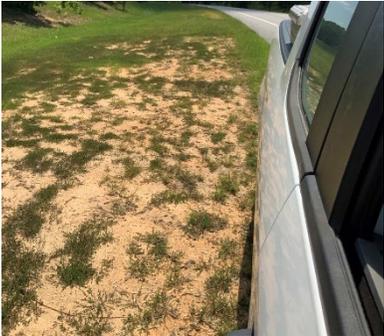
#	Material Type	Object ID	Failure Type	Photo	GIS Reference Page
1	Turf	TF_82	Bare Ground

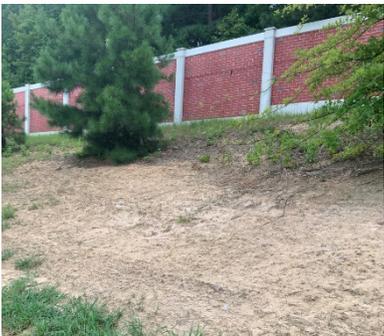
A23
4	Turf	TF_478	Bare Ground

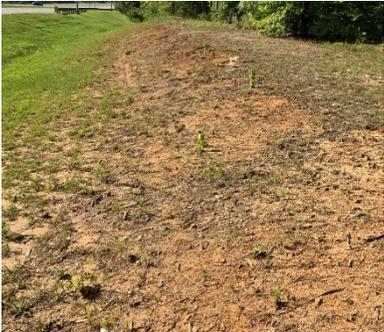
#	Material Type	Object ID	Failure Type	Photo	GIS Reference Page
5	Turf	TF_749	Bare Ground

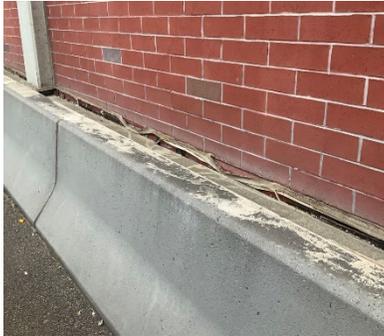
#	Material Type	Object ID	Failure Type	Photo	GIS Reference Page
1	Sound Wall	WL_49	Unsealed Cracks/Joints

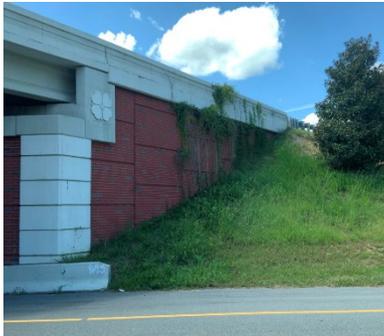
A19
2	Bridge Wall	WL_62	Vegetation

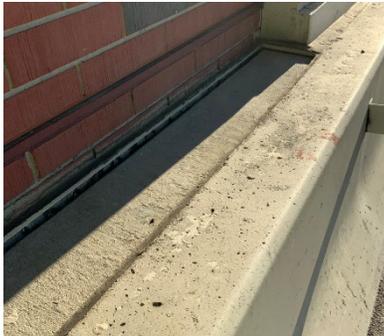
A23
3	Bridge Wall	WL_64	Unsealed Cracks/Joints

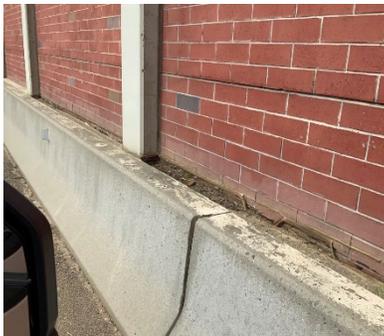
A23
4	Sound Wall	WL_96	Unsealed Cracks/Joints

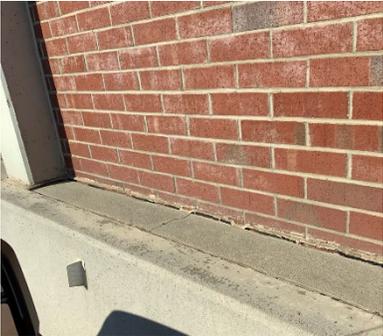
#	Material Type	Object ID	Failure Type	Photo	GIS Reference Page
5	Sound Wall	WL_119	Unsealed Cracks/Joints
