# Maintenance Rating Program

## Triangle Expressway

February 2024

2023 Fourth Quarter Report

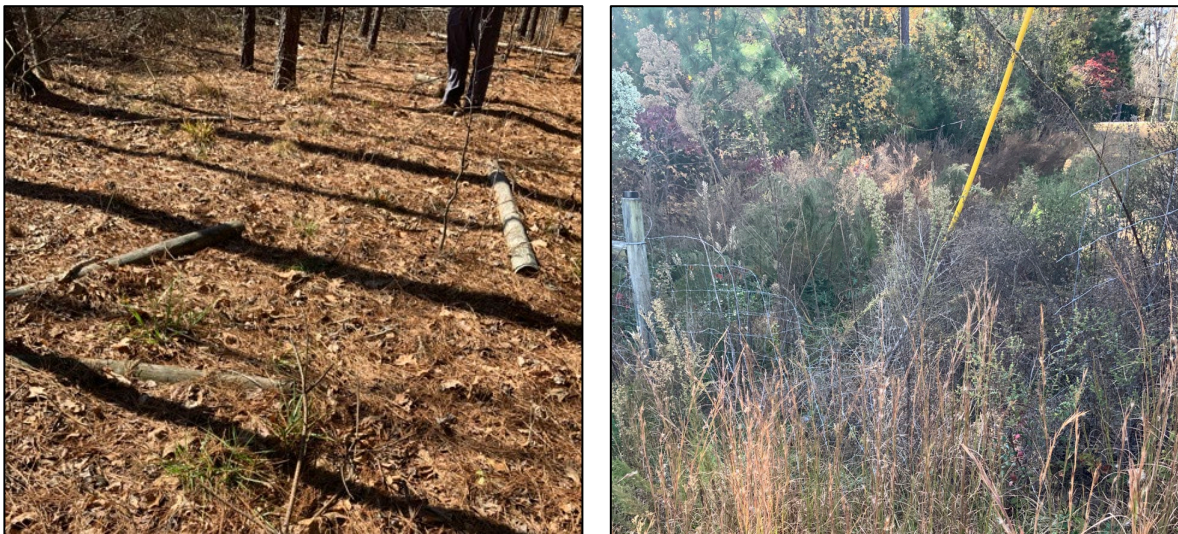
**Figure 3: Fences and Control Access Inspection Results Sample**

Fence and Control Access (71 rating – 23 of the 29 assets passed): Four of the six sections that did not pass had failed for openings great than 2 square feet. Two of the sections that did not pass inspection are presented in *Figure 3*.

Fence repair is scheduled through February and March of 2024.

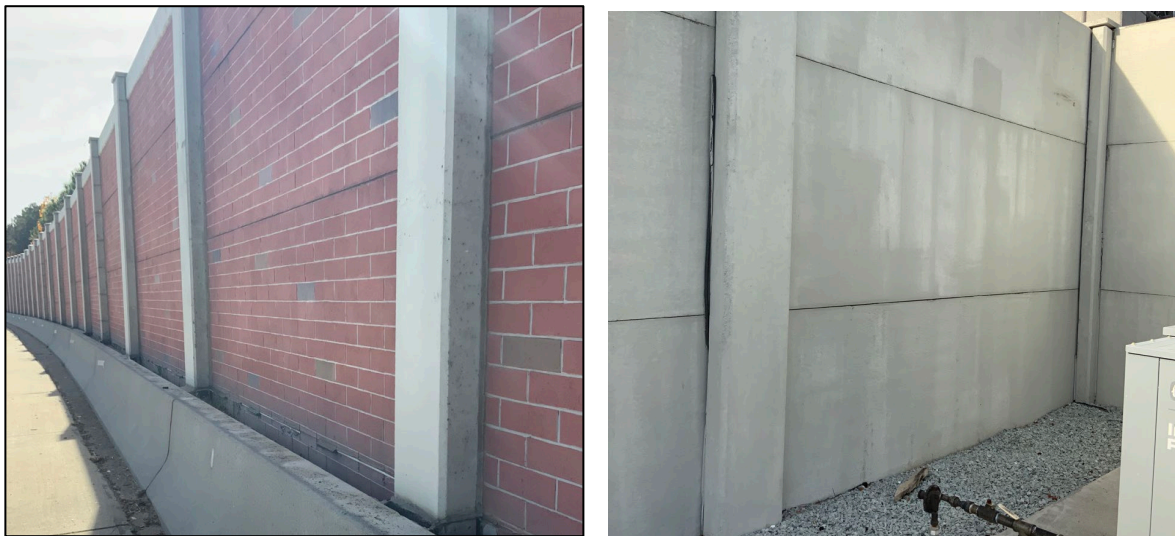
**Figure 4: Retaining Walls and Sound Barrier Walls Inspection Results Sample**

Retaining Walls and Sound Barrier Walls (72 rating – 13 of the 18 assets passed): All five of the wall sections that did not pass inspection had unsealed cracks/joints. Two of the sections that did not pass inspection are presented in *Figure 3*.

- 1) Walls shall be inspected during daily patrols.
- 2) Unwanted vegetation and graffiti (see graffiti standard) shall be scheduled for removal.
- 3) Minor wall or column damage shall be scheduled for repair within the annual work program.
- 4) Staining damage shall be scheduled for repair within the annual work program.
- 5) Any structural damage that poses a safety risk shall be scheduled immediately upon observation. Mitigate any safety hazard upon observation.

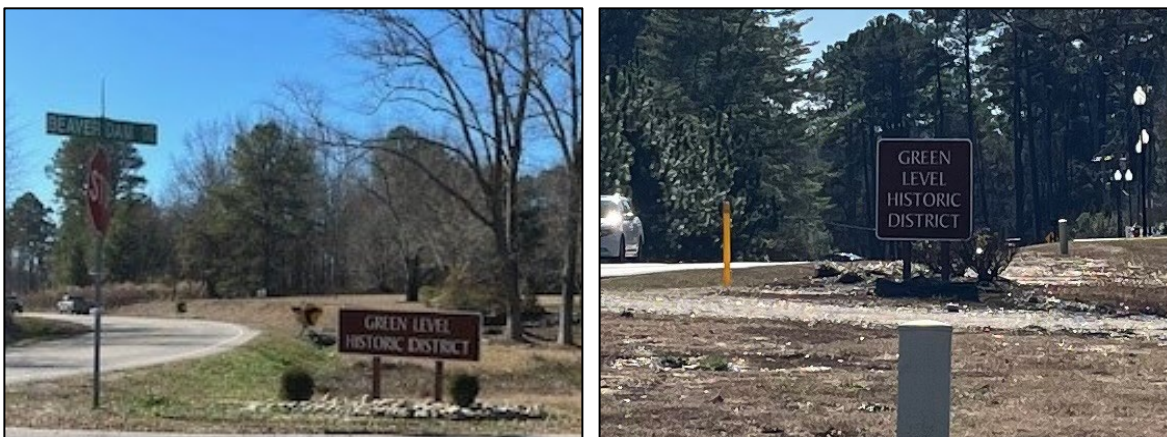
Figure 4: Green Level West Historic District Signs, Landscape Areas

As part of each quarterly inspection, an assessment team visits the two remaining Green Level Historic District signs to conduct a visual inspection of each sign and ensure they are in good standing. The two signs included in the inspection inventory were found to be in good condition. **Figure 4** shows the two signs assessed.

This quarter, the two Green Level Historic District signs inspected were found to be in good condition. Additionally, the landscaped areas surrounding the signs were found to be well maintained.

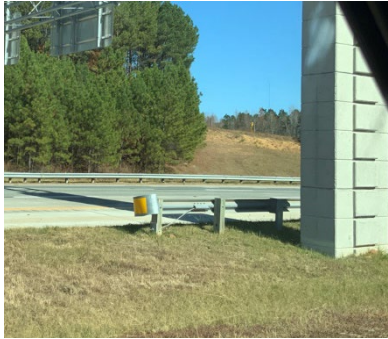
#	Material Type	Object ID	Failure Type	Photo	GIS Reference Page
1	Guardrail	BR_43	Functional Damage

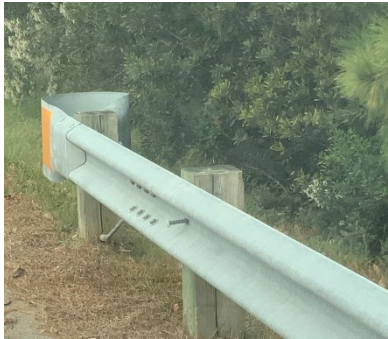
A26
2	Guardrail	BR_116	Missing Part

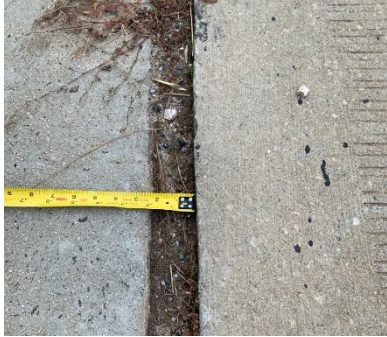
#	Material Type	Object ID	Failure Type	Photo	GIS Reference Page
1	Curb and Gutter	CG_174	Misalignment

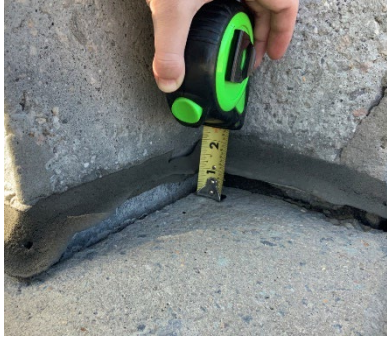
#	Material Type	Object ID	Failure Type	Photo	GIS Reference Page
1	Gantry Support	DS_218	Unsealed Crack/Joint

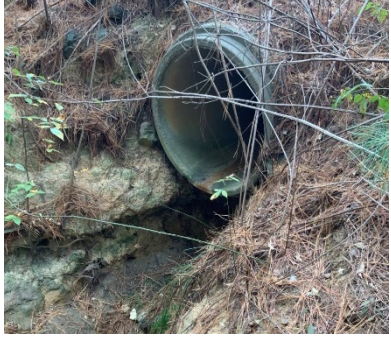
#	Material Type	Object ID	Failure Type	Photo	GIS Reference Page
1	Drain	DP_1130	Eroded Area

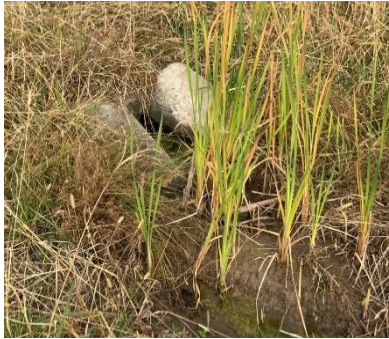
#	Material Type	Object ID	Failure Type	Photo	GIS Reference Page
1	Shoulder Drain	MDP_55	Obstruction

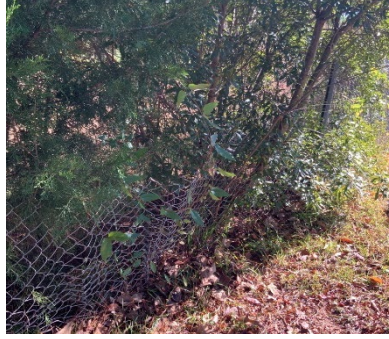
#	Material Type	Object ID	Failure Type	Photo	GIS Reference Page
5	Woven	FN_272	Height

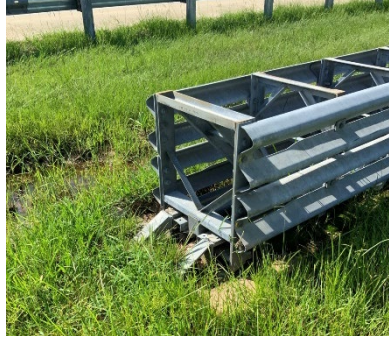
#	Material Type	Object ID	Failure Type	Photo	GIS Reference Page
1	Impact Attenuator	IA_12	Missing Parts

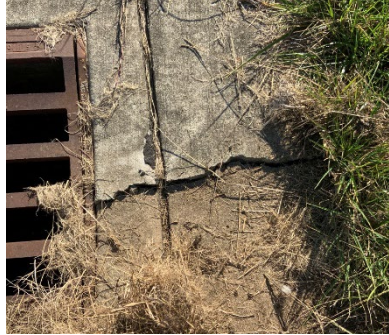
#	Material Type	Object ID	Failure Type	Photo	GIS Reference Page
1	Inlet	IN_368	Surface Damage

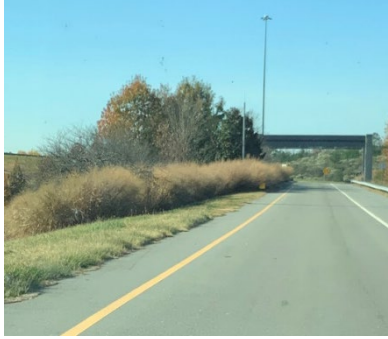
#	Material Type	Object ID	Failure Type	Photo	GIS Reference Page
1	Plant Bed	PB_228	Overgrown

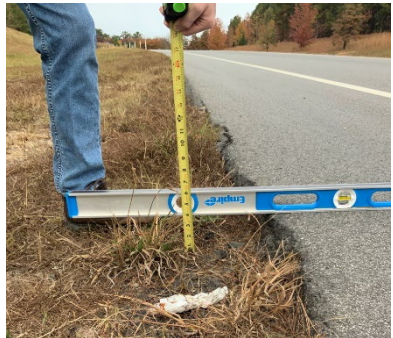
#	Material Type	Object ID	Failure Type	Photo	GIS Reference Page
1	Asphalt	LS_57	Drop off

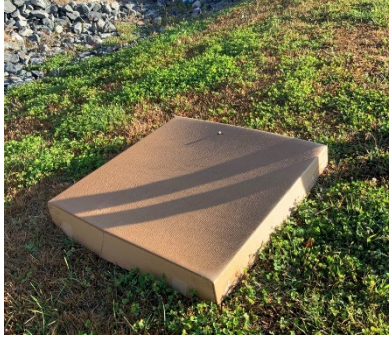
#	Material Type	Object ID	Failure Type	Photo	GIS Reference Page
1	Asphalt	LS_756	Litter

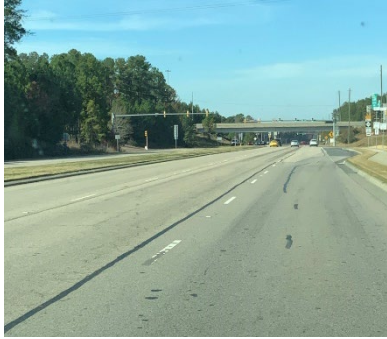
#	Material Type	Object ID	Failure Type	Photo	GIS Reference Page
1	Asphalt	LS_695	Nighttime Reflectivity	Not Available for Nighttime Failures	A26
2	Asphalt	LS_723	Line Width, Line Missing

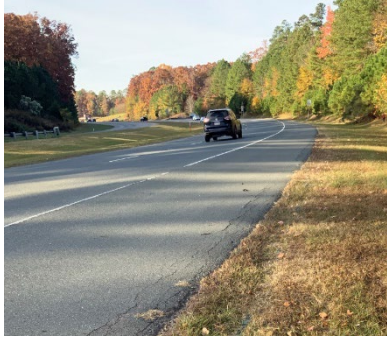
A6
3	Asphalt	LS_756	Line Missing

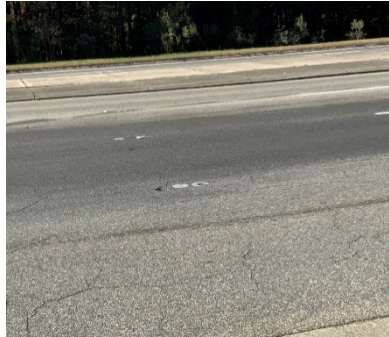
#	Material Type	Object ID	Failure Type	Photo	GIS Reference Page
1	Asphalt	LS_499	Nighttime Reflectivity	Not Available for Nighttime Failures	A23
2	Asphalt	LS_523	Nighttime Reflectivity	Not Available for Nighttime Failures	A24
3	Asphalt	LS_723	Nighttime Reflectivity	Not Available for Nighttime Failures	A6
4	Asphalt	LS_736	Markers Missing

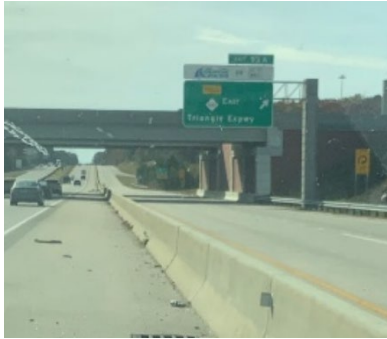
#	Material Type	Object ID	Failure Type	Photo	GIS Reference Page
1	Asphalt	LS_526	Missing, Nighttime Reflectivity

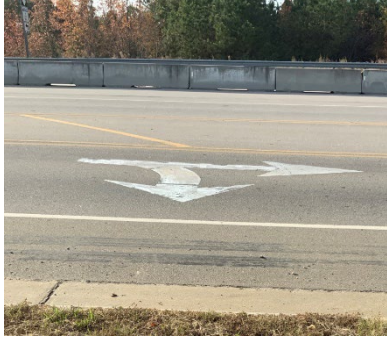
#	Material Type	Object ID	Failure Type	Photo	GIS Reference Page
1	Thru and Right	PS_581	Nighttime Reflectivity

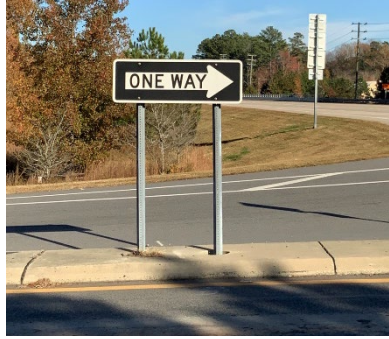
#	Sign Type	Object ID	Failure Type	Photo	GIS Reference Page
1	One Way	SN_322	Height

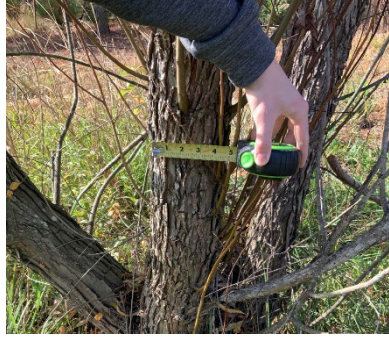
#	Material Type	Object ID	Failure Type	Photo	GIS Reference Page
1	Tree and Brush	TB_303	Lateral Clearance

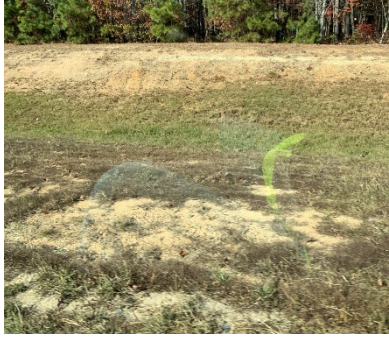
#	Material Type	Object ID	Failure Type	Photo	GIS Reference Page
1	Turf	TF_375	Bare Ground

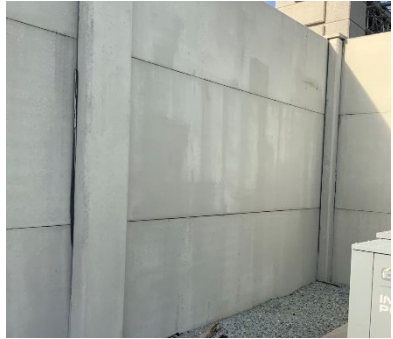
#	Material Type	Object ID	Failure Type	Photo	GIS Reference Page
5	Sound Wall	WL_121	Unsealed Cracks/Joints
