Maintenance Rating Program

Triangle Expressway

May 2024

2024 First Quarter Report

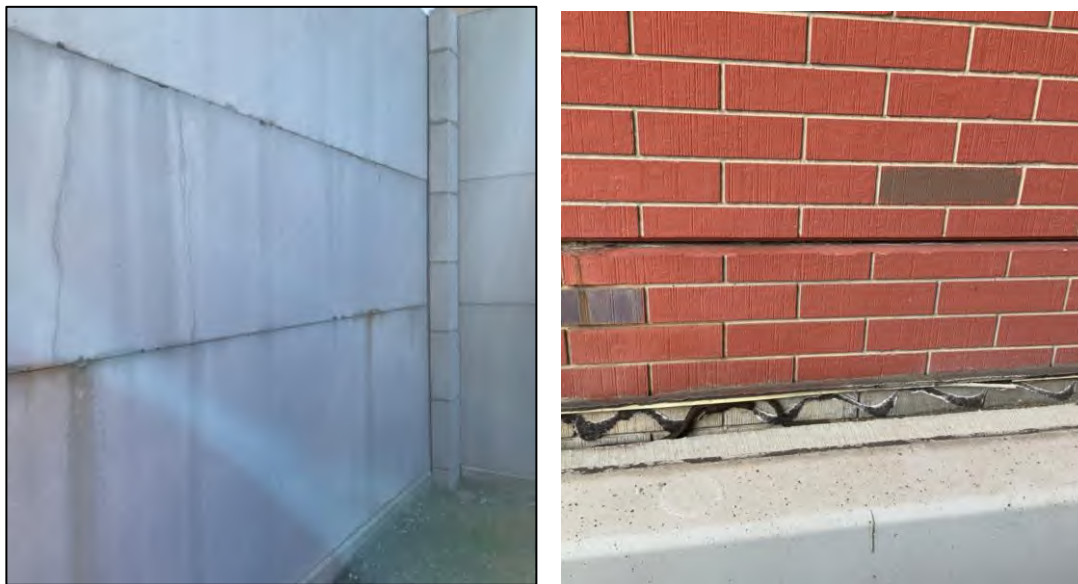
Figure 3: Retaining Walls and Sound Barrier Walls Inspection Results Sample

Retaining Walls and Sound Barrier Walls (72 rating – 13 of the 18 assets passed): All five of the wall sections that did not pass inspection had unsealed cracks/joints. Two of the sections that did not pass inspection are presented in *Figure 3*.

- 1) Walls shall be inspected during daily patrols.
- 2) Unwanted vegetation and graffiti (see graffiti standard) shall be scheduled for removal.
- 3) Minor wall or column damage shall be scheduled for repair within the annual work program.
- 4) Staining damage shall be scheduled for repair within the annual work program.
- 5) Any structural damage that poses a safety risk shall be scheduled immediately upon observation. Mitigate any safety hazard upon observation.

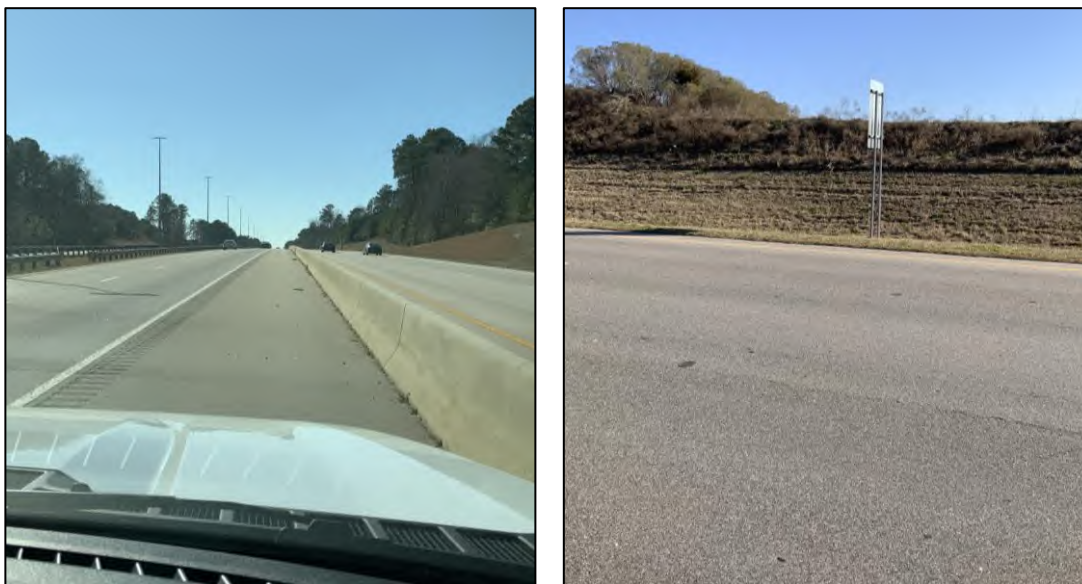
Figure 4: Delineators Inspection Results Sample

Delineators (75 rating – 24 of the 32 assets passed): Each of the eight sections that did not pass had failed for missing or non-reflective delineators. Two of the sections that did not pass inspection are presented in *Figure 3*.

- 1) Object markers and delineators are inspected by routine patrols and specifically after each mowing cycle for damage.
- 2) Missing and non-reflective object markers are replaced within the annual work program.
- 3) Missing and non-reflective delineators are replaced within 14 calendar days.

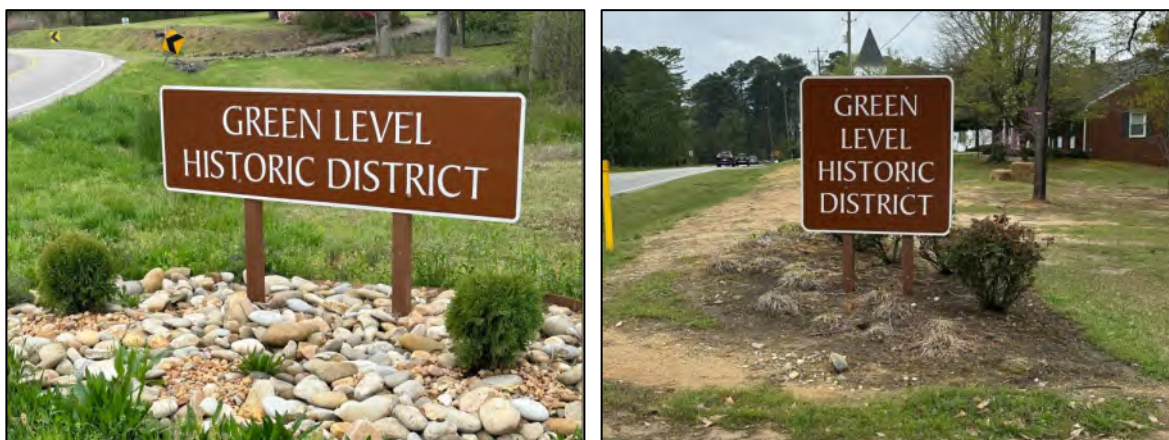
Figure 4: Green Level West Historic District Signs, Landscape Areas

As part of each quarterly inspection, an assessment team visits the two remaining Green Level Historic District signs to conduct a visual inspection of each sign and ensure they are in good standing. The two signs included in the inspection inventory were found to be in good condition. **Figure 4** shows the two signs assessed.

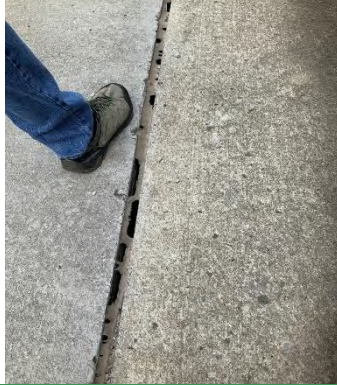
#	Material Type	Object ID	Failure Type	Photo	GIS Reference Page
1	Concrete	CG_54	Structural Damage

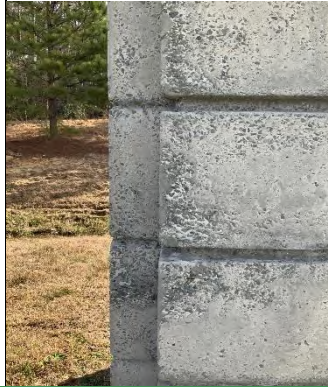
#	Material Type	Object ID	Failure Type	Photo	GIS Reference Page
1	Concrete	DS_194	Spalling

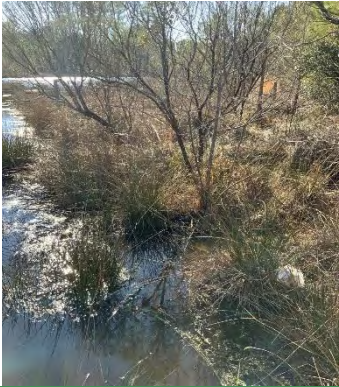
#	Material Type	Object ID	Failure Type	Photo	GIS Reference Page
1	Drain	DP_24	Obstruction

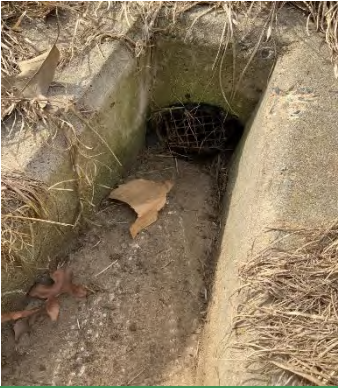
#	Material Type	Object ID	Failure Type	Photo	GIS Reference Page
1	Shoulder Drain	MDP_36	Rodent Screen

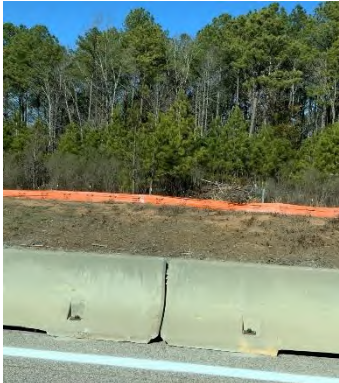
#	Material Type	Object ID	Failure Type	Photo	GIS Reference Page
1	Woven	FN_4	Hole Height

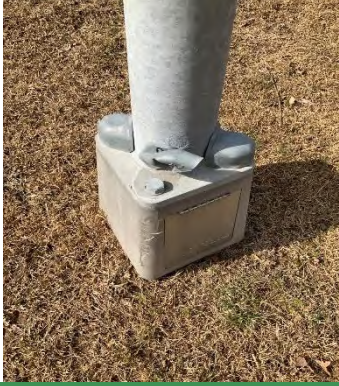
5	Single Roadway	HL_420	Part Damage

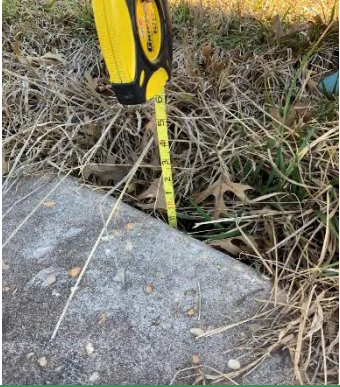
#	Material Type	Object ID	Failure Type	Photo	GIS Reference Page
1	Drop Inlet	IN_223	Eroded Area

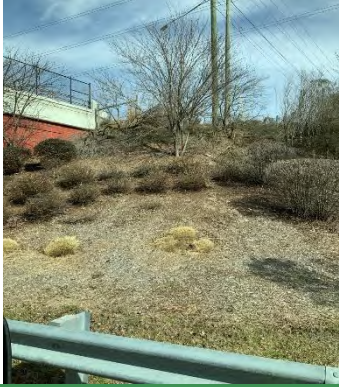
#	Material Type	Object ID	Failure Type	Photo	GIS Reference Page
1	Plant Bed	PB_184	Health

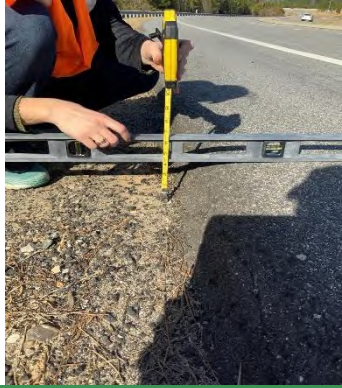
#	Material Type	Object ID	Failure Type	Photo	GIS Reference Page
1	Asphalt	LS_193	Drop off

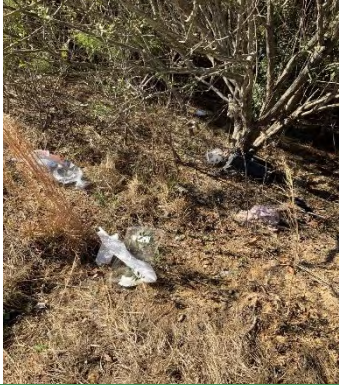
#	Material Type	Object ID	Failure Type	Photo	GIS Reference Page
1	Concrete	LS_422	Litter

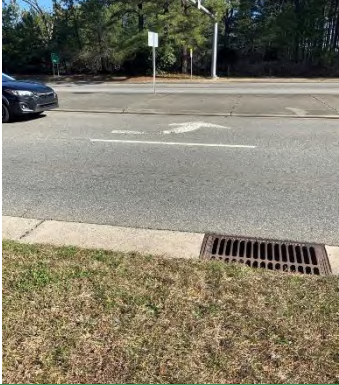
#	Material Type	Object ID	Failure Type	Photo	GIS Reference Page
1	Left Turn	PS_415	Nighttime Reflectivity

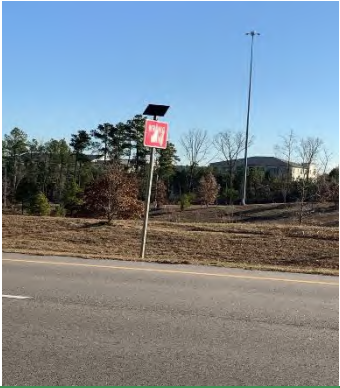
#	Sign Type	Object ID	Failure Type	Photo	GIS Reference Page
1	Wrong Way	SN_470	Surface Damage

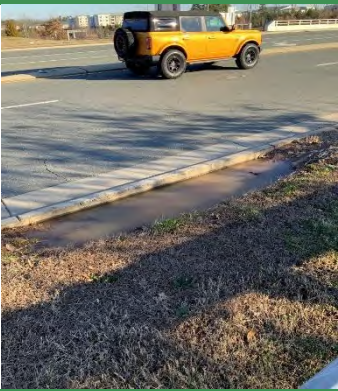
5	Turf	TF_878	Bare Ground
