# Maintenance Rating Program

## Triangle Expressway

2024 Second Quarter Report

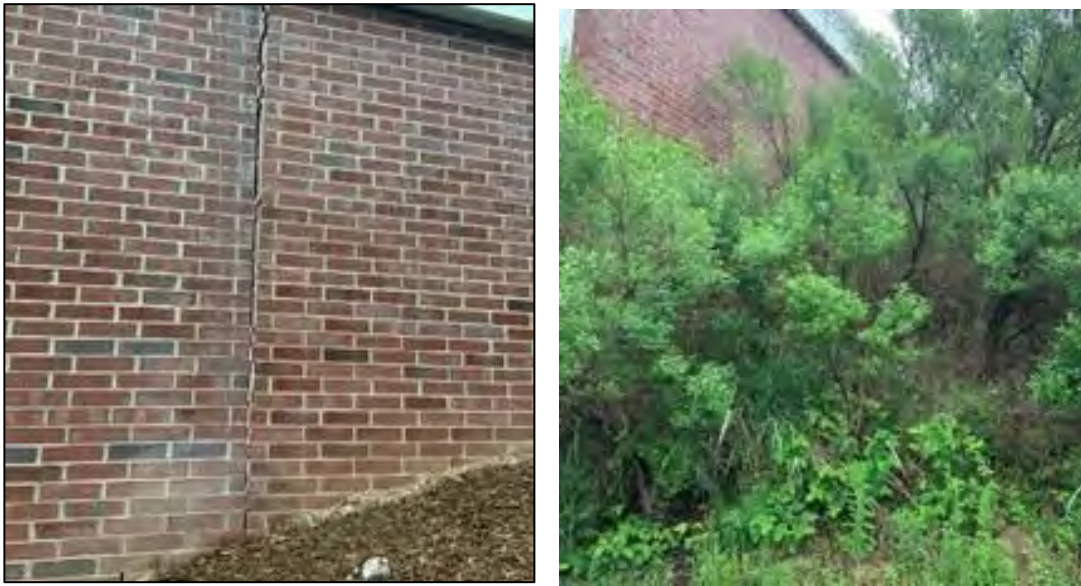
**Figure 3: Retaining Walls and Sound Barrier Walls Inspection Results Sample**

Retaining Walls and Sound Barrier Walls (78 rating – 14 of the 18 assets passed): Each of the four of the wall sections that did not pass inspection either had unsealed cracks/joints or overgrown vegetation. Two of the sections that did not pass inspection are presented in **Figure 3**.

To maintain/improve the condition ratings, it is recommended that walls and approach clearings be included with brush and overgrowth maintenance and completed as planned in the capital budget. Sealing any pre-existing cracks will help to alleviate future deterioration that may be exacerbated by the elements.

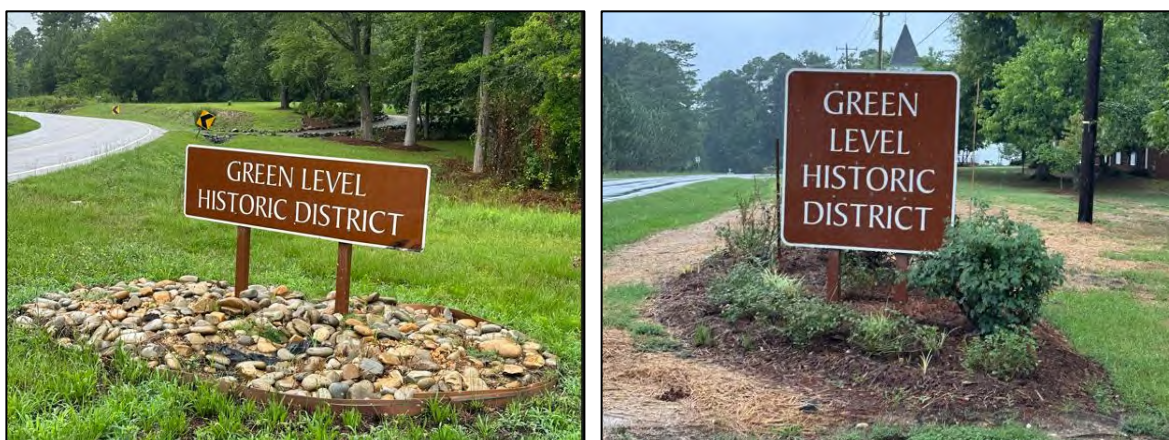
Figure 4: Green Level West Historic District Signs, Landscape Areas

As part of each quarterly inspection, an assessment team visits the two remaining Green Level Historic District signs to conduct a visual inspection of each sign and ensure they are in good standing. The two signs included in the inspection inventory were found to be in good condition. *Figure 4* shows the two signs assessed.

This quarter, the two Green Level Historic District signs inspected were found to be in good condition. Additionally, the landscaped areas surrounding the signs were found to be well maintained.

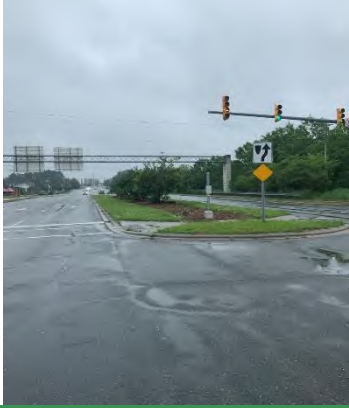
A30

#	Material Type	Object ID	Failure Type	Photo	GIS Reference Page
1	Plant Bed	PB_45	Health

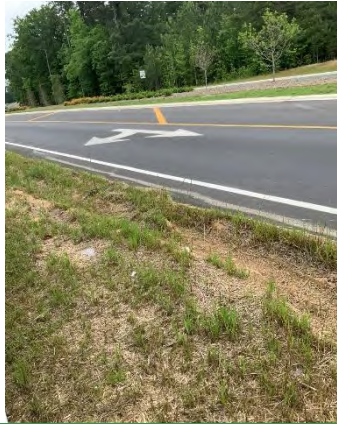
A26

#	Material Type	Object ID	Failure Type	Photo	GIS Reference Page
1	Asphalt	LS_14	Asphalt - Rutted

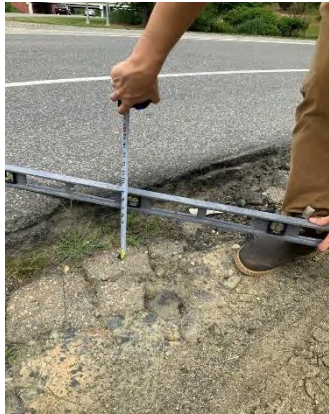
A17

#	Material Type	Object ID	Failure Type	Photo	GIS Reference Page
1	Asphalt	LS_187	Drop off

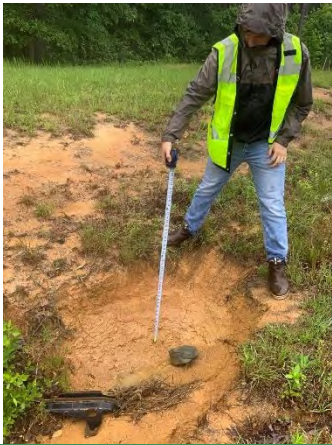
A25

#	Material Type	Object ID	Failure Type	Photo	GIS Reference Page
1	Concrete	LS_456	Ditch Erosion

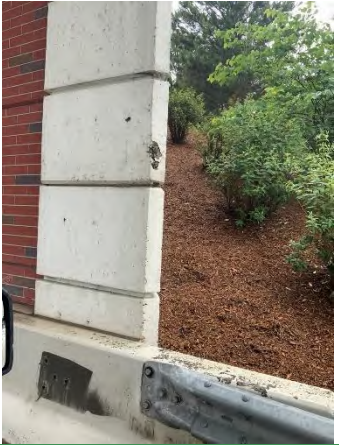
A11

A31
3	Bridge Wall	WL_21	Spalling
