Maintenance Rating Program

Triangle Expressway

November 2024

2024 Third Quarter Report

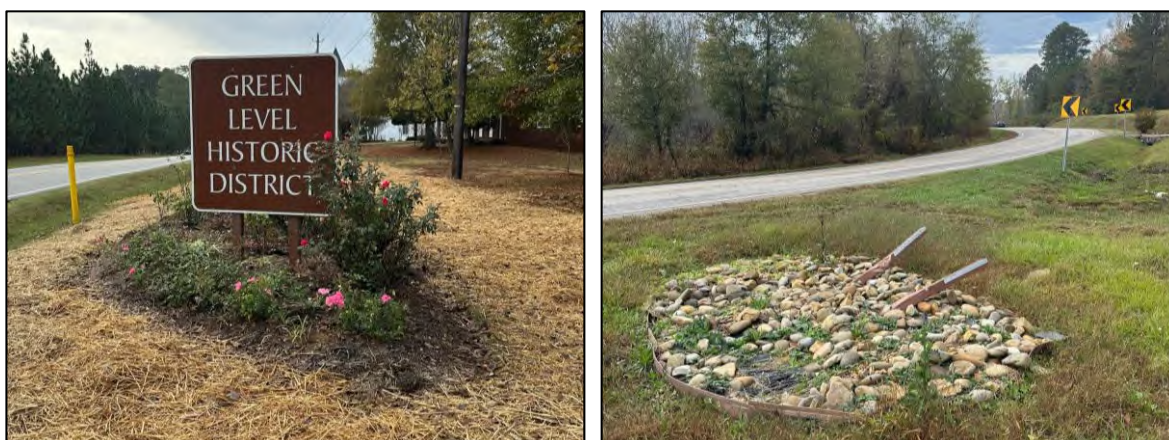
Figure 4: Green Level West Historic District Signs, Landscape Areas

As part of each quarterly inspection, an assessment team visits the two remaining Green Level Historic District signs to conduct a visual inspection of each sign and ensure they are in good standing. One of the two signs included in the inspection inventory was found to be in good condition, while the other has been stuck, damaged and in need of repair. **Figure 4** shows the two signs assessed.

This quarter, one of the two Green Level Historic District signs inspected was found to be in good condition, and the other will need to be repaired. The landscaped areas surrounding the signs were found to be well maintained.

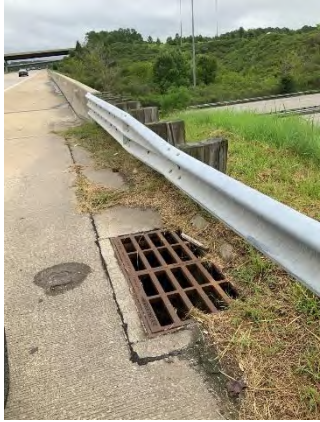
A3

#	Material Type	Object ID	Failure Type	Photo	GIS Reference Page
1	Curb	CG_348	Settlement

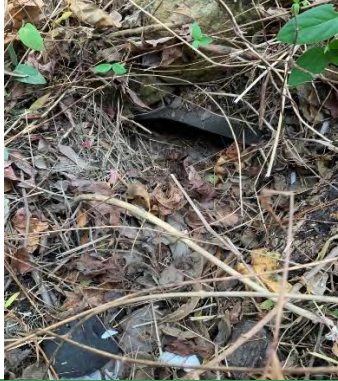
A4

#	Material Type	Object ID	Failure Type	Photo	GIS Reference Page
1	Drain	DP_440	Obstruction

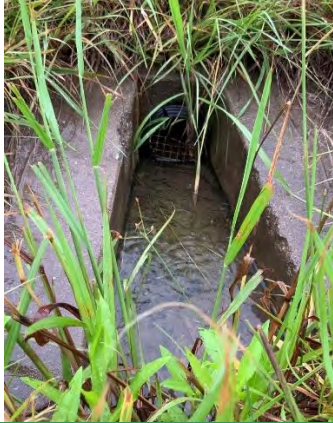
#	Material Type	Object ID	Failure Type	Photo	GIS Reference Page
1	Shoulder Drain	MDP_113	Rodent Screen

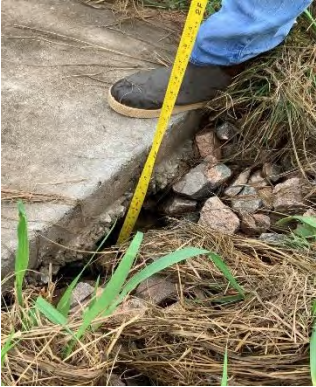
#	Material Type	Object ID	Failure Type	Photo	GIS Reference Page
1	Drop Inlet	IN_459	Eroded Area

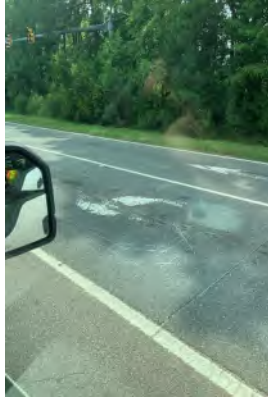
#	Material Type	Object ID	Failure Type	Photo	GIS Reference Page
1	Left Turn	PS_423	Daytime Assessment / Nighttime Reflectivity
