NORTH CAROLINA
Turnpike Authority

Maintenance Rating Program

Triangle Expressway

2019 Second Quarter Report

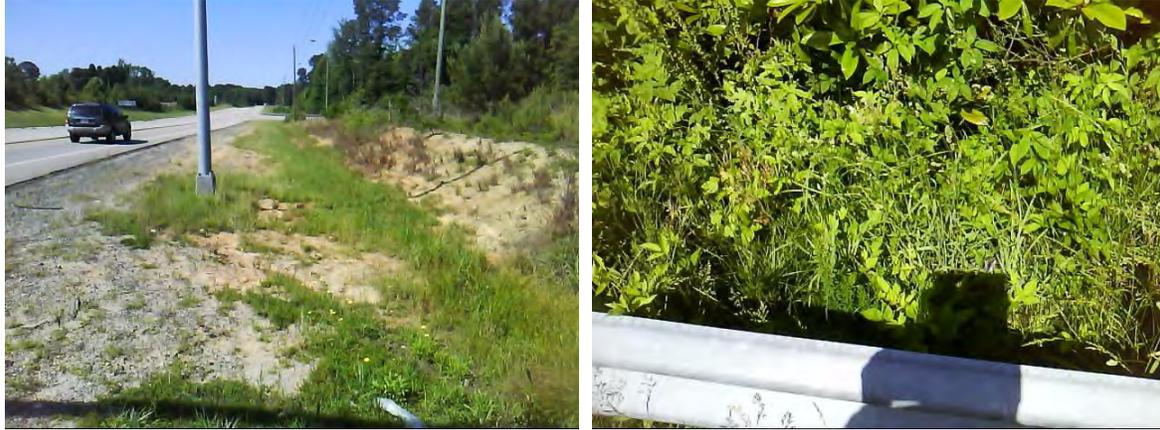
Figure 3: Turf Inspection Results Sample

Turf Condition (73 rating – 24 of the 33 assets passed): Of the 9 turf areas that did not pass the inspection, 8 were due to bare ground conditions and 1 was due to the presence of noxious weeds. Two of these turf areas are presented in **Figure 3**.

To continue to improve the Turf Condition rating, it is recommended that the maintenance provider continue with an aggressive schedule for seeding and fertilization cycles of bare ground areas during the spring and early summer. As part of their routine, the maintenance provider should closely monitor mowing heights during the 2019 mowing cycle pursuant to the NCTA Roadway and Facility Maintenance Standards V6, referenced below. It was observed during the second quarter inspection that turf areas unusually exceeded the previous mowing evaluation standard of 12 inches throughout the corridor. Since this observation, mowing duties have been assigned to another company to ensure the mowing cycle is properly maintained.

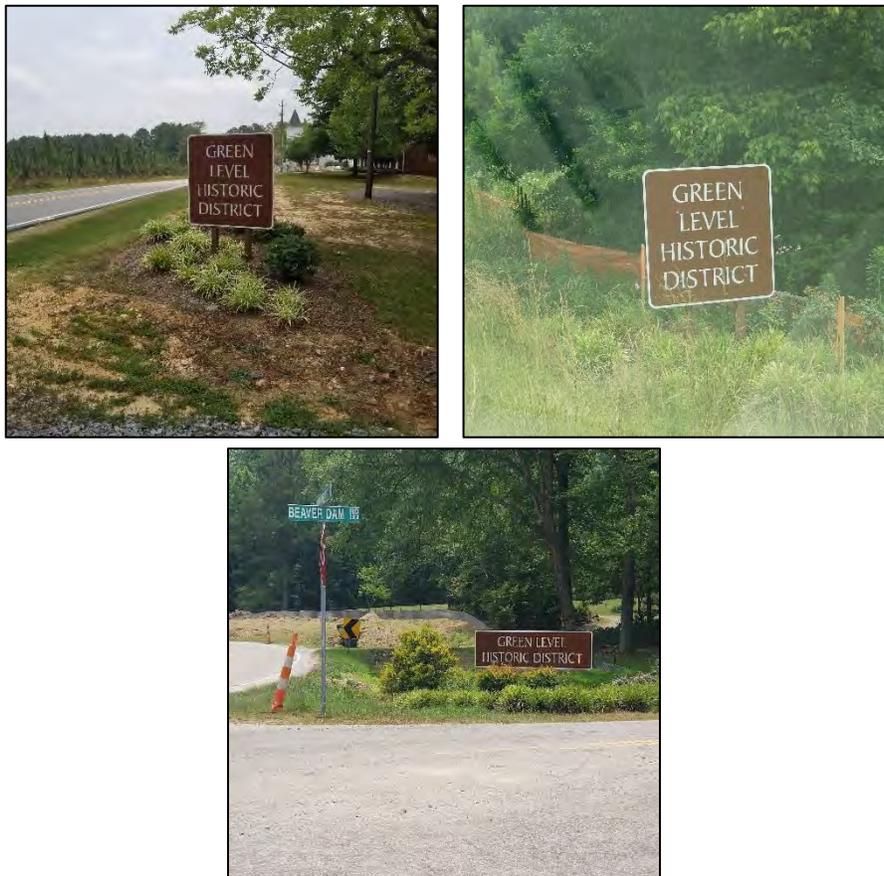
Figure 4: Green Level West Historic District Signs, Landscape Areas

As part of each quarterly inspection, an assessment team visits the three Green Level Historic District signs to conduct a visual inspection of each sign and ensure they are in good standing. The three signs included in the inspection inventory were found to be in good condition, with the landscaped areas being well maintained. Construction activities were identified adjacent to two of the three signs; however, the landscaped beds surrounding the signs were protected. **Figure 4** shows these signs.

This quarter, the three Green Level Historic District signs inspected were found to be in good condition. Additionally, the landscaped areas surrounding the signs were found to be well maintained.

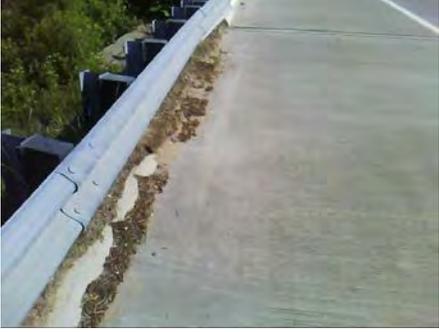
#	Material Type	Object ID	Failure Type	Photo	GIS Reference Page
1	Shoulder Berm	CG_78	Material Accumulation

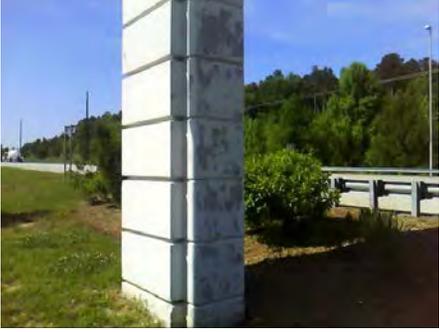
#	Material Type	Object ID	Failure Type	Photo	GIS Reference Page
1	Gantry Support	DS_45	Paint Scaling

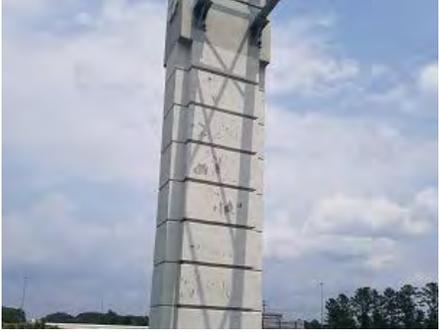
#	Material Type	Object ID	Failure Type	Photo	GIS Reference Page
5	Overhead Sign Support	DS_184	Paint Scaling

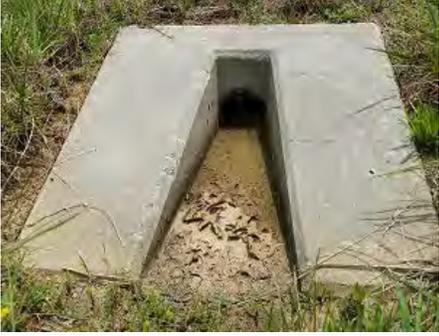
#	Material Type	Object ID	Failure Type	Photo	GIS Reference Page
1	Shoulder Drain	MDP_77	Missing Rodent Screen

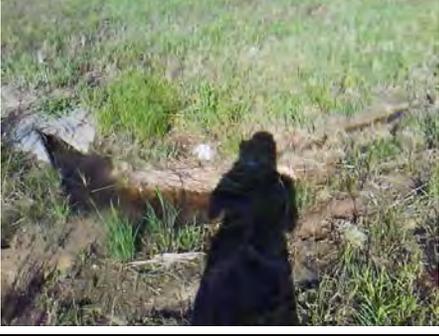
A15
2	Shoulder Drain	MDP_157	Obstruction

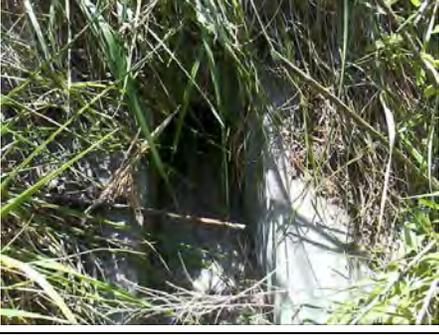
A29
3	Shoulder Drain	MDP_189	Missing Rodent Screen

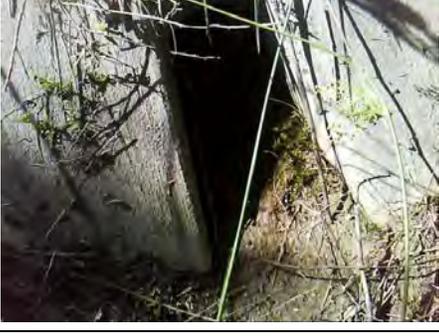
A27
4	Shoulder Drain	MDP_198	Obstruction/ Missing Rodent Screen

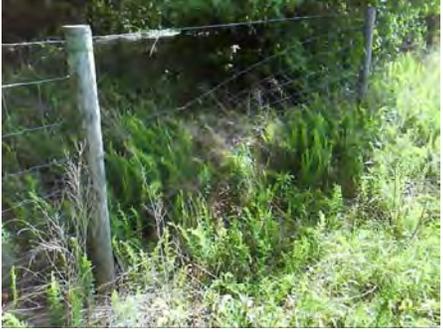
#	Material Type	Object ID	Failure Type	Photo	GIS Reference Page
1	Woven	FN_219	Fence Hole

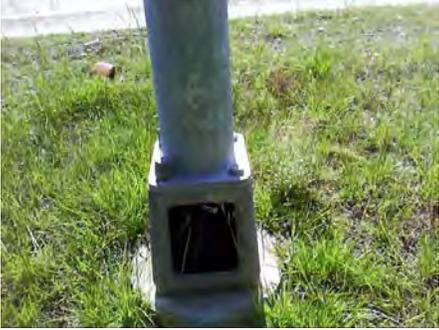
#	Material Type	Object ID	Failure Type	Photo	GIS Reference Page
1	Single Roadway	HL_51	Part Damage

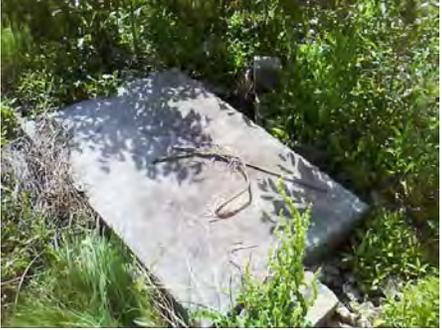
#	Material Type	Object ID	Failure Type	Photo	GIS Reference Page
1	OTCB	IN_481	Surface Damage

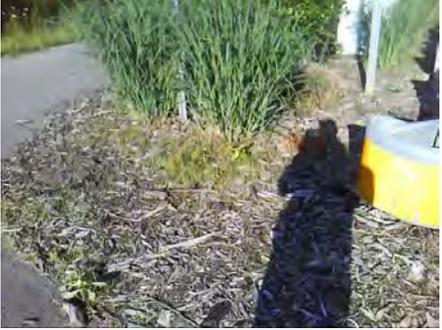
#	Material Type	Object ID	Failure Type	Photo	GIS Reference Page
1	Plant Bed	PB_258	Weeds

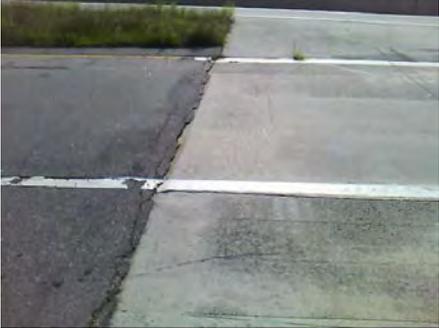
#	Material Type	Object ID	Failure Type	Photo	GIS Reference Page
1	Asphalt	LS_200	Rutted Areas

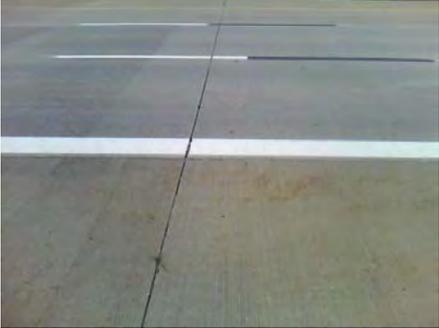
#	Material Type	Object ID	Failure Type	Photo	GIS Reference Page
1	Concrete	LS_34	Joint Malfunction

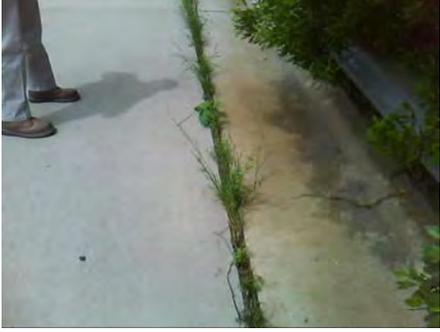
#	Material Type	Object ID	Failure Type	Photo	GIS Reference Page
1	Concrete	LS_86	Paved Shoulder Joint Separation

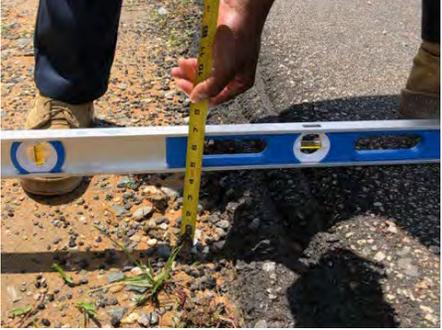
#	Material Type	Object ID	Failure Type	Photo	GIS Reference Page
1	Asphalt	LS_548	Shoulder Drop-Off

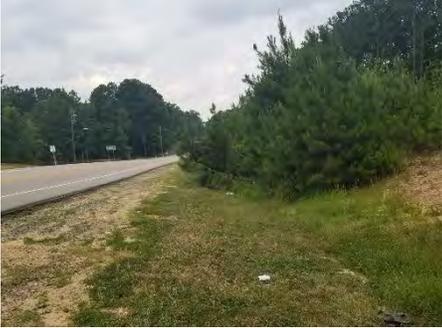
#	Material Type	Object ID	Failure Type	Photo	GIS Reference Page
1	Asphalt	LS_548	Blocked Ditch

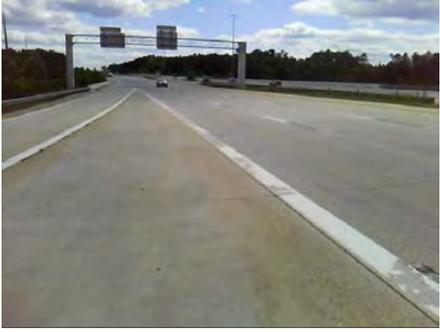
#	Material Type	Object ID	Failure Type	Photo	GIS Reference Page
1	Concrete	LS_37	Line Width, Line Missing

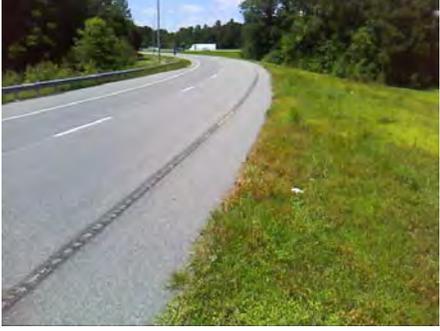
A7, A8
2	Asphalt	LS_209	Line Width, Line Missing, Nighttime Reflectivity

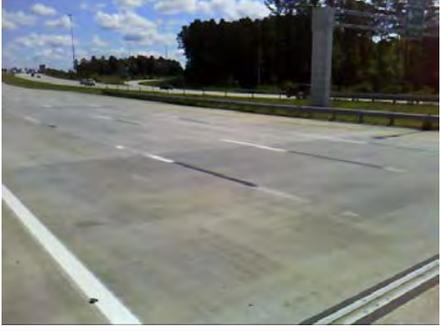
A33
3	Concrete	LS_603	Line Width, Line Missing, Nighttime Reflectivity

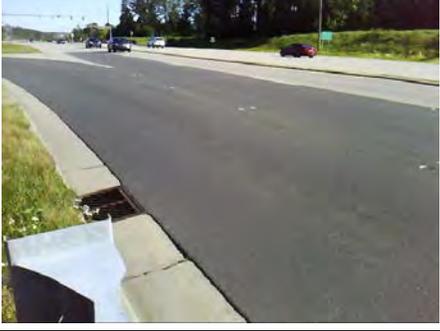
A8
4	Asphalt	LS_716	Line Missing, Nighttime Reflectivity

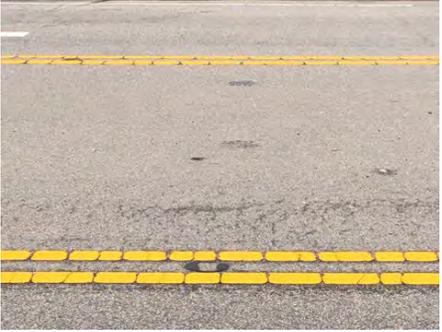
#	Material Type	Object ID	Failure Type	Photo	GIS Reference Page
1	Asphalt	LS_394	Nighttime Reflectivity	Not available for Nighttime failure.	A18
2	Asphalt	LS_548	Missing Markers

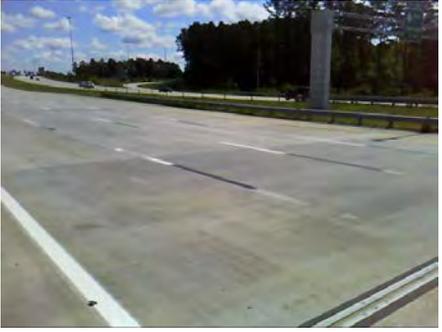
A17
3	Concrete	LS_603	Missing Markers

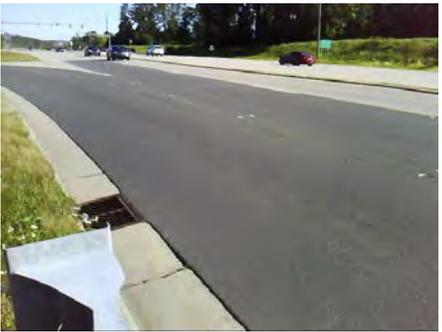
A8
4	Asphalt	LS_648	Nighttime Reflectivity	Not available for Nighttime failure.	A24
5	Asphalt	LS_716	Missing Markers

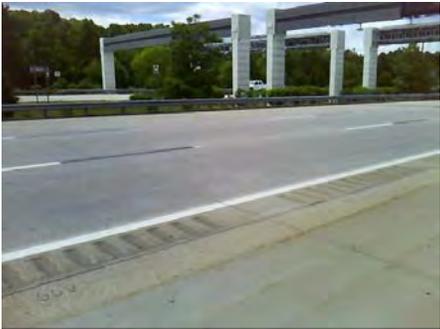
#	Material Type	Object ID	Failure Type	Photo	GIS Reference Page
1	Concrete	LS_88	Missing Delineators

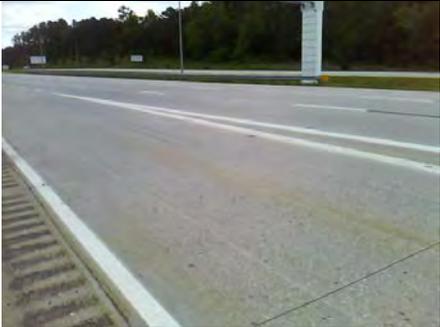
A11
2	Concrete	LS_155	Missing Delineators

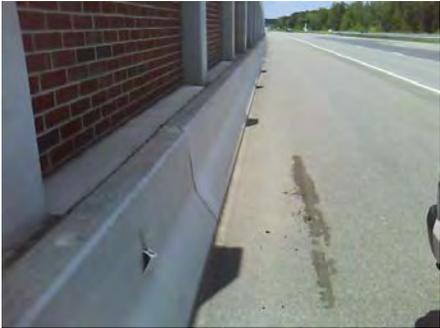
A12
3	Asphalt	LS_277	Missing Delineators

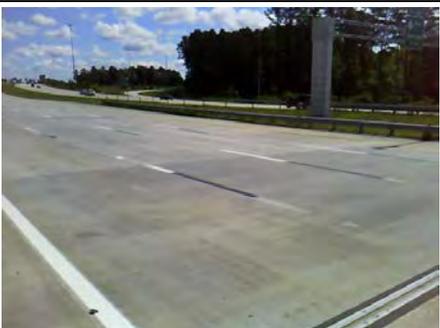
A35
4	Concrete	LS_603	Missing Delineators

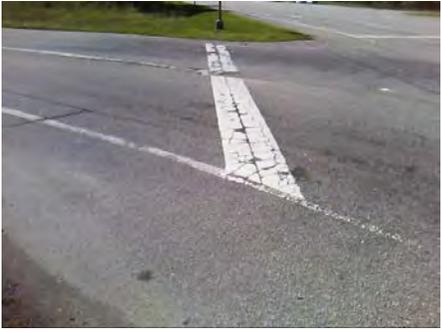
#	Material Type	Object ID	Failure Type	Photo	GIS Reference Page
1	Stop Bar	PS_5	Daytime Assessment

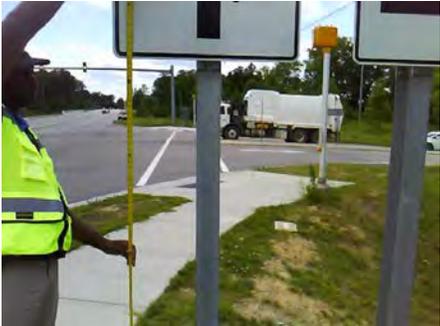
#	Sign Type	Object ID	Failure Type	Photo	GIS Reference Page
1	Toll Other	SN_170	Height Requirement

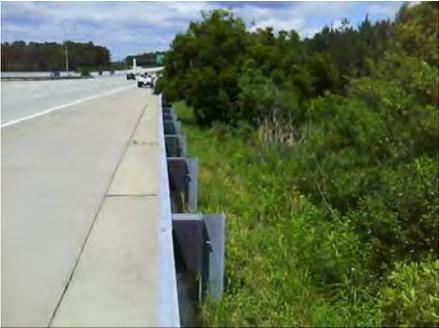
#	Material Type	Object ID	Failure Type	Photo	GIS Reference Page
1	Tree and Brush	TB_57	Clearance

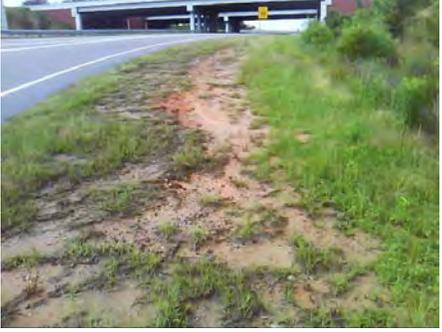
#	Material Type	Object ID	Failure Type	Photo	GIS Reference Page
1	Turf	TF_208	Bare Ground

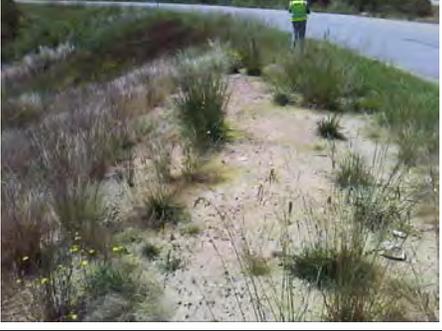
A28
4	Turf	TF_380	Bare Ground

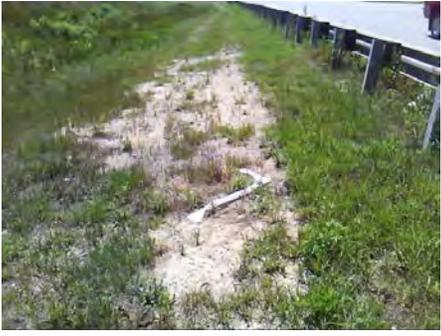
#	Material Type	Object ID	Failure Type	Photo	GIS Reference Page
5	Turf	TF_450	Bare Ground

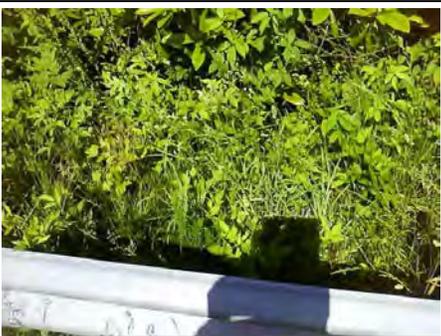
A32
8	Turf	TF_672	Noxious Weeds

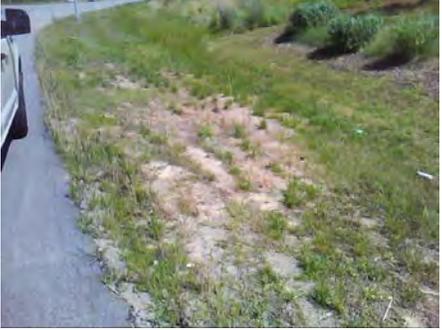
#	Material Type	Object ID	Failure Type	Photo	GIS Reference Page
9	Turf	TF_1012	Bare Ground

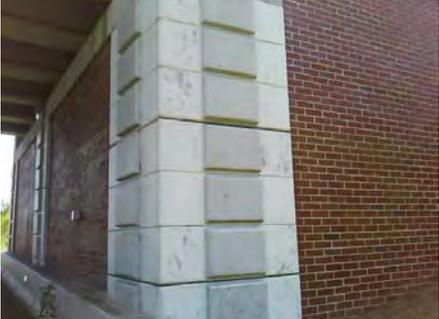
#	Material Type	Object ID	Failure Type	Photo	GIS Reference Page
1	Bridge Wall	WL_12	Paint Scaling
