NORTH CAROLINA
Turnpike Authority

Maintenance Rating Program

Triangle Expressway

2017 First Quarter Report

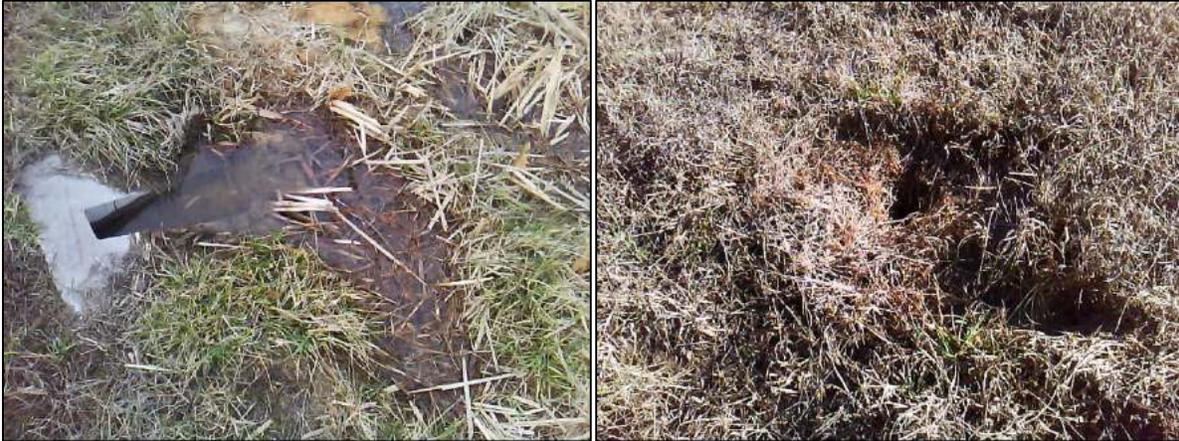
Figure 3: Miscellaneous Drainage Failures

Miscellaneous Drainage (55 rating – 15 of the 33 assets failed). All 15 miscellaneous drainage failures, occurred due to obstruction. Two of the failing miscellaneous drainage structures are presented in **Figure 3**.

Some of the obstruction failures are a result of inadequate gradient flow away from the edge drain outlets. In order to avoid affecting the natural flow of water near the drainage features, it is recommended that outlet elevations be checked against the outflow ditch elevations to ensure positive drainage. Appropriate grading of the ditch line may be necessary to provide positive flow.

In accordance with the *NCTA Roadway and Facility Maintenance Standards V4* referenced below, it is recommended that the maintenance provider plan annual cleaning of these drainage features to remove any debris or overgrown vegetation. Additionally, it is recommended that the maintenance provider schedule repairs of the erosion soil buildup problems that have been identified along the ditch line near and adjacent to the outlet.

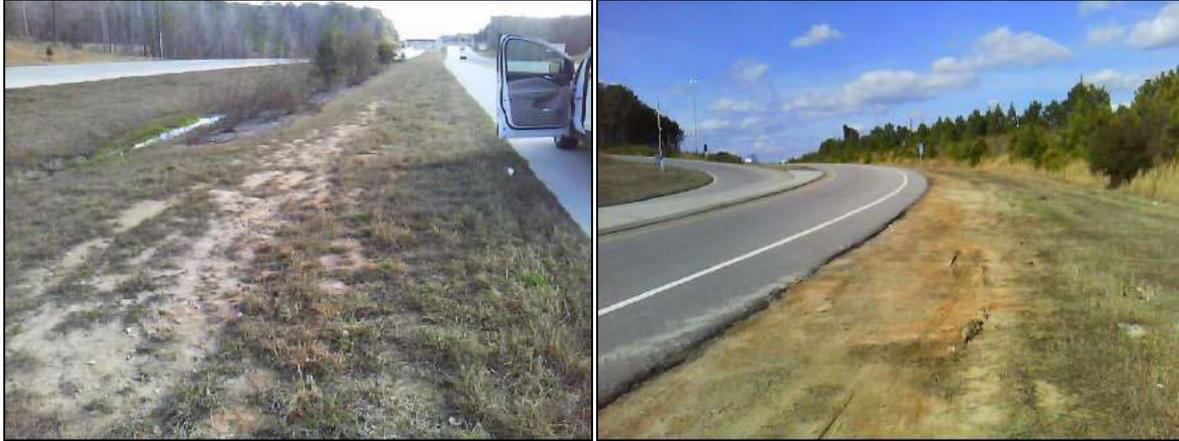
Figure 4: Turf Failures

Turf Condition (75 rating – 18 of the 71 assets failed). All 18 turf area failures were due to bare ground conditions. Two of the failing turf areas are presented in *Figure 4*.

Improvements in turf condition were not expected in the first quarter rating, since bare ground areas is the dominant failure category in turf condition and warm season grasses were dormant during the winter months. Continued seeding of bare ground areas with warm season grasses is recommended for this summer, as well as continued monitoring of mowing heights during the 2017 mowing cycle pursuant to the *NCTA Roadway and Facility Maintenance Standards V4*, referenced below.

- i. Apply pre- and post- emergent broadleaf weed control in accordance with the manufacturer's recommendations in April.
- ii. Bare ground areas shall be scheduled for seeding as necessary.
- c. Fall:
 - i. Apply post-emergence herbicides to select locations in accordance with the manufacturer's recommendations in August.
 - ii. Bare ground areas shall be seeded in the fall as needed.

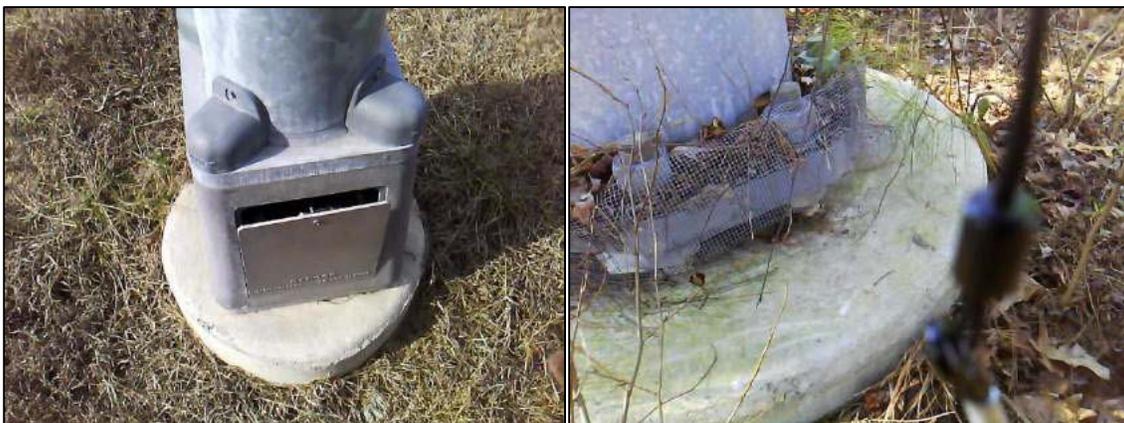
Figure 5: Highway Lighting Failures

Highway Lighting (73 rating – 11 of the 41 assets failed). Out of the 11 highway lights inspected, 8 failed because of functional damage, 2 failed for part damage, and one failed for missing parts. Two of the failing highway lights are presented in *Figure 5*.

After investigating circuit-wide failures, the maintenance provider has confirmed that water intrusion in junction boxes and splices is eroding conduit wiring earlier than expected for a normal life-cycle of 10 to 15 years. In order to reduce the number of future circuit-wide failures, it may be necessary to run new properly sealed conduit along with re-wiring the circuit portions that continue to exhibit frequent outages.

Another common problem encountered by the maintenance provider is photo-sensor cells that routinely malfunction and are being replaced as needed. It is recommend that a full system-wide replacement be scheduled as photo-cells have a short life span and would need replacing on a routine cycle. Proactive cyclical measures can minimize the need for reactive responses and minimize multiple call-outs of crews.

In order to avoid future damage, it is recommended that all non-functioning or damaged highway lights noted during the inspections be repaired and/or replaced in accordance with the *NCTA Roadway and Facility Maintenance Standards V4*, referenced below.

Also, it is recommended that the maintenance provider repair and/or replace all damaged highway lights and that a conduit and photo-sensor cells replacement plan is set in place to avoid future highway lighting failures. It is also recommended that all damaged fence segments be repair and/or replace as soon as possible. In addition, mowing heights should continue to be closely monitored during each mowing cycle, and bare areas fertilization efforts should be continued to promote new growth.

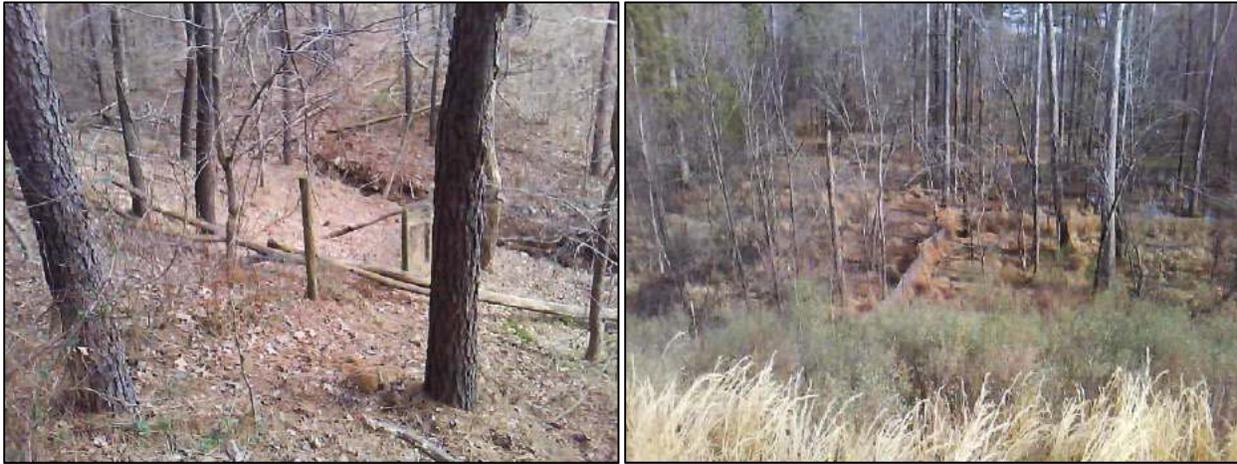
Figure 6: Fence Failures

Fence (79 rating – 6 of the 29 assets failed). Out of the 29 fence segments inspected, 5 failed because of height and 1 failed for having the gate opened. Two of the failing fence segments are presented in **Figure 6**.

In order to avoid future fence damages, all damaged fences noted by inspectors shall be repaired and/or replaced in accordance with the *NCTA Roadway and Facility Maintenance Standards V4*, referenced below.

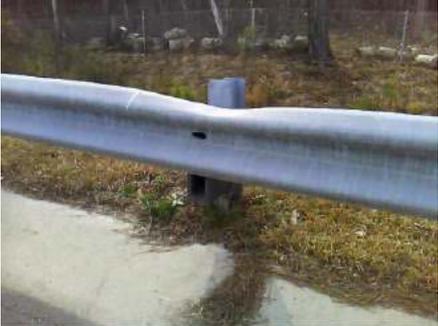
#	Material Type	Object ID	Failure Type	Photo	GIS Reference Page
1	Guardrail	BR_186	Missing Parts

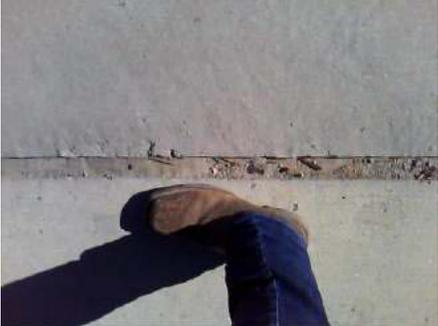
#	Material Type	Object ID	Failure Type	Photo	GIS Reference Page
1	Concrete	CG_42	Misalignment

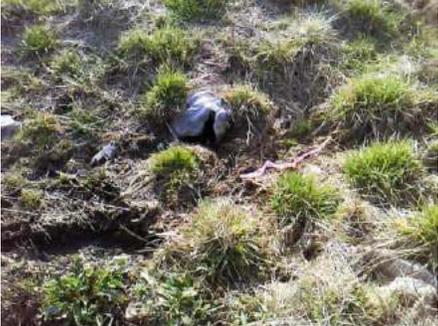
#	Material Type	Object ID	Failure Type	Photo	GIS Reference Page
1	Drain	DP_406	Obstruction, End Treatment Damage

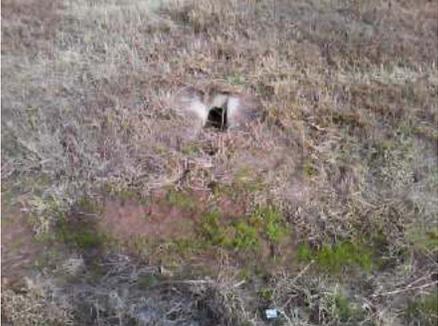
#	Material Type	Object ID	Failure Type	Photo	GIS Reference Page
1	Shoulder Drain	MDP_1	Obstruction

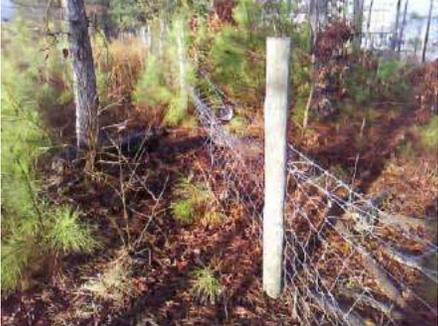
#	Material Type	Object ID	Failure Type	Photo	GIS Reference Page
1	Woven	FN_1	Fence Height, Hole Height

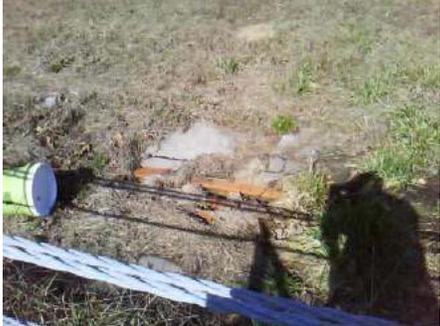
#	Material Type	Object ID	Failure Type	Photo	GIS Reference Page
1	Inlets	IN_879	Obstruction

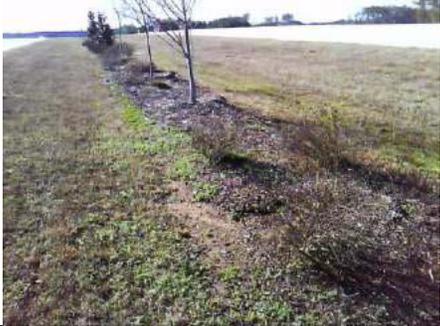
#	Material Type	Object ID	Failure Type	Photo	GIS Reference Page
1	Plant Bed	PB_88	Weeds

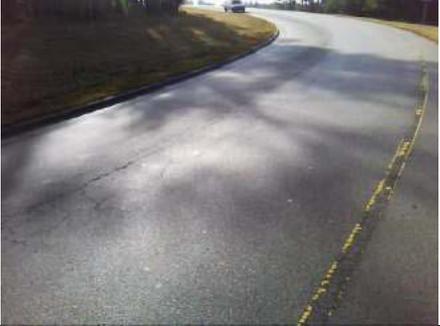
#	Material Type	Object ID	Failure Type	Photo	GIS Reference Page
1	Asphalt	LS_3	Unsealed Crack

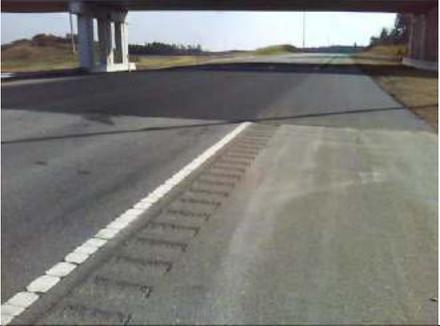
#	Material Type	Object ID	Failure Type	Photo	GIS Reference Page
1	Asphalt	LS_287	Rumble Strips

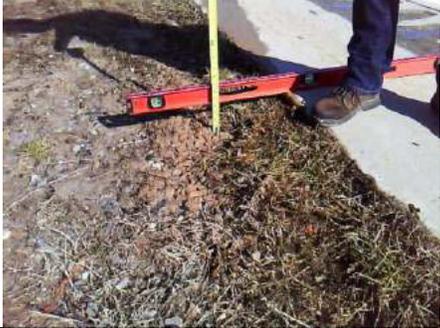
#	Material Type	Object ID	Failure Type	Photo	GIS Reference Page
1	Concrete	LS_20	Shoulder Drop Off

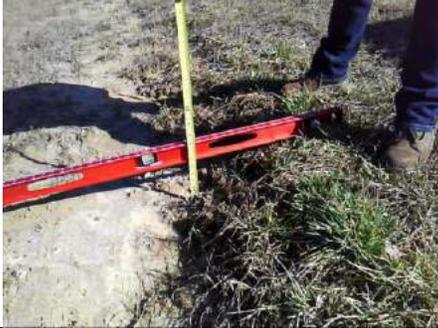
#	Material Type	Object ID	Failure Type	Photo	GIS Reference Page
1	Concrete	LS_143	Slope Failure

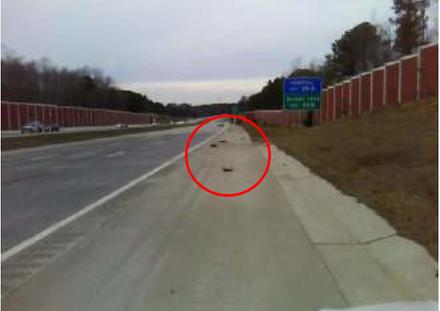
#	Material Type	Object ID	Failure Type	Photo	GIS Reference Page
1	Concrete	LS_421	Litter

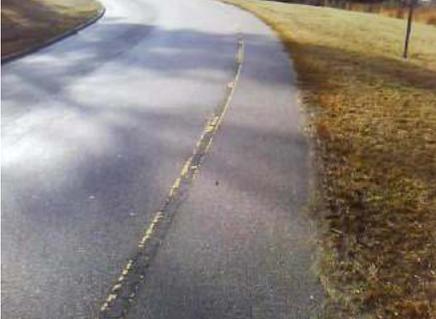
#	Material Type	Object ID	Failure Type	Photo	GIS Reference Page
1	Asphalt	LS_3	Nighttime Line Visibility, Line width, Missing Line

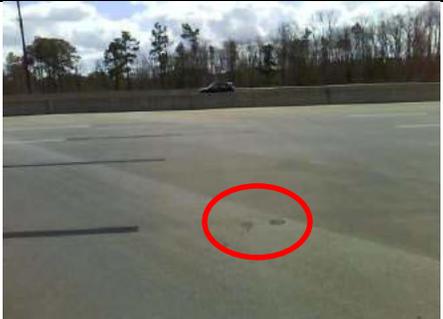
#	Material Type	Object ID	Failure Type	Photo	GIS Reference Page
1	Concrete	LS_330	Missing Markers

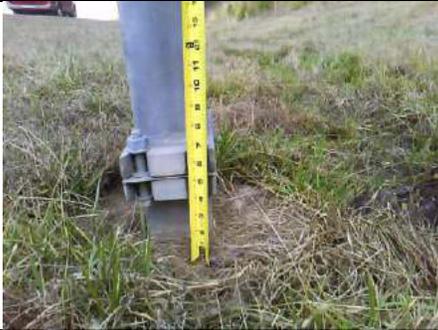
#	Sign Type	Object ID	Failure Type	Photo	GIS Reference Page
1	Toll Payments	SN_21	Sign Support

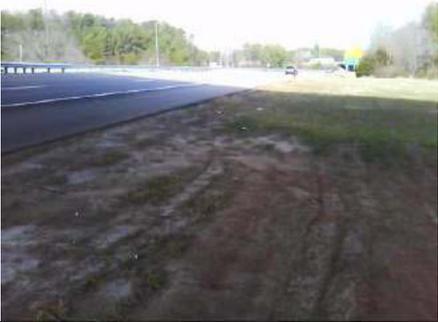
#	Material Type	Object ID	Failure Type	Photo	GIS Reference Page
1	Turf	TF_20	Bare Ground
