NORTH CAROLINA
Turnpike Authority

Maintenance Rating Program

Triangle Expressway

2017 Third Quarter Report

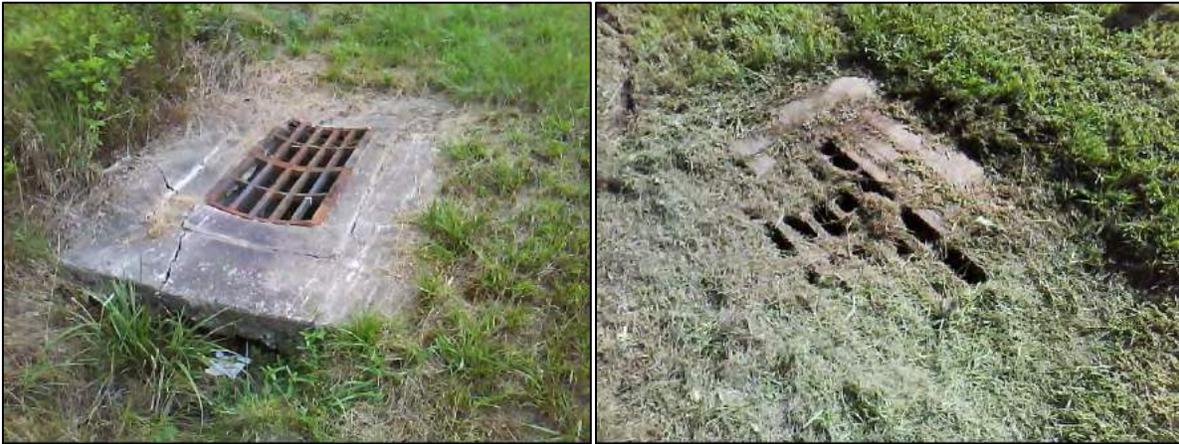
Figure 3: Inlet Failures

Inlets (74 rating – 9 of the 34 asset failed): Out of the 9 miscellaneous drainage failures, 6 occurred due to obstruction, 2 occurred due to erosion, and 1 occurred due to surface damage. Two of the failing inlet structures are presented in **Figure 3**.

To improve inlet performance throughout the facility, it is recommended that the maintenance provider inspect inlets pursuant to the *NCTA Roadway and Facility Maintenance Standards V4*, referenced below. During inspections, it is also recommended that the maintenance provider remove any debris accumulation upon observation.

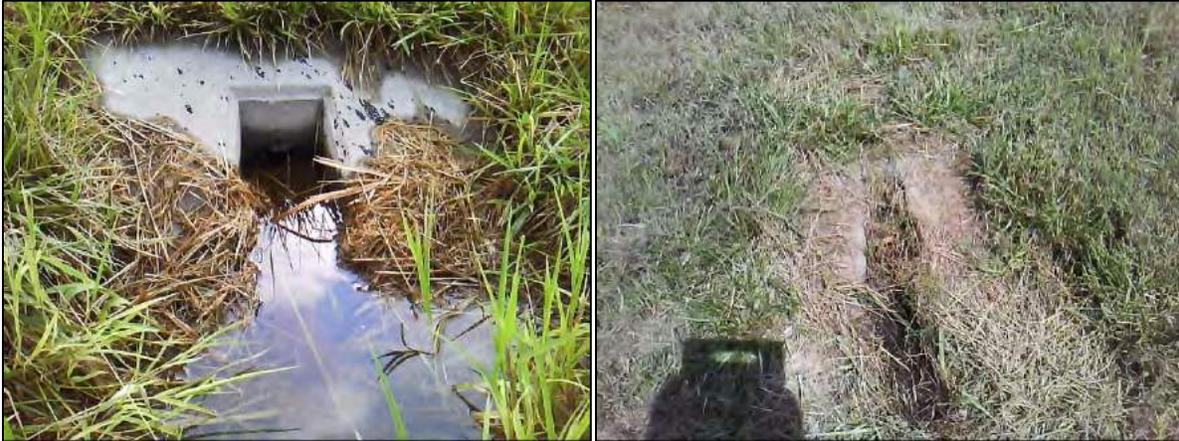
Figure 4: Miscellaneous Drainage Failures

Miscellaneous Drainage (71 rating – 10 of the 35 assets failed): Out of the 10 miscellaneous drainage failures, 7 occurred due to obstruction and 3 occurred due to erosion at the outlet to freeway edge drains. Two of the failing miscellaneous drainage structures (edge drains) are presented in **Figure 4**.

It should be noted that some of the obstruction failures are a result of inadequate gradient flow away from the edge drain outlets. To avoid affecting the natural flow of water near the drainage features and potential pavement failures, it is recommended that outlet elevations be checked against the outflow ditch elevations to ensure positive drainage. Appropriate grading of the ditch line may be necessary to provide positive flow.

In accordance with *NCTA Roadway and Facility Maintenance Standards V4*, referenced below, the maintenance provider shall plan annual cleaning of these drainage features to remove any debris or overgrown vegetation. It is also recommended that the maintenance provider continue to follow the routine patrol schedule and repair any erosion or soil buildup problems along the ditch line near the outlets. Edge drains are a critical component of extending the life cycle of pavements as they provide a means for water to drain away from the subgrade and base.

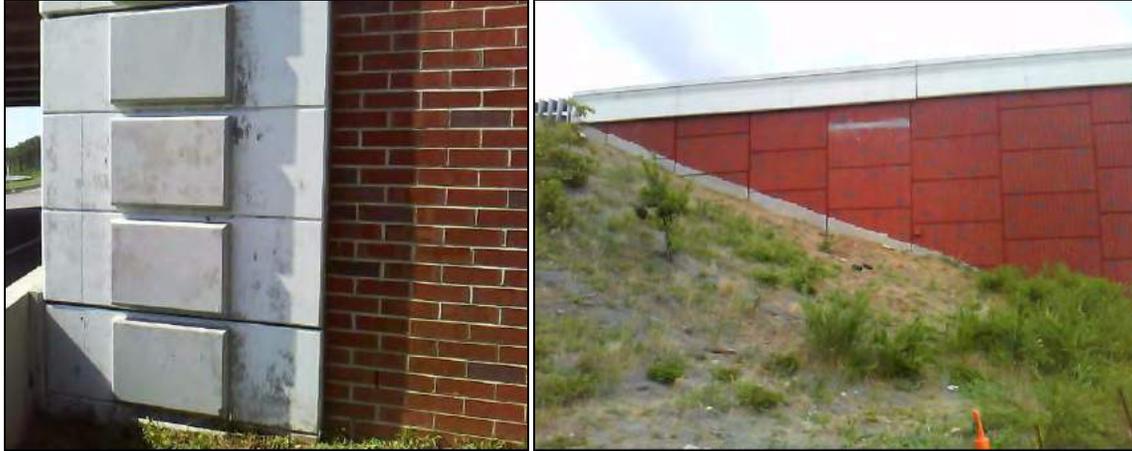
Figure 5: Retaining and Sound Barrier Walls Failures

Retaining Walls and Sound Barrier Walls (75 rating – 4 of the 16 assets failed): All 4 of the wall failures occurred due to paint scaling. Two of the failing wall segments are presented in **Figure 5**.

In accordance with *NCTA Roadway and Facility Maintenance Standards V4*, referenced below, it is recommended that the maintenance provider plan for and schedule paint repairs within the annual work program.

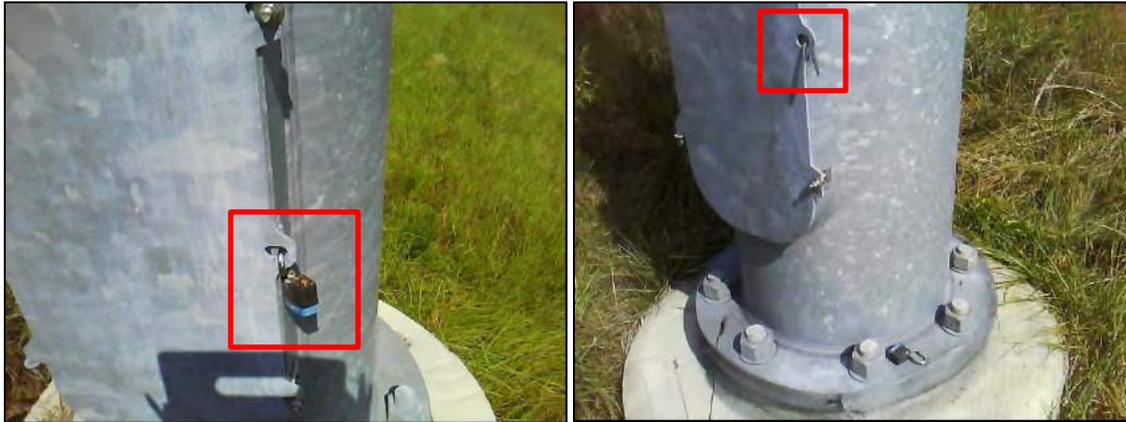
Figure 6: Highway Lighting Failures

Highway Lighting (60 rating – 17 of the 42 assets failed): Out of the 42 highway lights inspected, 8 failed due to functional damage, 5 failed due to damaged parts, and 4 failed due to missing parts. Two of the failing highway lights are presented in **Figure 6**.

To increase this asset’s rating, it is recommended that all non-functioning or damaged highway lights noted during the inspection be repaired and/or replaced in accordance with the *NCTA Roadway and Facility Maintenance Standards V4*, referenced below.

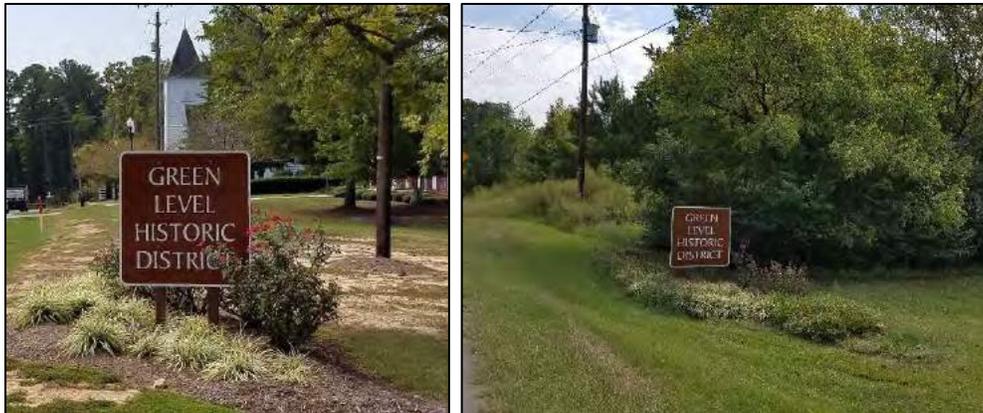
Figure 7: Green Level West Historic District Signs, Landscape Areas

As part of each quarterly inspection, assessors visit the four Green Level Historic District signs to conduct a visual inspection of each sign and ensure they are in good standing. During this quarter, the sign located at the intersection of Green Level Church Road and Green Level West Road was excluded from the inspection inventory due to its removal during the completion of a Town of Cary development project near the intersection. The three signs included in the inspection inventory were found to be in good condition, with the landscaped areas being well maintained. **Figure 7** shows two of these signs.

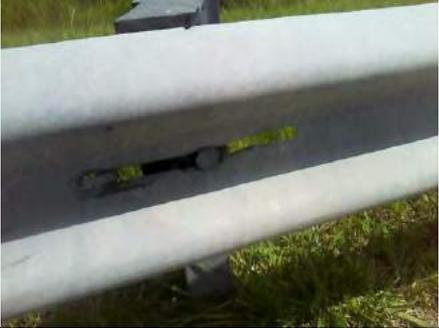
#	Material Type	Object ID	Failure Type	Photo	GIS Reference Page
1	Guardrail	BR_206	Functional Damage

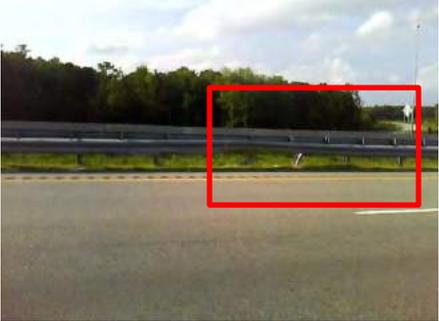
A6
2	Guardrail	BR_597	Functional Damage, Missing Parts

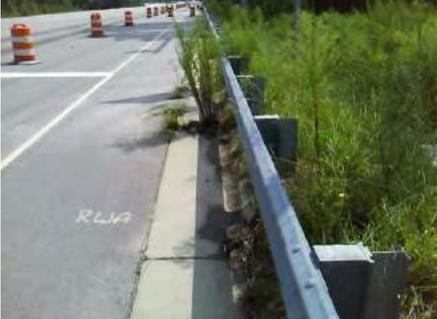
#	Material Type	Object ID	Failure Type	Photo	GIS Reference Page
1	Valley	CG_14	Obstruction

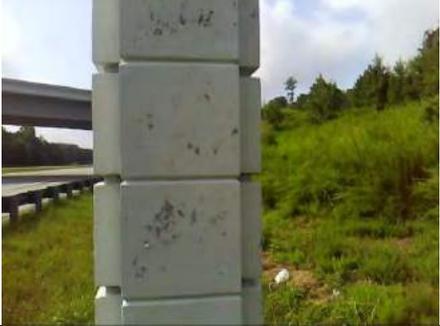
#	Material Type	Object ID	Failure Type	Photo	GIS Reference Page
1	Sign Support	DS_305	Paint Scaling

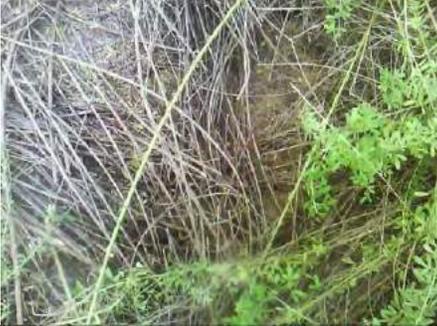
#	Material Type	Object ID	Failure Type	Photo	GIS Reference Page
1	Lateral Pipe	DP_1109	Obstruction

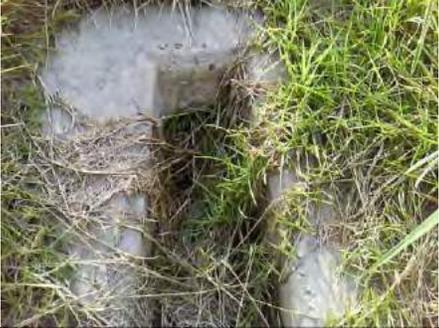
#	Material Type	Object ID	Failure Type	Photo	GIS Reference Page
1	Shoulder Drain	MDP_22	Obstruction

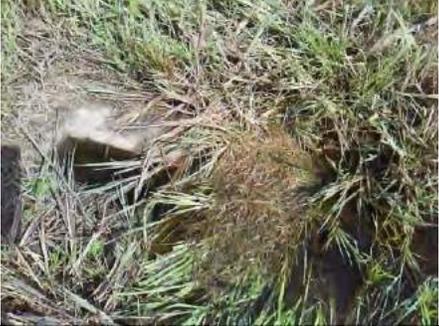
#	Material Type	Object ID	Failure Type	Photo	GIS Reference Page
5	Shoulder Drain	MDP_50	Obstruction

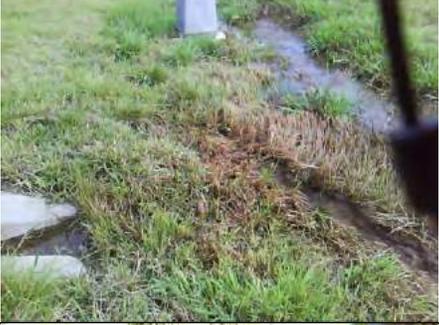
A18
6	Shoulder Drain	MDP_60	Erosion

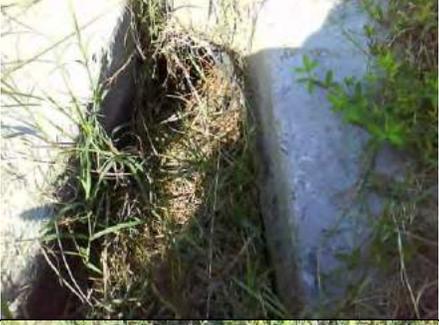
A20
7	Shoulder Drain	MDP_140	Obstruction, Grate Damage

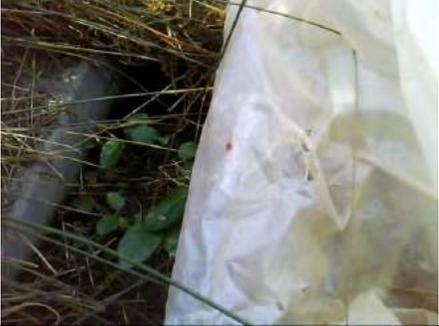
#	Material Type	Object ID	Failure Type	Photo	GIS Reference Page
9	Shoulder Drain	MDP_149	Obstruction

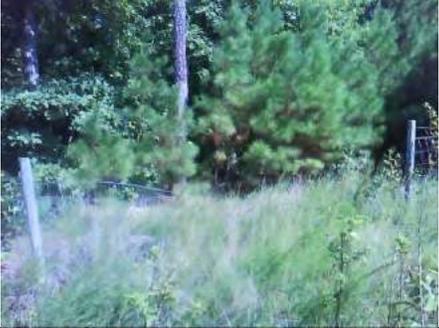
#	Material Type	Object ID	Failure Type	Photo	GIS Reference Page
1	Woven	FN_151	Fence Height

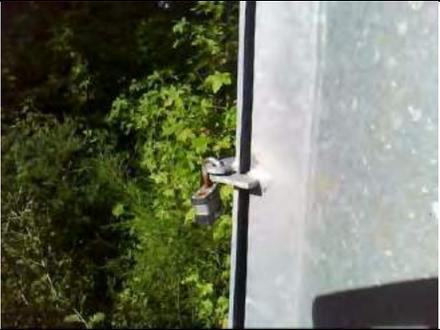
#	Material Type	Object ID	Failure Type	Photo	GIS Reference Page
1	Single Roadway	HL_16	Functional Damage	Not Available for Nighttime Failure.	A19
2	Single Roadway	HL_31	Functional Damage	Not Available for Nighttime Failure.	A21
3	Single Roadway	HL_36	Functional Damage	Not Available for Nighttime Failure.	A22
4	High Mast	HL_67	Damaged Lock

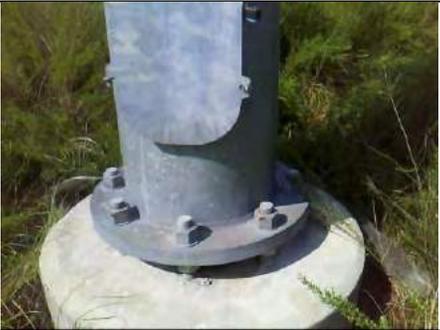
A12
5	Single Roadway	HL_124	Functional Damage	Not Available for Nighttime Failure.	A10
6	High Mast	HL_134	Missing Rodent Screen

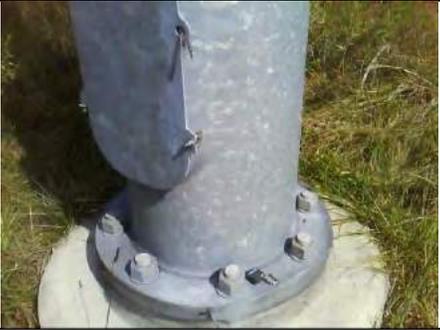
A7
7	High Mast	HL_135	Missing Lock

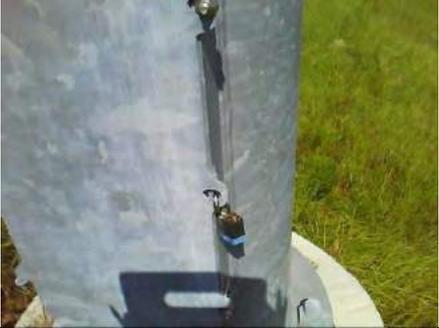
#	Material Type	Object ID	Failure Type	Photo	GIS Reference Page
9	High Mast	HL_155	Damaged Lock

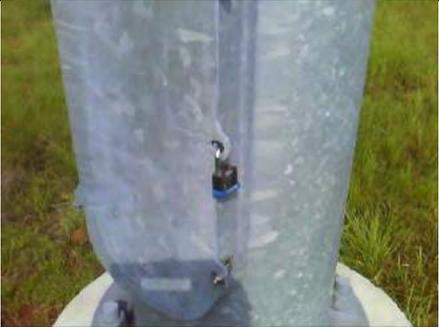
A6
10	High Mast	HL_156	Functional Damage, Damaged Lock

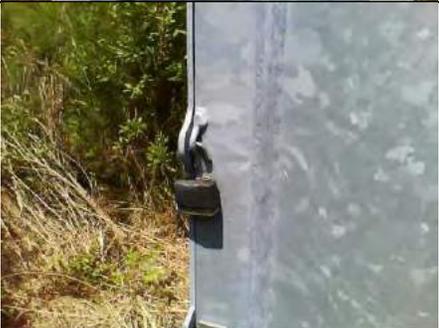
A7
11	High Mast	HL_174	Damaged Lock

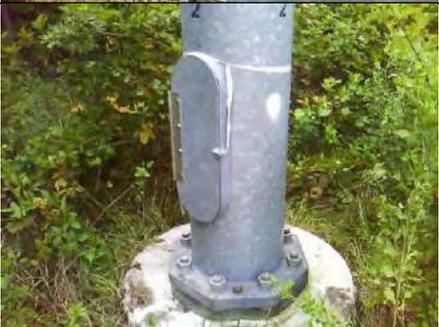
A51
12	High Mast	HL_282	Functional Damage, Missing Lock

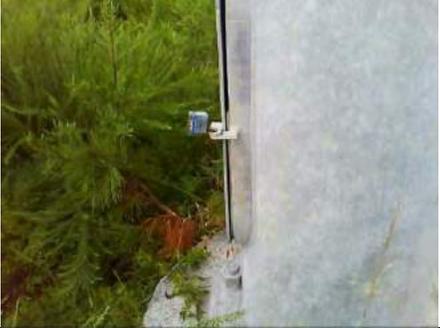
#	Material Type	Object ID	Failure Type	Photo	GIS Reference Page
13	High Mast	HL_291	Functional Damage, Damaged Lock

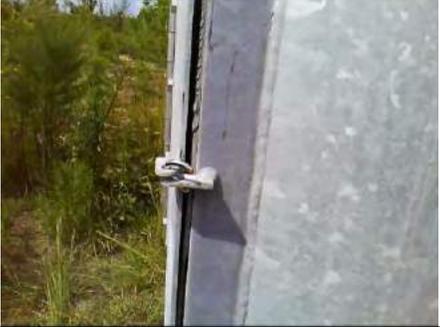
A35
14	Single Roadway	HL_294	Functional Damage	Not Available for Nighttime Failure.	A35
15	Double Roadway	HL_316	Functional Damage	Not Available for Nighttime Failure.	A40
16	High Mast	HL_320	Damaged Lock

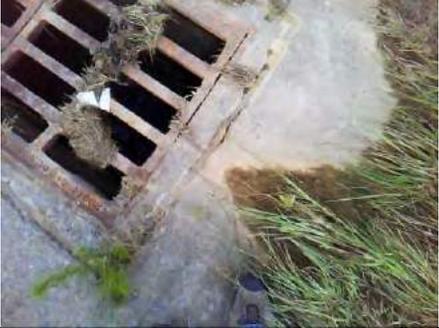
#	Material Type	Object ID	Failure Type	Photo	GIS Reference Page
1	Inlets	IN_22	Surface Damage

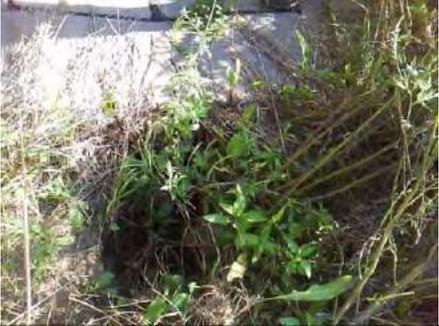
#	Material Type	Object ID	Failure Type	Photo	GIS Reference Page
5	Inlets	IN_474	Erosion, Surface Damage

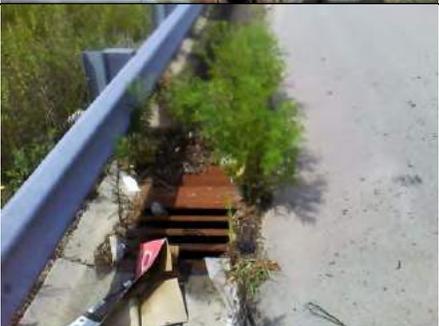
A43
7	Inlets	IN_683	Obstruction

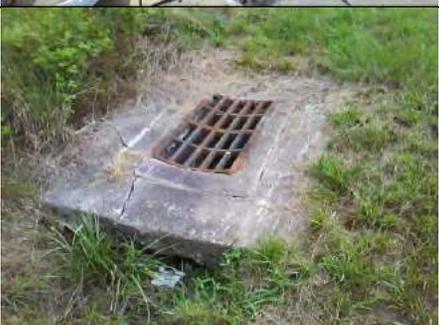
A28
8	Inlets	IN_853	Erosion, Surface Damage

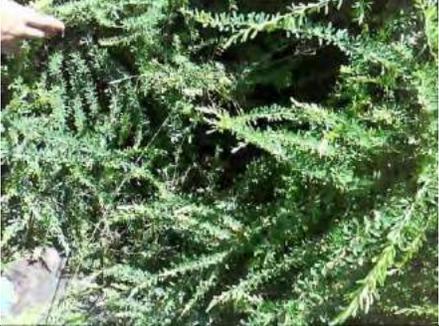
#	Material Type	Object ID	Failure Type	Photo	GIS Reference Page
9	Inlets	IN_935	Obstruction

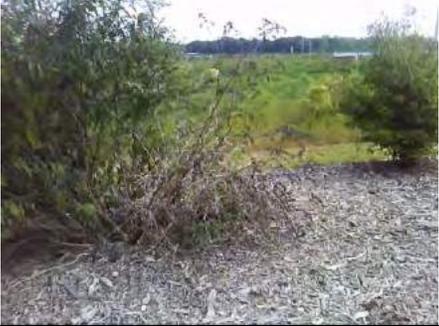
#	Material Type	Object ID	Failure Type	Photo	GIS Reference Page
1	Plant Bed	PB_30	Health

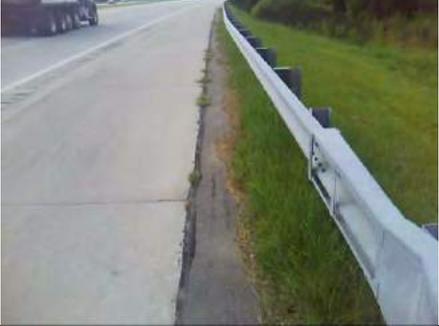
#	Material Type	Object ID	Failure Type	Photo	GIS Reference Page
1	Concrete	LS_112	Paved Shoulder Joint

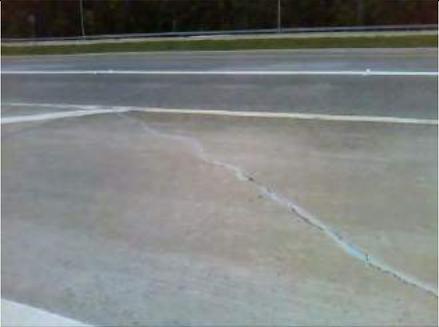
A15
2	Concrete	LS_492	Paved Shoulder Crack

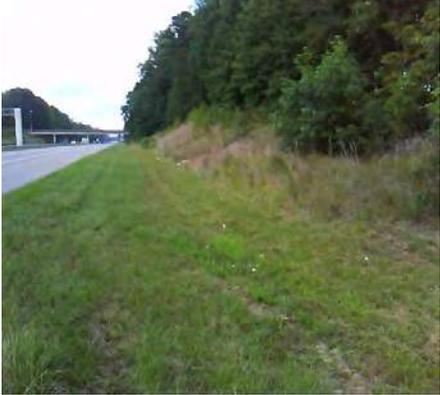
#	Material Type	Object ID	Failure Type	Photo	GIS Reference Page
1	Asphalt	LS_547	Litter

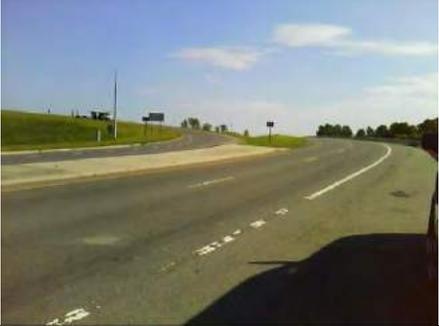
#	Material Type	Object ID	Failure Type	Photo	GIS Reference Page
1	Asphalt	LS_302	Nighttime Visibility, Line Width

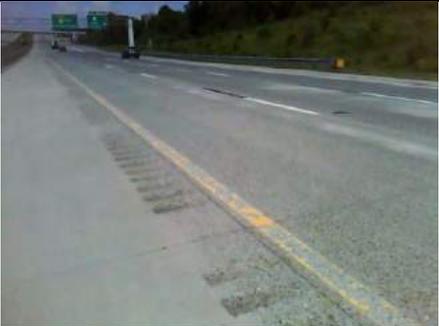
A3
2	Concrete	LS_316	Nighttime Visibility	Not Available for Nighttime Failure.	A5
3	Concrete	LS_406	Nighttime Visibility, Line Missing

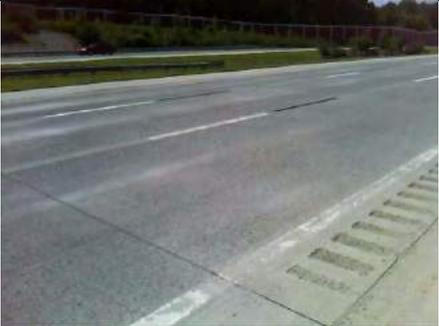
A30
4	Concrete	LS_423	Line Missing

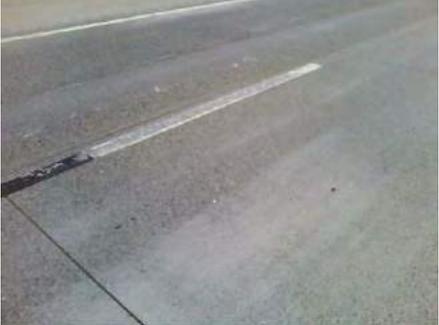
A33
5	Concrete	LS_480	Nighttime Visibility, Line Missing

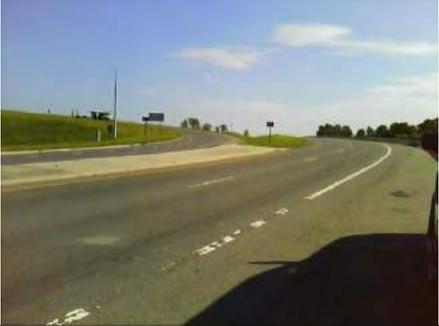
#	Material Type	Object ID	Failure Type	Photo	GIS Reference Page
1	Asphalt	LS_302	Nighttime Reflectivity, Missing Markers, Markers Count

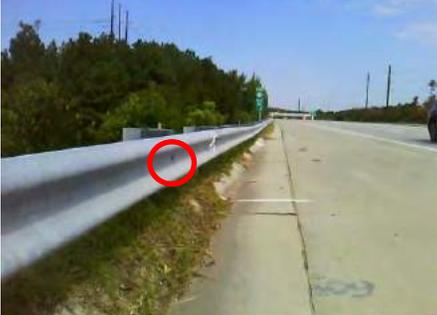
#	Material Type	Object ID	Failure Type	Photo	GIS Reference Page
1	Concrete	LS_112	Missing Markers

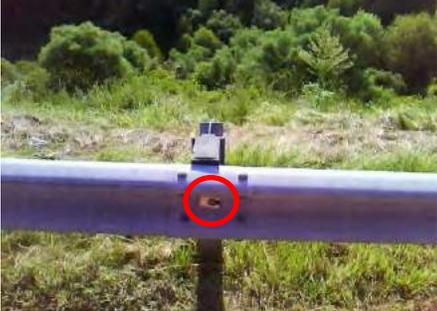
A15
2	Asphalt	LS_302	Missing Markers

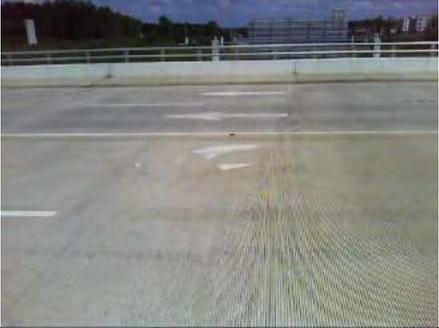
#	Material Type	Object ID	Failure Type	Photo	GIS Reference Page
1	Left Turn	PS_449	Nighttime Reflectivity, Day Time Assessment

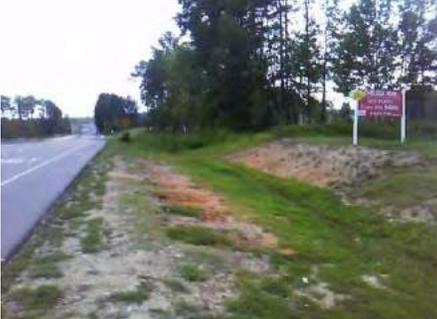
#	Material Type	Object ID	Failure Type	Photo	GIS Reference Page
1	Turf	TF_108	Bare Ground

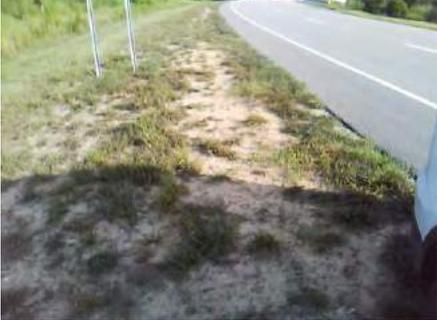
A39
4	Turf	TF_237	Bare Ground

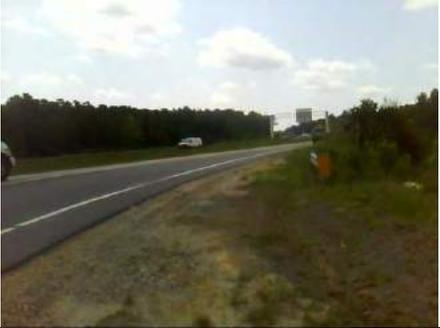
#	Material Type	Object ID	Failure Type	Photo	GIS Reference Page
5	Turf	TF_294	Bare Ground

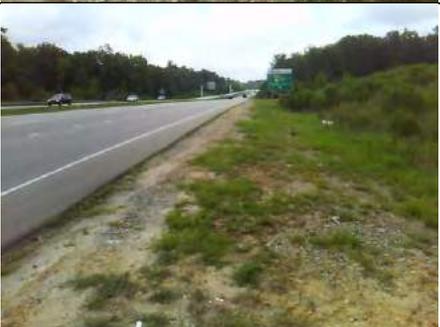
A44, A45
8	Turf	TF_464	Bare Ground

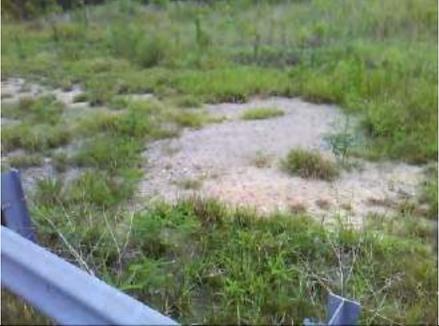
#	Material Type	Object ID	Failure Type	Photo	GIS Reference Page
9	Turf	TF_471	Bare Ground

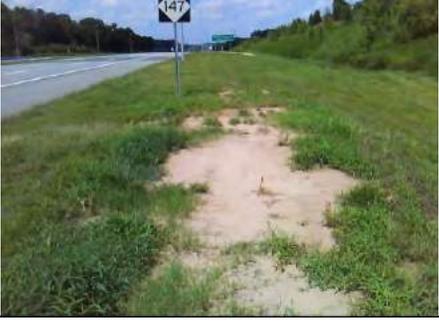
A6
12	Turf	TF_870	Bare Ground

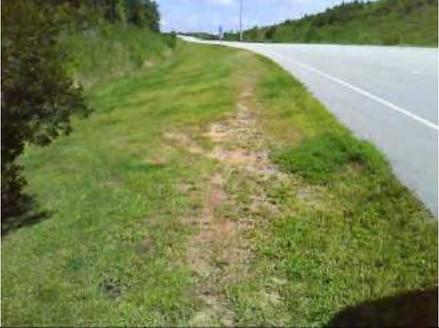
#	Material Type	Object ID	Failure Type	Photo	GIS Reference Page
13	Turf	TF_894	Bare Ground

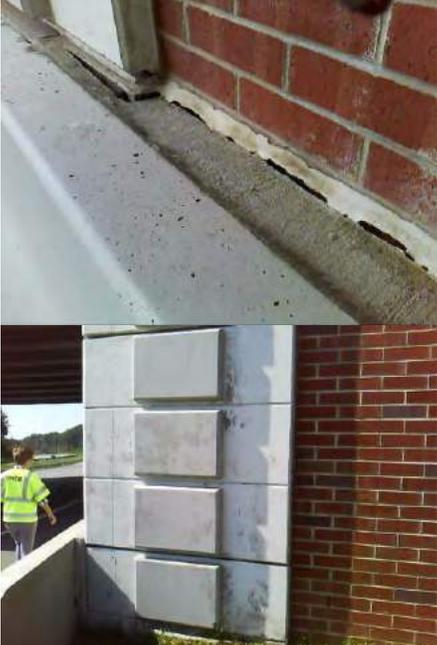
#	Material Type	Object ID	Failure Type	Photo	GIS Reference Page
1	MSE Wall	WL_5	Unsealed Joint, Paint Scaling

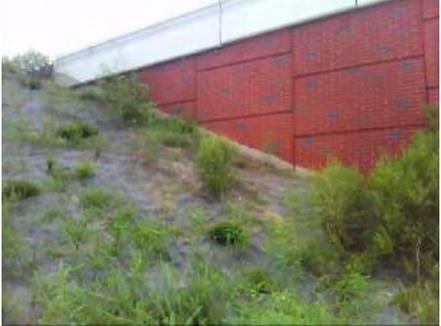
#	Material Type	Object ID	Failure Type	Photo	GIS Reference Page
4	MSE Wall	WL_73	Paint Scaling
