NORTH CAROLINA
Turnpike Authority

Maintenance Rating Program

Triangle Expressway

2018 Second Quarter Report

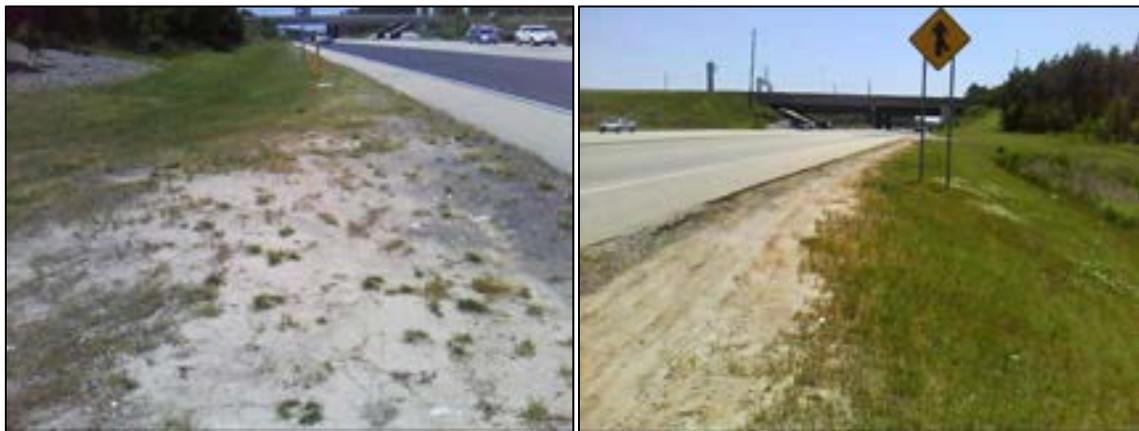
Figure 3: Turf Areas

Turf Condition (69 rating – 19 of the 62 assets failed). All 19 turf areas that did not pass the inspection had bare ground conditions. Two of these turf areas are presented in **Figure 3**.

To improve the Turf Condition rating, it is recommended that the maintenance provider follow an aggressive schedule for seeding and fertilization cycles of bare ground areas throughout the rest of the summer season. Some areas will require scarifying of the soil as these areas are heavily compacted and inundated with aggregate. Additionally, as part of the 2018 mowing cycle the maintenance provider should continue to closely monitor mowing heights and follow the maintenance program pursuant to the NCTA Roadway and Facility Maintenance Standards V4 for turf maintenance, copied below.

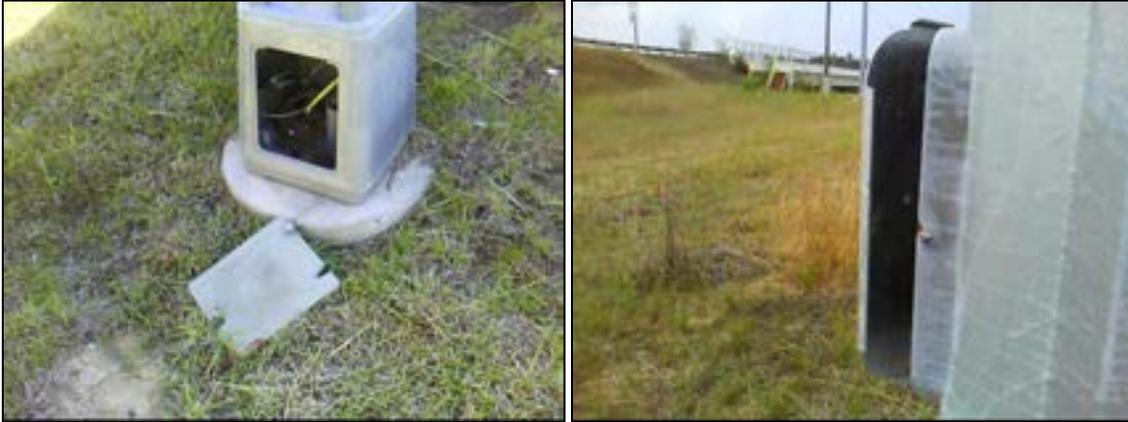
Figure 4: Highway Lighting

Highway Lighting (78 rating – 11 of the 50 assets failed). Out of the 11 highway lights that did not pass inspection, 7 had functional damage, 3 had damaged parts, and 1 had missing parts. Two of these highway lights are presented in **Figure 4**.

All highway lighting fixtures on Triangle Expressway have been scheduled to be replaced with LED fixtures starting in June 2018. This work is part of the new NCDOT lighting maintenance contract that would transfer the responsibility of lighting functionality maintenance to a private maintenance provider for the next 15 years. Therefore, starting in July 2018 lighting functionality will no longer be part of the NCTA MRP; highway lights will only be assessed for missing or damaged parts.

To increase future highway lighting ratings, it is recommended that all damaged highway lights noted during the inspection be repaired and/or replaced in accordance with the *NCTA Roadway and Facility Maintenance Standards V4*, referenced below. Additional care should be taken to ensure all access panels are properly secured to prevent rodent and other animal intrusion.

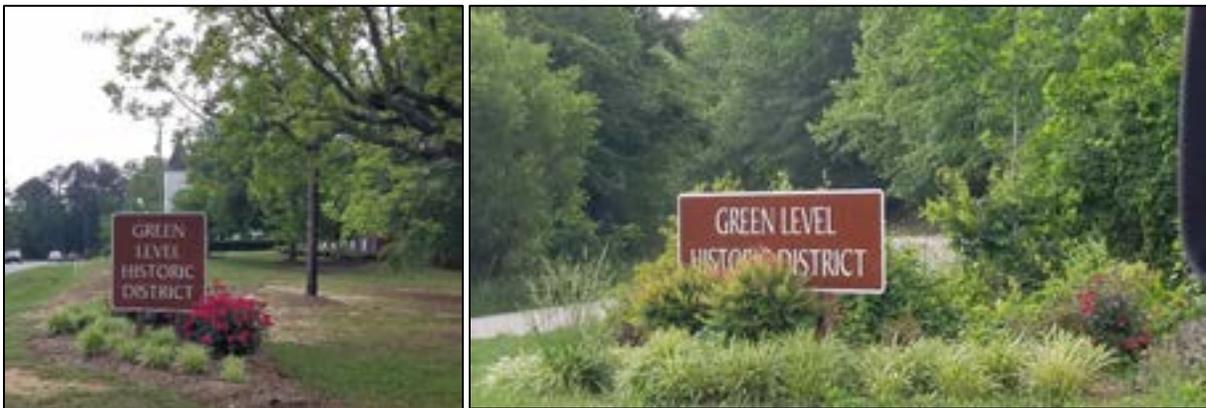
Figure 5: Green Level West Historic District Signs, Landscape Areas

As part of each quarterly inspection, an assessment team visits the Green Level Historic District signs to conduct a visual inspection of each sign and ensure they are in good standing. During this quarter, the three signs included in the inspection inventory were found to be in good condition, with the landscaped areas being well maintained. **Figure 5** shows two of these signs.

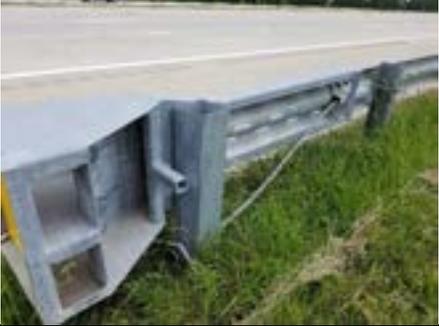
#	Material Type	Object ID	Failure Type	Photo	GIS Reference Page
1	Guardrail	BR_132	Functional Damage

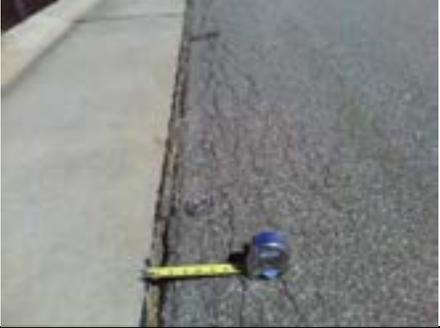
#	Material Type	Object ID	Failure Type	Photo	GIS Reference Page
1	Shoulder Berm Gutter	CG_144	Misalignment

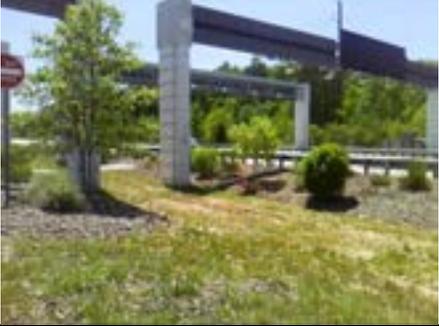
#	Material Type	Object ID	Failure Type	Photo	GIS Reference Page
1	Gantry Support	DS_44	Paint Scaling

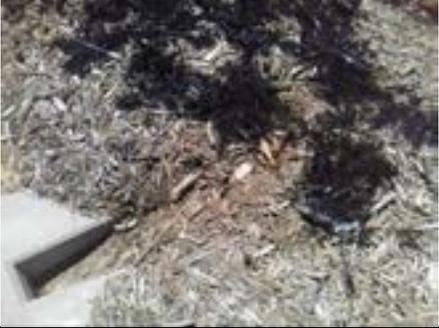
#	Material Type	Object ID	Failure Type	Photo	GIS Reference Page
1	Shoulder Drain	MDP_57	Obstruction

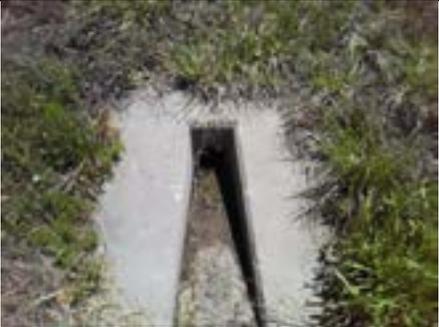
A21, A22
2	Shoulder Drain	MDP_66	Missing Rodent Screen

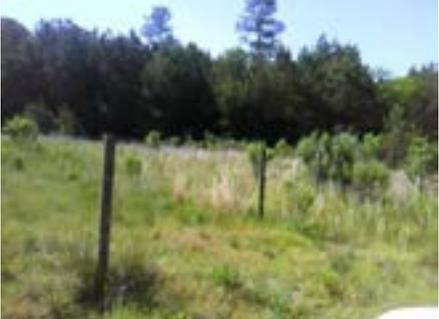
#	Material Type	Object ID	Failure Type	Photo	GIS Reference Page
1	Woven	FN_26	Hole Height

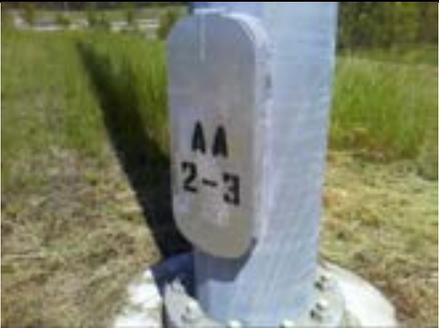
#	Material Type	Object ID	Failure Type	Photo	GIS Reference Page
1	Double Roadway	HL_6	Functional Damage	Not Available for Nighttime Failure.	A45
2	Single Roadway	HL_7	Functional Damage	Not Available for Nighttime Failure.	A45
3	Single Roadway	HL_17	Functional Damage	Not Available for Nighttime Failure.	A45
4	High Mast	HL_30	Missing Part

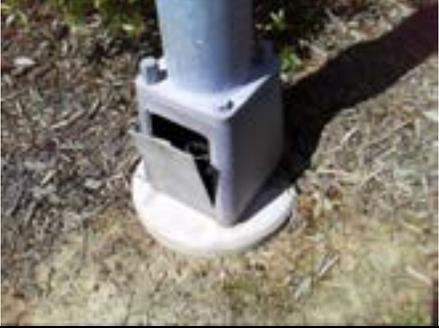
A46
5	Double Roadway	HL_93	Part Damage

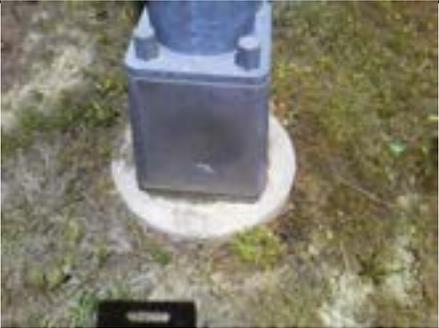
A27
6	Single Roadway	HL_205	Functional Damage	Not Available for Nighttime Failure.	A55
7	High Mast	HL_274	Functional Damage	Not Available for Nighttime Failure.	A37
8	Double Roadway	HL_308	Part Damage

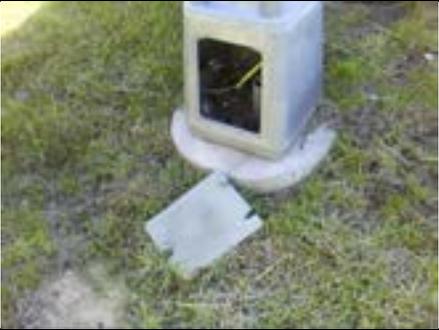
#	Material Type	Object ID	Failure Type	Photo	GIS Reference Page
9	Single Roadway	HL_311	Part Damage, Functional Damage

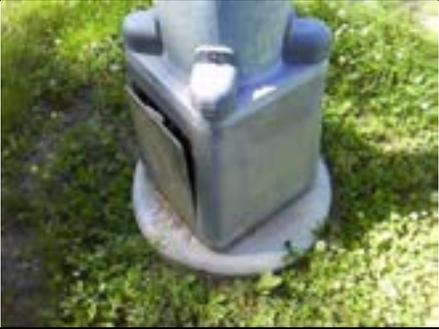
A32
10	Single Roadway	HL_337	Part Damage

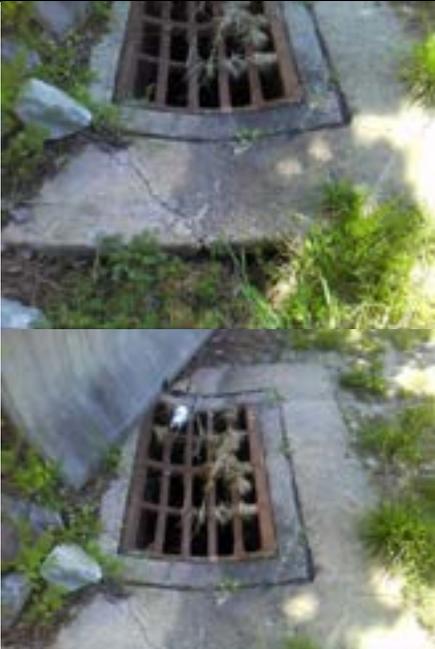
#	Material Type	Object ID	Failure Type	Photo	GIS Reference Page
1	Inlets	IN_506	Erosion, Surface Damage

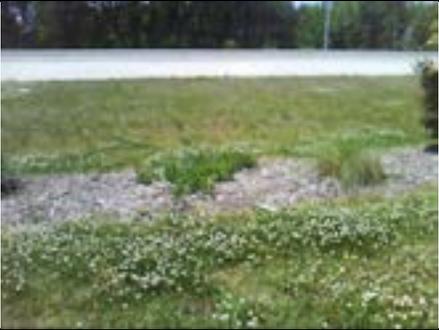
#	Material Type	Object ID	Failure Type	Photo	GIS Reference Page
1	Plant Bed	PB_88	Weeds

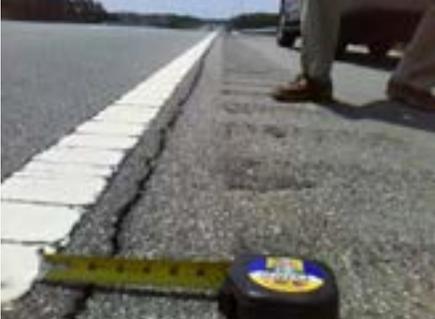
#	Material Type	Object ID	Failure Type	Photo	GIS Reference Page
1	Asphalt	LS_291	Paved Shoulder Crack

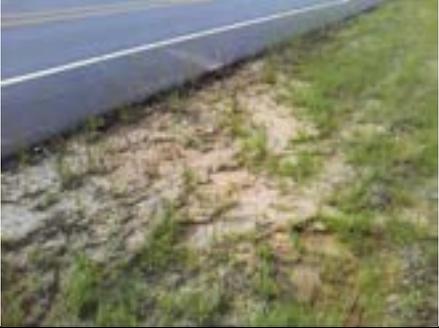
#	Material Type	Object ID	Failure Type	Photo	GIS Reference Page
1	Asphalt	LS_10	Shoulder Drop-Off

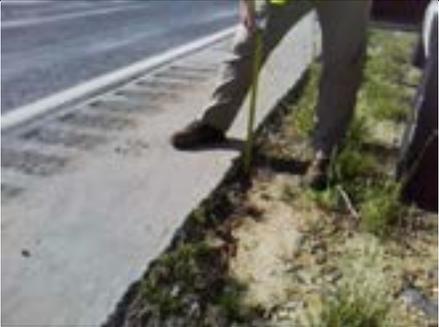
A photograph showing a road with a white line marking. The asphalt shoulder on the right side of the road is missing, dropping off into a grassy area.	A46
2	Concrete	LS_399	Shoulder Drop-Off

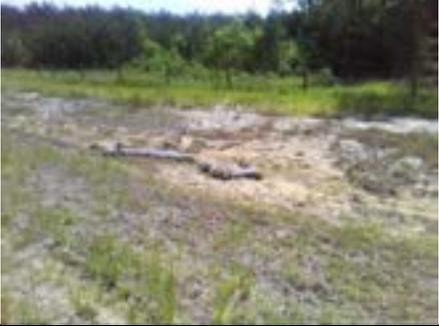
#	Material Type	Object ID	Failure Type	Photo	GIS Reference Page
1	Asphalt	LS_10	Slope Deviation

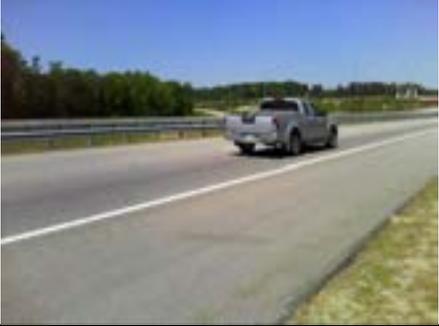
#	Material Type	Object ID	Failure Type	Photo	GIS Reference Page
1	Asphalt	LS_376	Missing Delineators

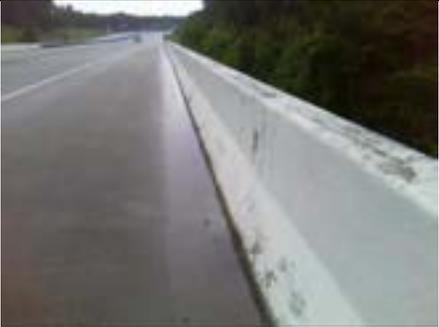
A41, A42
2	Concrete	LS_577	Missing Delineators

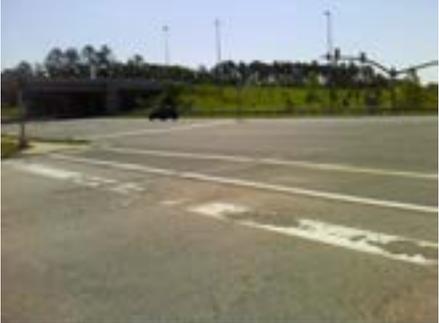
#	Material Type	Object ID	Failure Type	Photo	GIS Reference Page
1	Stop Bar	PS_34	Nighttime Reflectivity	Not Available for Nighttime Failure	A21
2	Stop Bar	PS_137	Nighttime Reflectivity, Daytime Assesment

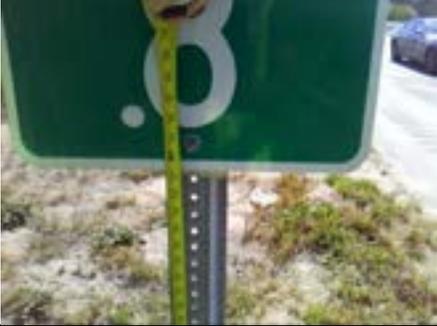
#	Sign Type	Object ID	Failure Type	Photo	GIS Reference Page
1	Mile Marker	SN_19	Height Requirement

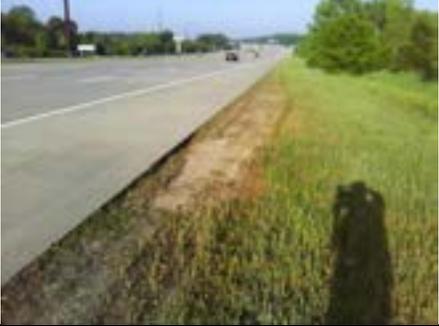
#	Material Type	Object ID	Failure Type	Photo	GIS Reference Page
1	Turf	TF_4	Bare Ground

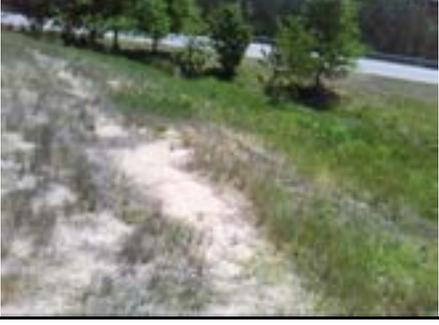
A41, A42
4	Turf	TF_216	Bare Ground

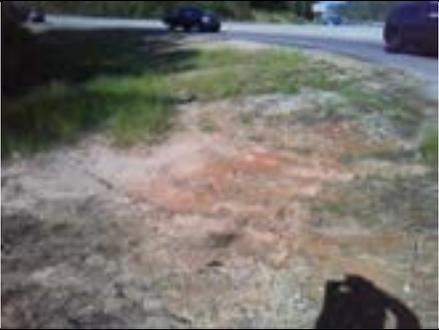
#	Material Type	Object ID	Failure Type	Photo	GIS Reference Page
5	Turf	TF_222	Bare Ground

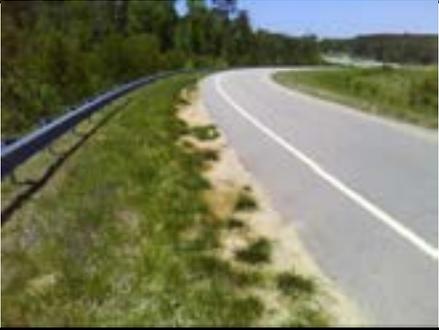
A48, A49
8	Turf	TF_411	Bare Ground

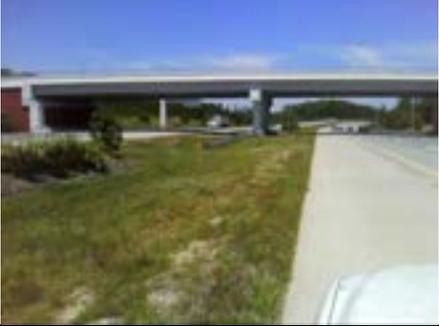
#	Material Type	Object ID	Failure Type	Photo	GIS Reference Page
9	Turf	TF_533	Bare Ground

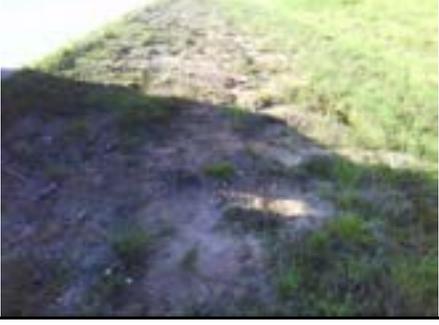
A19, A20
12	Turf	TF_595	Bare Ground

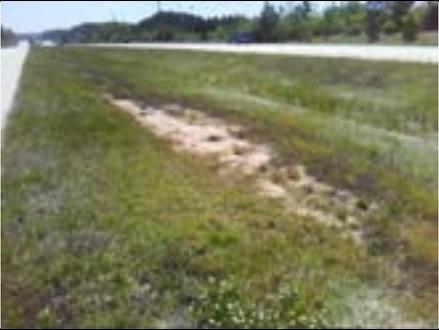
#	Material Type	Object ID	Failure Type	Photo	GIS Reference Page
13	Turf	TF_596	Bare Ground

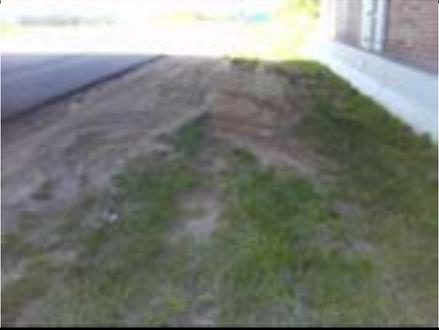
A15, A16
16	Turf	TF_748	Bare Ground

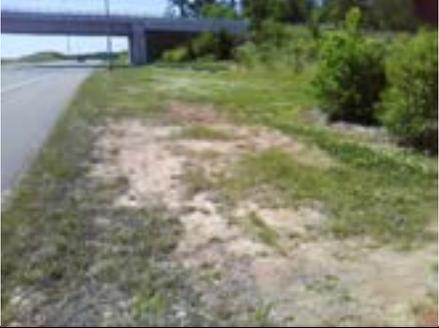
#	Material Type	Object ID	Failure Type	Photo	GIS Reference Page
17	Turf	TF_842	Bare Ground

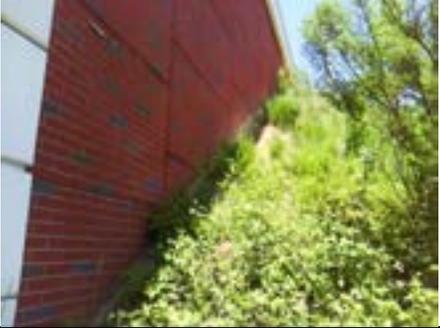
#	Material Type	Object ID	Failure Type	Photo	GIS Reference Page
1	Concrete	WL_36	Paint Scale
