# Maintenance Rating Program

Triangle Expressway

2024 Fourth Quarter Report

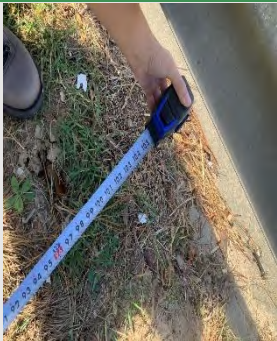
| # | Material Type | Object ID | Failure Type | Photo | GIS Reference Page |
|---|---|---|---|--|---|
| 2 | Tree and Brush | TB_325 | Barrier Clearance (10ft) | | A11 |
