# Maintenance Rating Program Monroe Expressway

Quarter 1 MRP Assessment

May 2023

NCTA Monroe By-Pass Roadway Maintenance Performance Rating Program; Q1, FY 2023 Rating

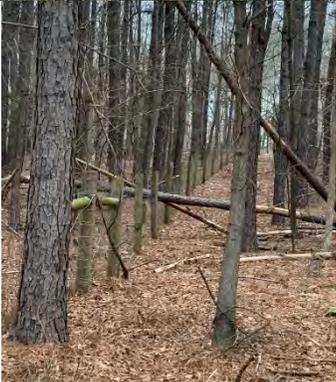
| # | Material Type | Object ID | Failure Type | Photo | GIS Reference Page |
|---|---|---|---|--|---|
| 3 | Woven | FN_493 | Hole | | B25 |
