Maintenance Rating Program

Triangle Expressway

2023 Second Quarter Report

NCTA Triangle Expressway Roadway Maintenance Performance Rating Program; Q2, FY 2023 Rating

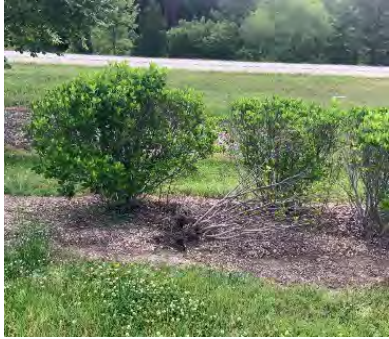
A photograph showing a dense, overgrown shrub in a plant bed. The ground is covered with dry, brown mulch or grass. The background shows more greenery and a cloudy sky.	A31
2	Plant Bed	PB_190	Health

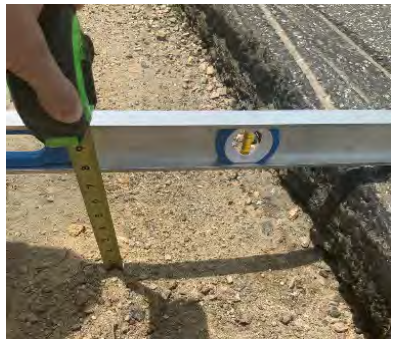
A6
2	Asphalt	LS_784	Elevation Deviation
