Maintenance Rating Program

Triangle Expressway

2022 Second Quarter Report

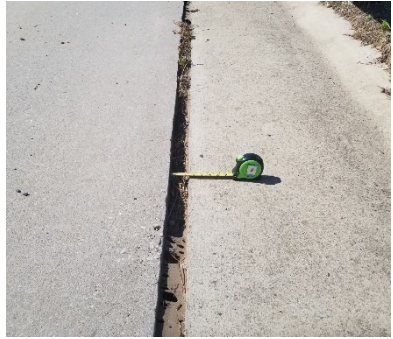
A30
2	Shoulder Berm Gutter	CG_57	Separation
