Maintenance Rating Program

Triangle Expressway

2022 Fourth Quarter Report

NCTA Triangle Expressway Roadway Maintenance Performance Rating Program; Q4, CY 2022 Rating

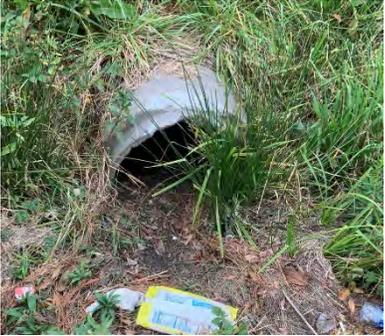
A1
2	Drain	DP_408	Obstruction

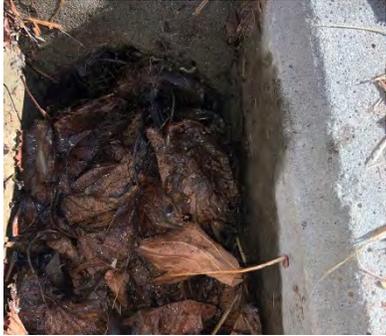
A19
2	Shoulder Drain	MDP_118	Rodent Screen, Obstruction

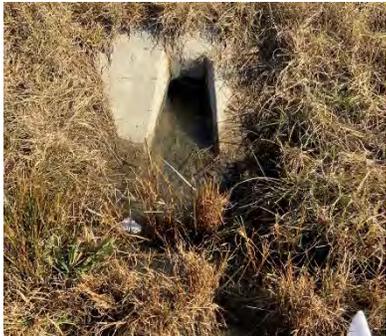
A19
3	Shoulder Drain	MDP_141	Obstruction

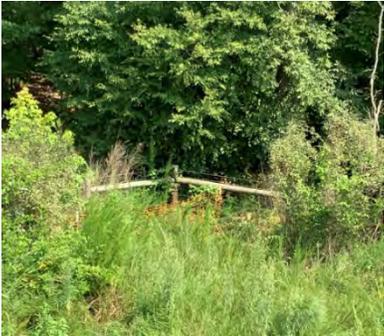
#	Material Type	Object ID	Failure Type	Photo	GIS Reference Page
1	Woven	FN_43	Fence Hole

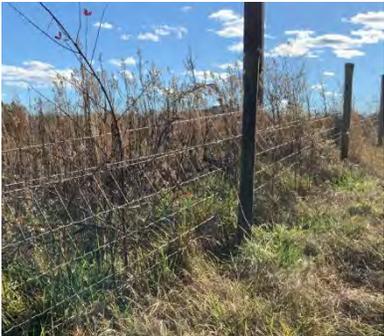
A28
2	Woven	FN_63	Height

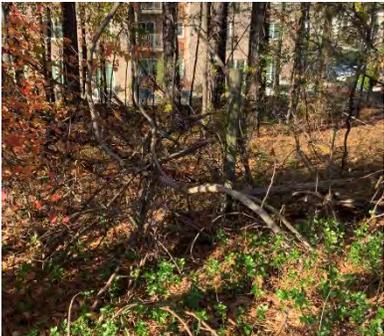
A5
3	Woven	FN_302	Height

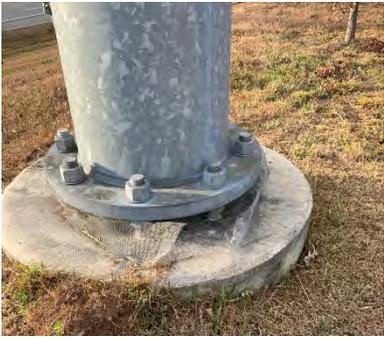
A28
2	High Mast	HL_203	Rodent Screen

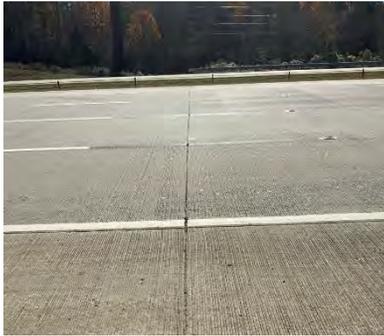
#	Material Type	Object ID	Failure Type	Photo	GIS Reference Page
1	Concrete	LS_342	Joint Malfunction

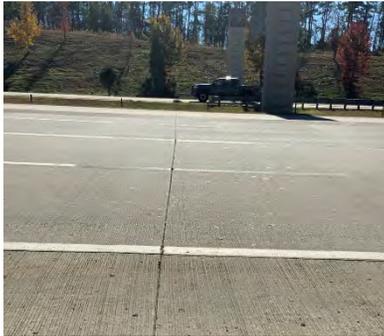
A4
2	Concrete	LS_343	Joint Malfunction

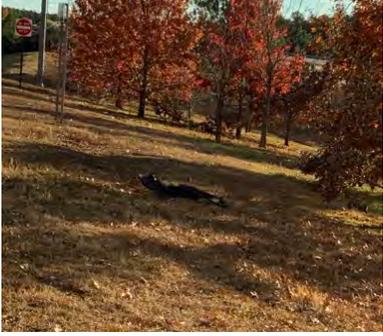
#	Material Type	Object ID	Failure Type	Photo	GIS Reference Page
1	Asphalt	LS_206	Litter

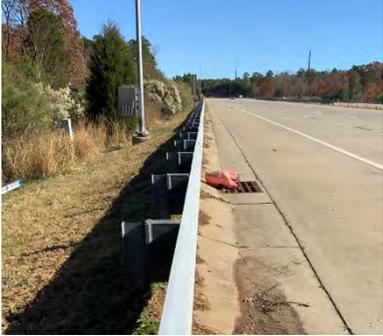
A32
2	Concrete	LS_342	Litter

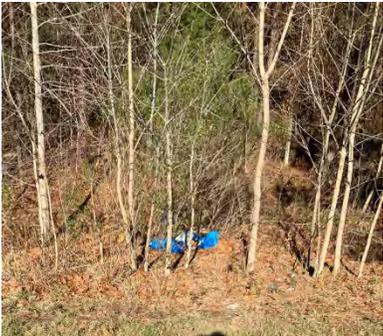
A4
3	Concrete	LS_343	Litter

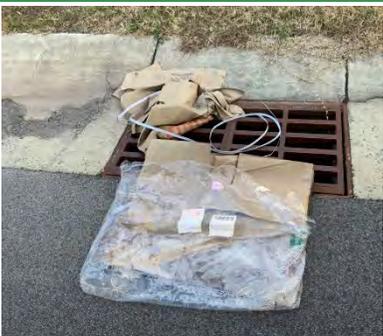
A4
4	Asphalt	LS_768	Litter

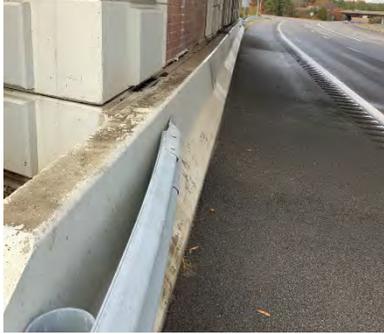
#	Material Type	Object ID	Failure Type	Photo	GIS Reference Page
1	Asphalt	LS_203	Nighttime Reflectivity	Not Available for Nighttime Failures	A3
2	Asphalt	LS_269	Missing

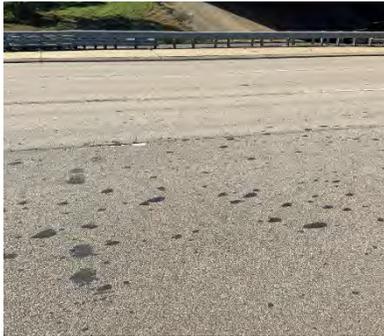
A29
3	Asphalt	LS_725	Missing

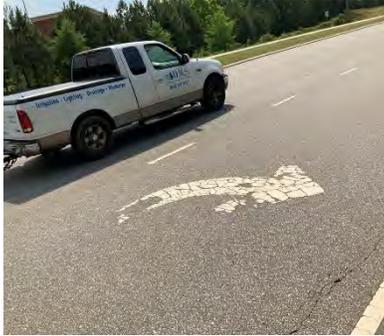
#	Material Type	Object ID	Failure Type	Photo	GIS Reference Page
1	Left Turn	PS_423	Nighttime Reflectivity	Not Available for Nighttime Failures	A1
2	Left Turn	PS_432	Nighttime Reflectivity	Not Available for Nighttime Failures	A5
3	Only	PS_509	Nighttime Reflectivity, Daytime Assessment

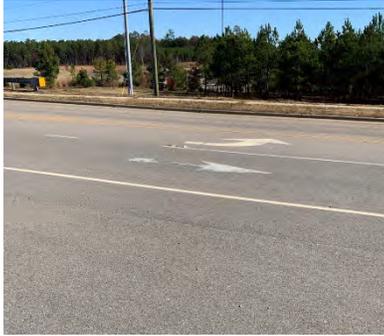
A5
4	Thru and Right	PS_558	Nighttime Reflectivity	Not Available for Nighttime Failures	A27
5	Thru Lane	PS_568	Nighttime Reflectivity, Daytime Assessment

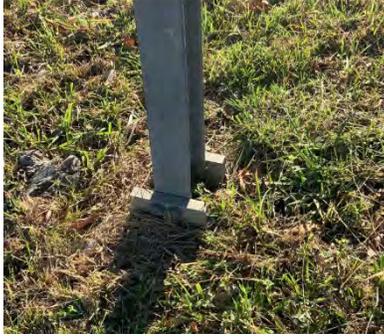
#	Sign Type	Object ID	Failure Type	Photo	GIS Reference Page
1	Exit	SN_405	Slip Base

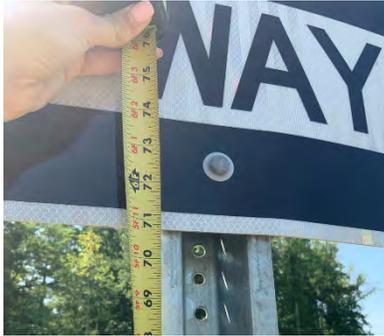
A3
2	Right Lane Ends	SN_564	Night Reflectivity	Not Available for Nighttime Failures	A2
3	One Way	SN_1208	Height

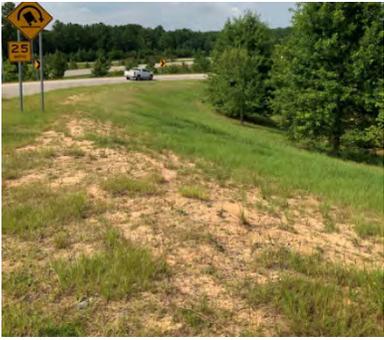
A23
2	Turf	TF_240	Bare Ground

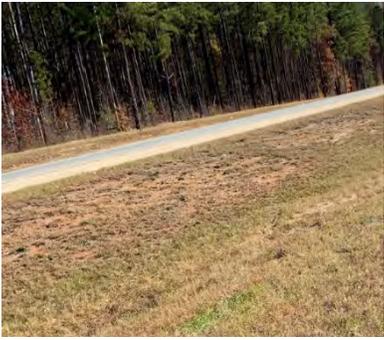
A23
3	Turf	TF_334	Bare Ground

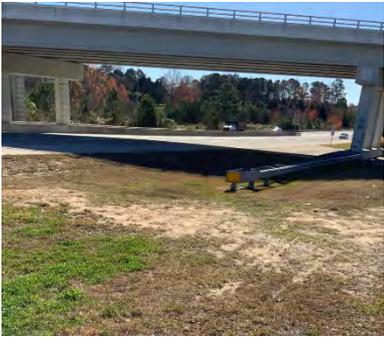
A18
6	Turf	TF_665	Bare Ground

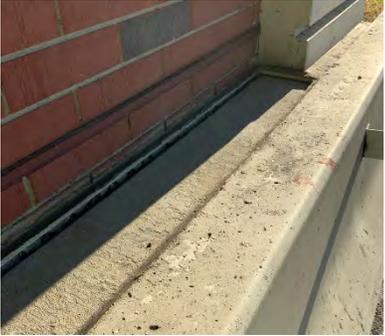
A18
2	Bridge Wall	WL_64	Unsealed Cracks/Joints

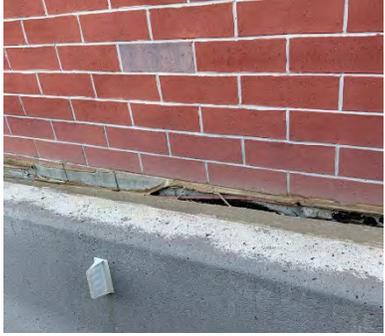
A23
3	Sound Wall	WL_98	Unsealed Cracks/Joints

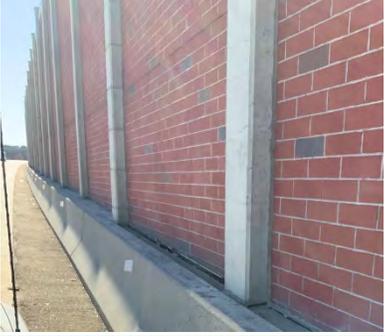
A18
4	Sound Wall	WL_101	Unsealed Cracks/Joints
