Maintenance Rating Program

Triangle Expressway

2023 First Quarter Report

NCTA Triangle Expressway Roadway Maintenance Performance Rating Program; Q1, FY 2023 Rating

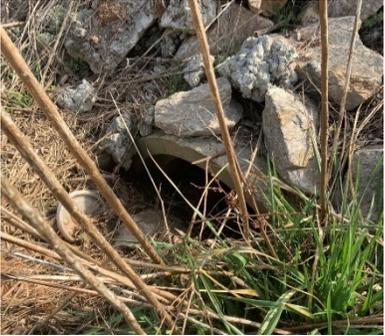
A12
2	Drain	DP_709	Obstruction

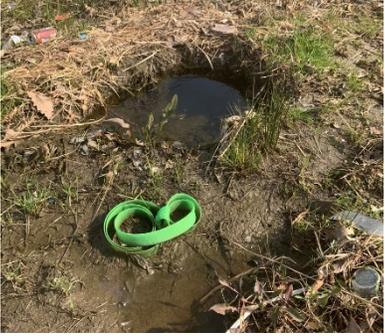
A2
3	Drain	DP_788	Obstruction

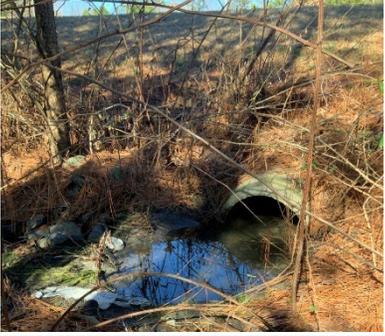
A23
4	Drain	DP_860	Obstruction

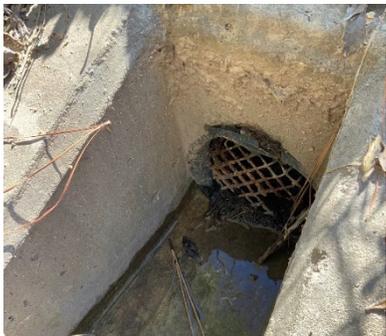
A26
4	Shoulder Drain	MDP_169	Rodent Screen

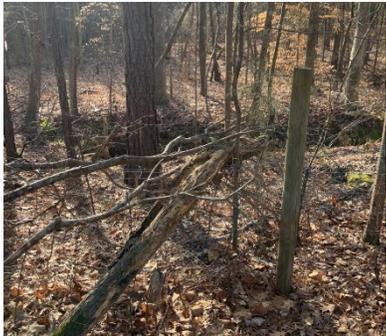
A5
2	Woven	FN_217	Height

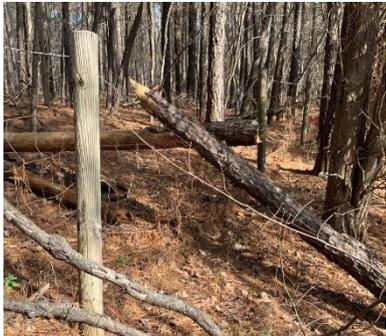
A2
3	Woven	FN_248	Height

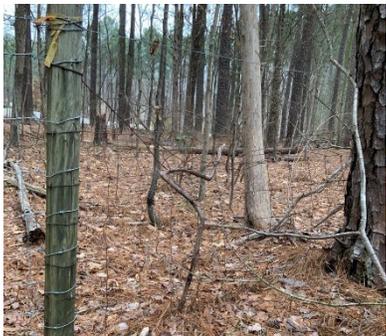
A29
4	Woven	FN_301	Fence Hole

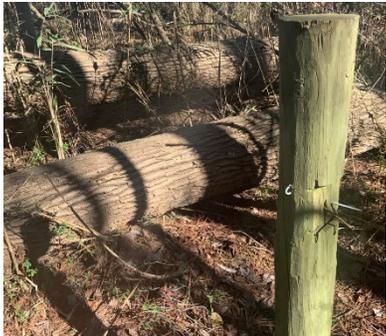
A1
6	Woven	FN_328	Height

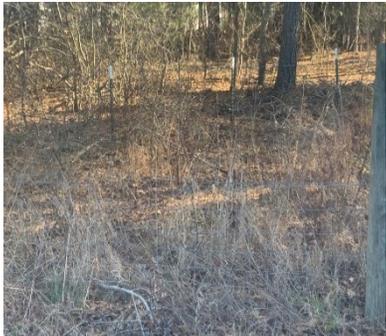
A16
7	Woven	FN_356	Height

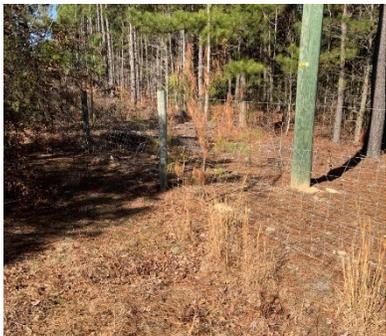
A15
8	Woven	FN_486	Fence Hole

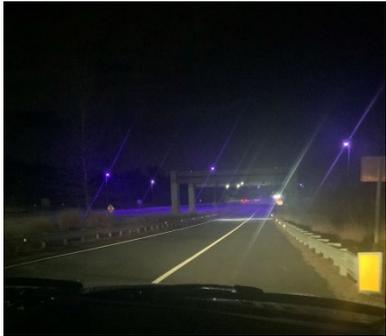
A12
2	Asphalt	LS_242	Nighttime Reflectivity

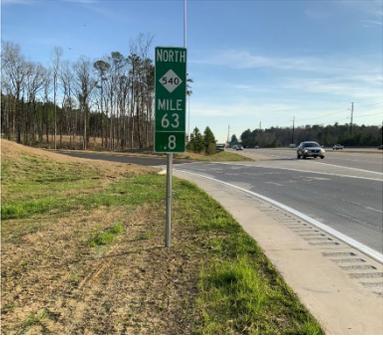
A26
2	Mile Post	SN_224	Lateral Clearance

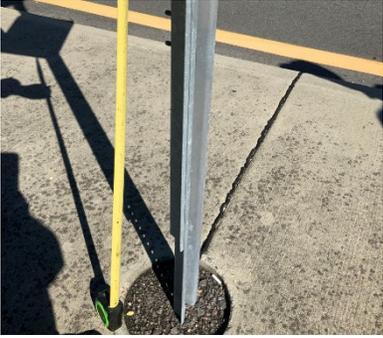
A9
3	Merge	SN_313	Sign Support
