Maintenance Rating Program

Triangle Expressway

2023 Second Quarter Report

NCTA Triangle Expressway Roadway Maintenance Performance Rating Program; Q2, FY 2023 Rating

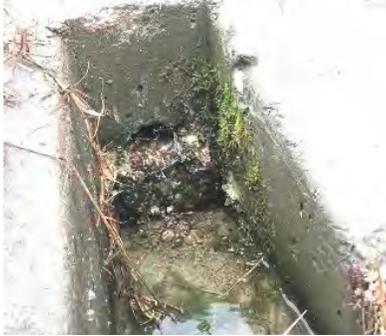
A13
2	Shoulder Drain	MDP_93	Obstruction

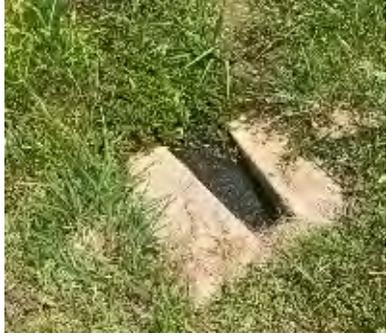
A17
3	Shoulder Drain	MDP_98	Obstruction/ Rodent Screen

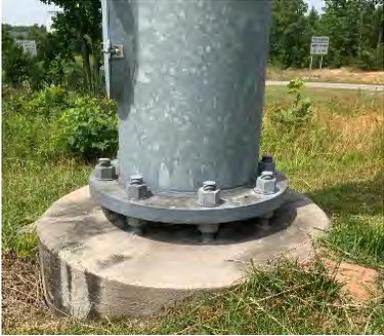
A26
1	High Mast	HL_203	Rodent Screen

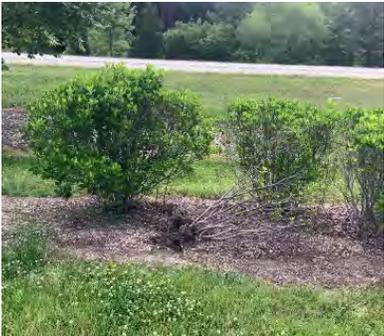
A31
2	Plant Bed	PB_190	Health

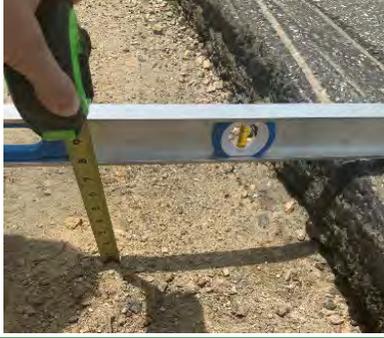
A6
2	Asphalt	LS_784	Elevation Deviation

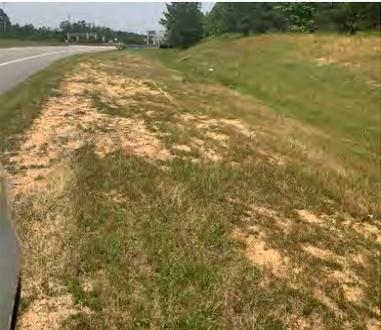
A16
2	Turf	TF_512	Bare Ground

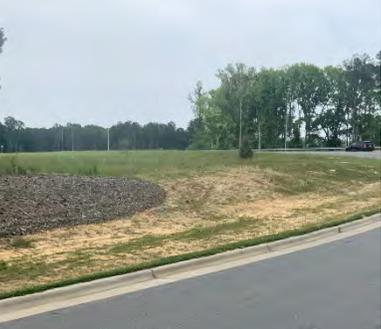
A15
3	Turf	TF_1054	Bare Ground
