NORTH CAROLINA  
**Turnpike Authority**

## Maintenance Rating Program

Triangle Expressway

### 2020 First Quarter Report

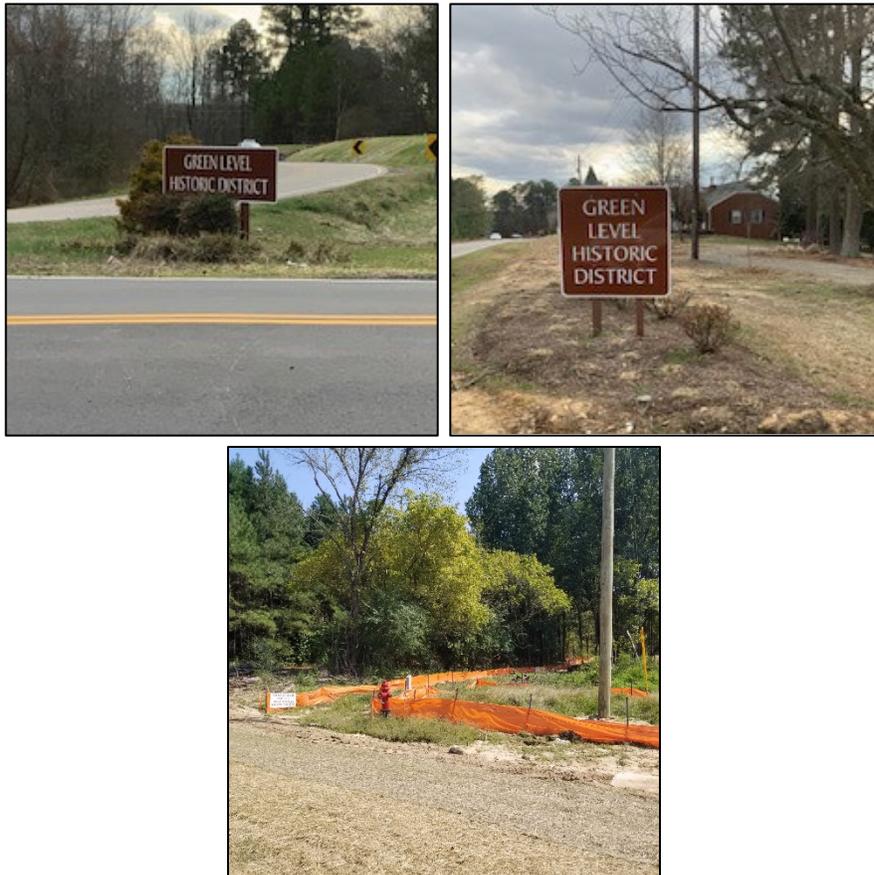
**Figure 3: Green Level West Historic District Signs, Landscape Areas**

As part of each quarterly inspection, an assessment team visits the three Green Level Historic District signs to conduct a visual inspection of each sign and ensure they are in good standing. Two of the three signs included in the inspection inventory were found to be in good condition, with the landscaped areas being well maintained. The third sign had been temporarily removed due to nearby construction activities.

**Figure 3** shows the two signs assessed and the area of the third sign.

This quarter, the two Green Level Historic District signs inspected were found to be in good condition while the third sign was identified to have been removed for a Town of Cary development project near Green Level West Road. Additionally, the landscaped areas surrounding the signs were found to be well maintained.

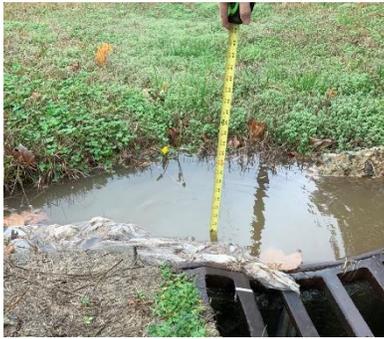
A30
2	Drainage Pipe	DP_666	Erosion

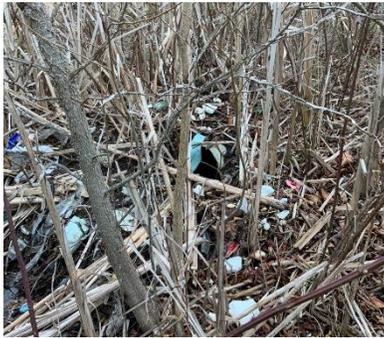
A31
3	Drainage Pipe	DP_758	Obstruction

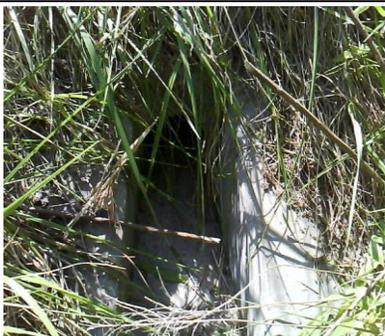
A29
3	Shoulder Drain	MDP_189	Rodent Screen

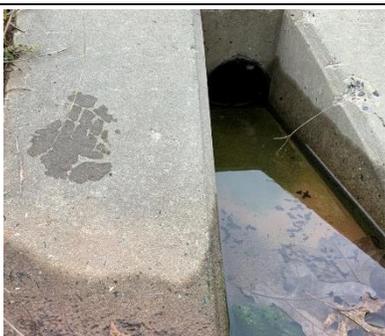
A25
4	Shoulder Drain	MDP_211	Rodent Screen

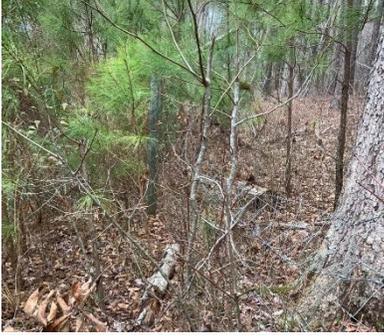
A27
2	Woven	FN_97	Fence Height

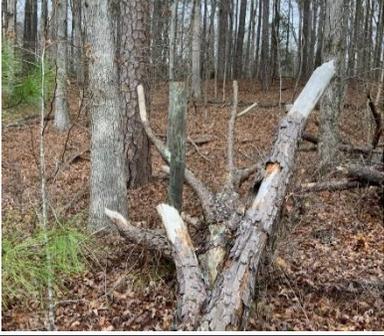
A15
3	Woven	FN_430	Fence Height

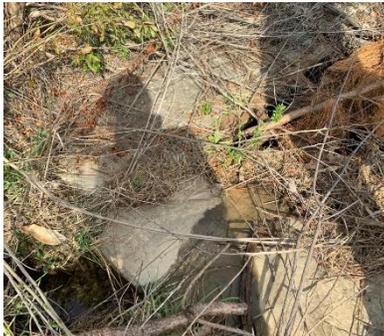
A35
2	Inlet	IN_580	Obstruction / Eroded Area

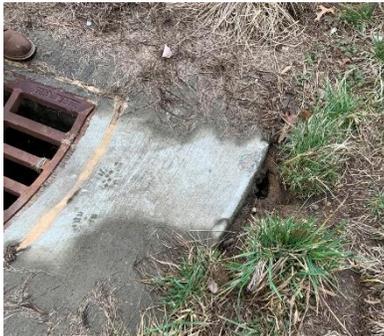
A18, A19
3	Inlet	IN_914	Eroded Area

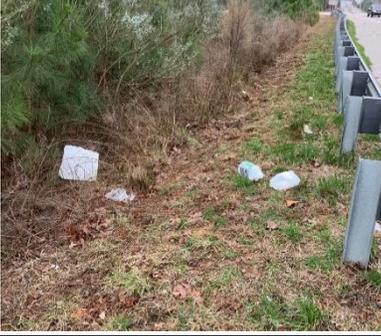
A14
2	Asphalt	LS_395	Litter

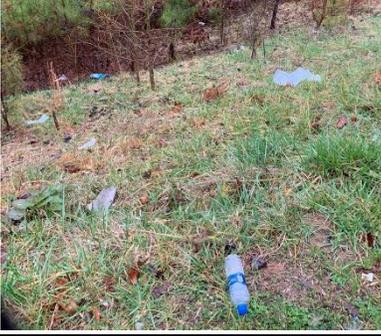
A19
3	Concrete	LS_407	Litter

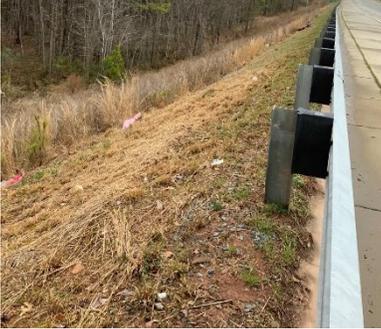
A20
4	Concrete	LS_472	Litter

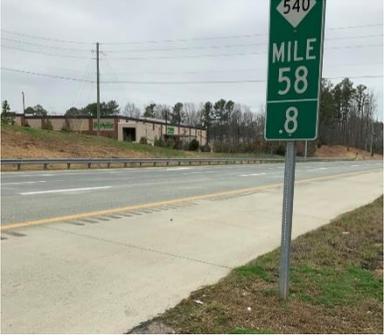
A7
2	Mile Post	SN_711	Lateral Clearance

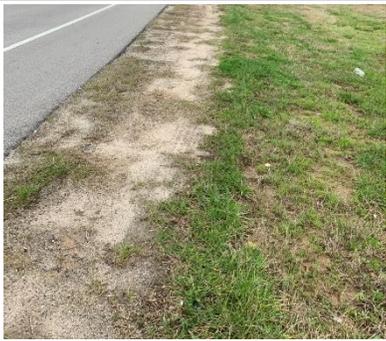
A24
2	Turf	TF_340	Bare Ground

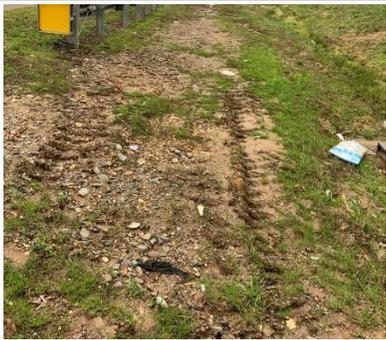
A25
3	Turf	TF_450	Bare Ground
