NORTH CAROLINA
Turnpike Authority

Maintenance Rating Program

Triangle Expressway

2020 Fourth Quarter and Annual Report

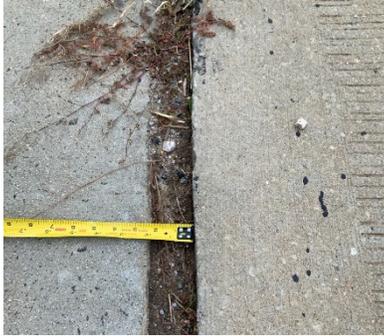
A28
2	Curb and Gutter	CG_174	Misalignment

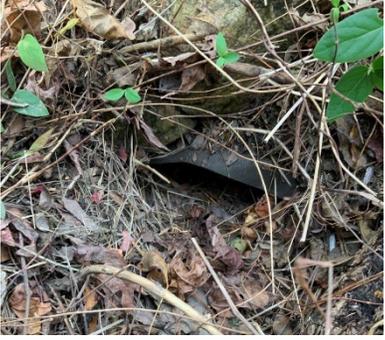
A1
2	Drain	DP_440	Obstruction, Erosion

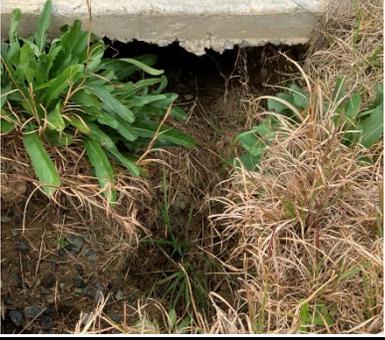
A5
3	Drain	DP_786	Erosion, Water Infiltration, End Protection

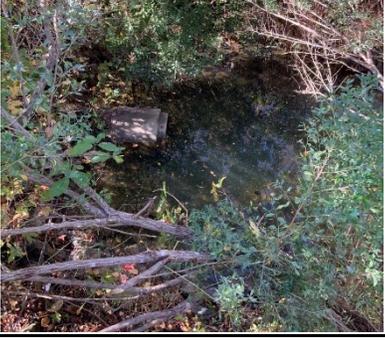
A25
4	Drain	DP_1007	Obstruction

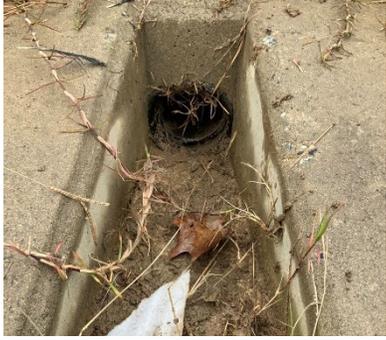
A10
2	Shoulder Drain	MDP_54	Rodent Screen

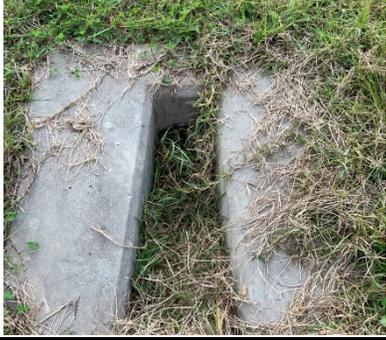
A12
3	Shoulder Drain	MDP_56	Obstruction

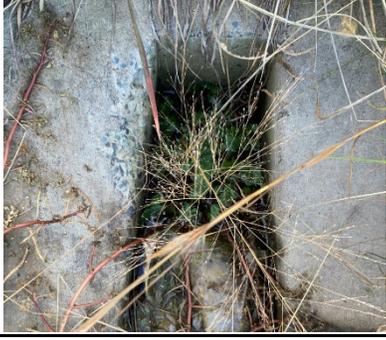
A13
4	Shoulder Drain	MDP_68	Obstruction

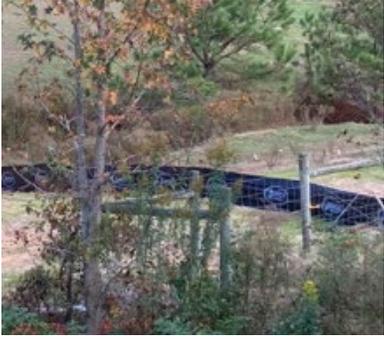
A15
2	Woven	FN_83	Fence Hole

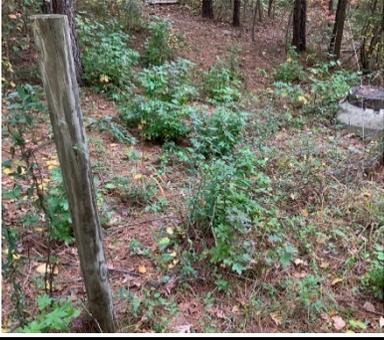
A15
3	Woven	FN_125	Fence Hole

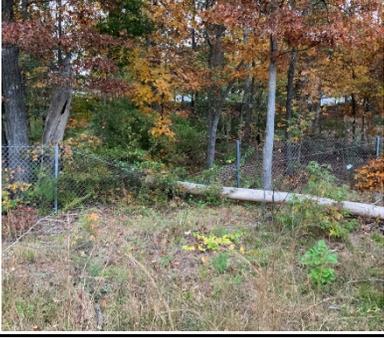
A11
4	Chain Link	FN_452	Hole Height

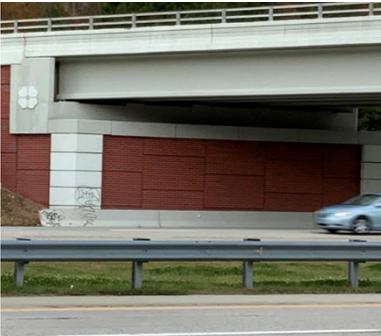
#	Material Type	Object ID	Failure Type	Photo	GIS Reference Page
1	Bridge Wall	GR_1	Graffiti

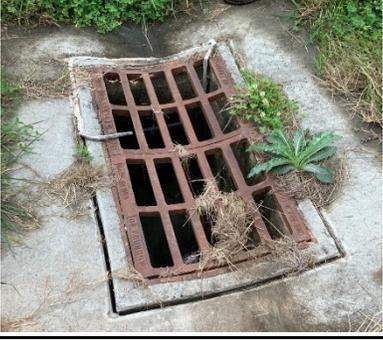
A3
4	Inlet	IN_717	Surface Damage

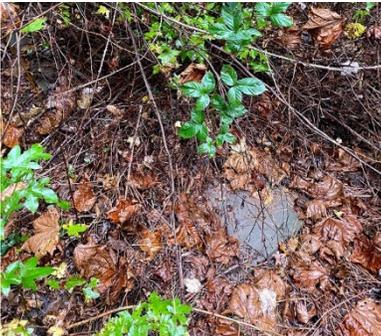
#	Material Type	Object ID	Failure Type	Photo	GIS Reference Page
5	Inlet	IN_843	Obstruction

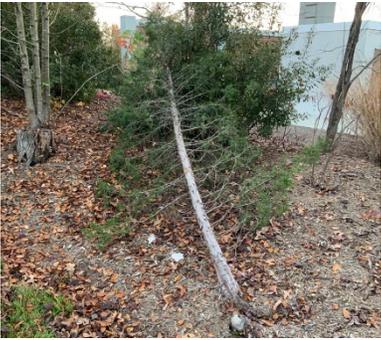
#	Material Type	Object ID	Failure Type	Photo	GIS Reference Page
1	Plant Bed	PB_37	Health

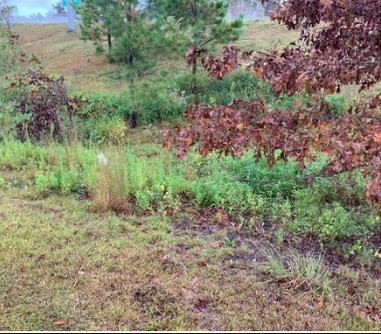
A33
2	Plant Bed	PB_55	Weeds

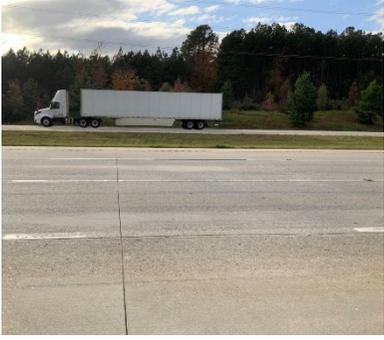
A8
2	Concrete	LS_90	Line Missing

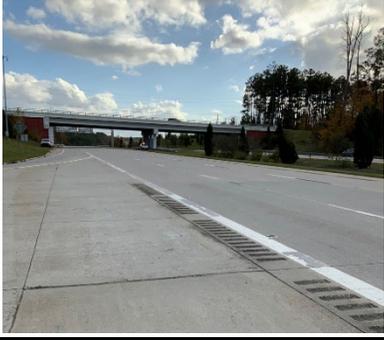
A12
3	Concrete	LS_94	Line Missing

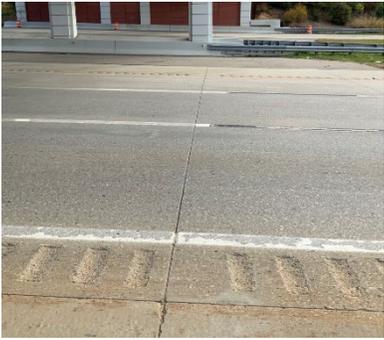
A12
4	Concrete	LS_128	Nighttime Reflectivity	Not Available for Nighttime Failure	A8
5	Concrete	LS_129	Line Missing

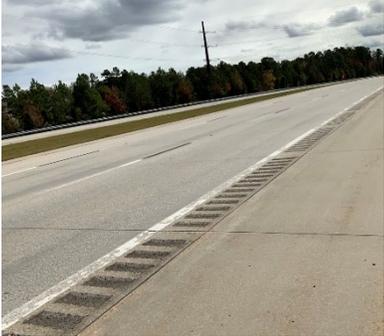
#	Material Type	Object ID	Failure Type	Photo	GIS Reference Page
6	Concrete	LS_134	Line Missing

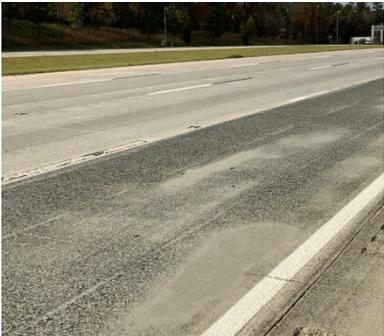
A9
7	Concrete	LS_429	Line Missing

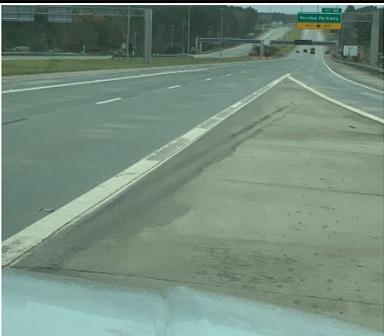
A21
8	Concrete	LS_482	Line Missing

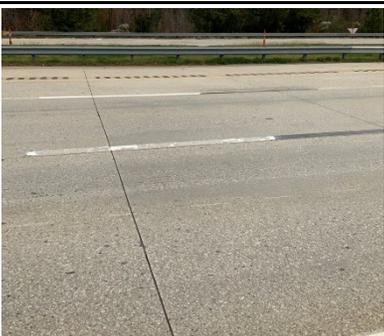
A29
9	Concrete	LS_605	Line Missing

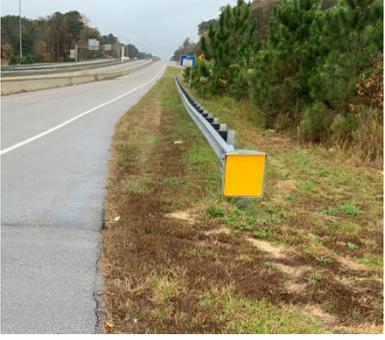
A5
2	Asphalt	LS_533	Missing & Nighttime Reflectivity

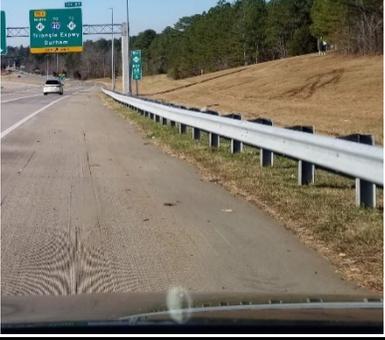
A24
3	Concrete	LS_588	Missing & Nighttime Reflectivity

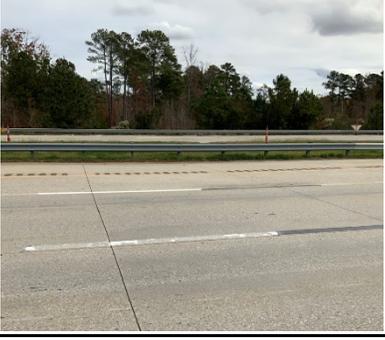
A2
4	Concrete	LS_605	Missing & Nighttime Reflectivity

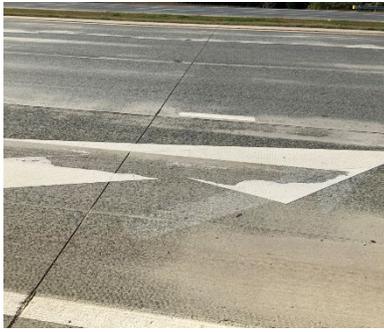
#	Material Type	Object ID	Failure Type	Photo	GIS Reference Page
1	Merge Left	PS_41	Daytime Assessment

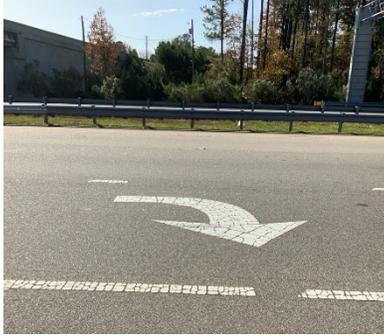
A15
2	Right Turn	PS_157	Nighttime Reflectivity

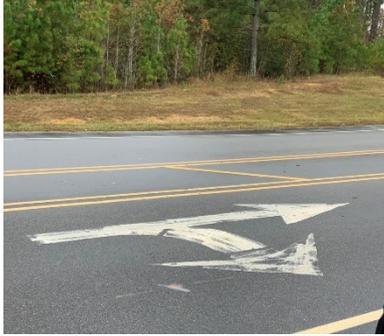
A17
3	Thru and Right	PS_557	Daytime Assessment

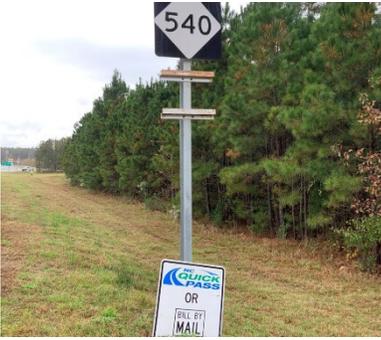
#	Sign Type	Object ID	Failure Type	Photo	GIS Reference Page
1	NC Route	SN_112	Surface Damage

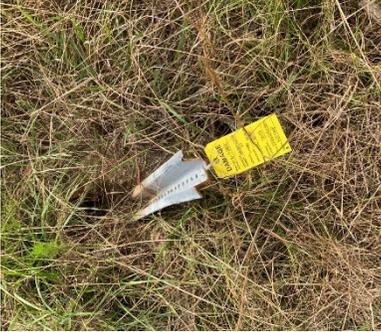
A27
2	Mile Post	SN_667	Missing Parts

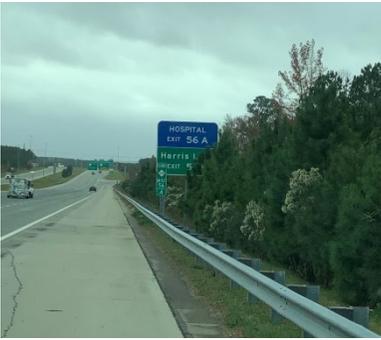
#	Material Type	Object ID	Failure Type	Photo	GIS Reference Page
1	Tree and Brush	TB_173	Sight Distance

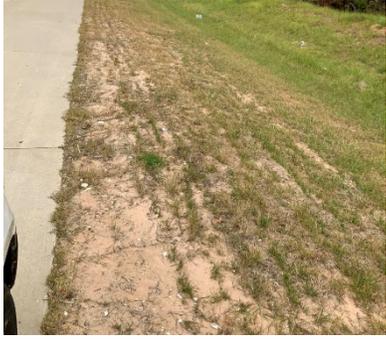
A9
2	Turf	TF_48	Bare Ground

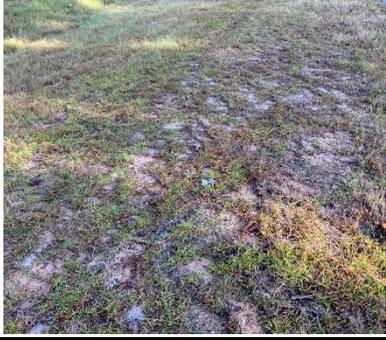
A8
3	Turf	TF_85	Bare Ground

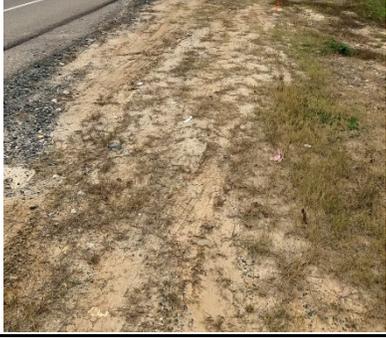
A16
4	Turf	TF_93	Bare Ground

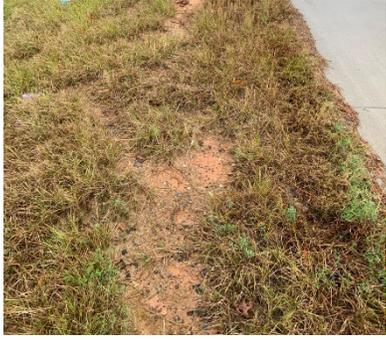
A26
6	Turf	TF_151	Bare Ground

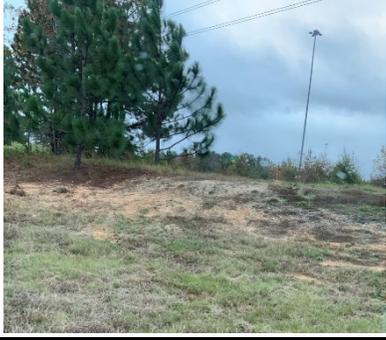
A26
7	Turf	TF_238	Bare Ground

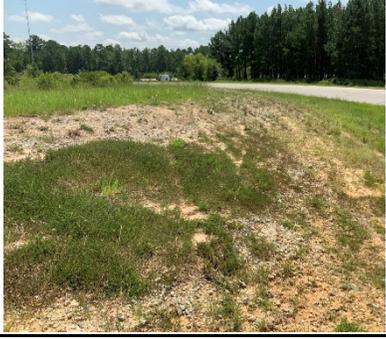
A24
8	Turf	TF_239	Bare Ground

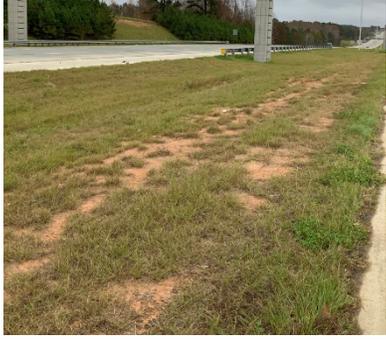
A28
10	Turf	TF_322	Bare Ground

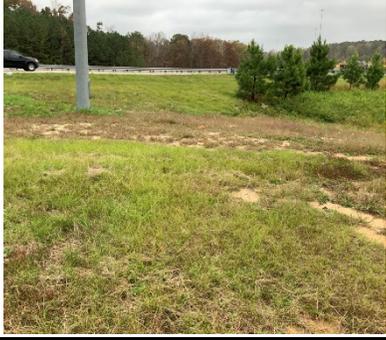
A27
11	Turf	TF_346	Bare Ground

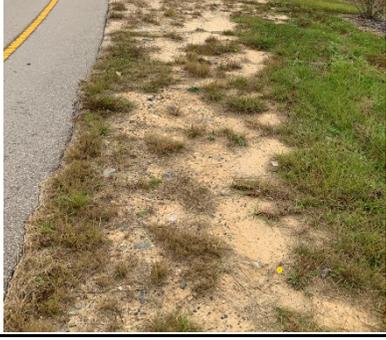
A24
12	Turf	TF_379	Bare Ground

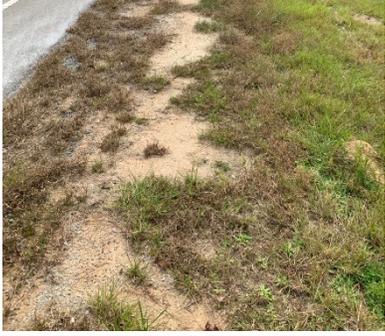
#	Material Type	Object ID	Failure Type	Photo	GIS Reference Page
13	Turf	TF_409	Bare Ground

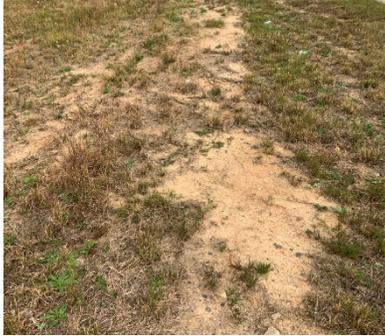
A22
14	Turf	TF_469	Bare Ground

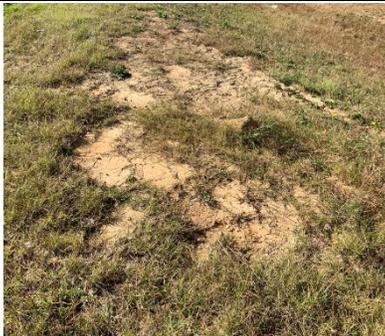
A22
15	Turf	TF_501	Bare Ground

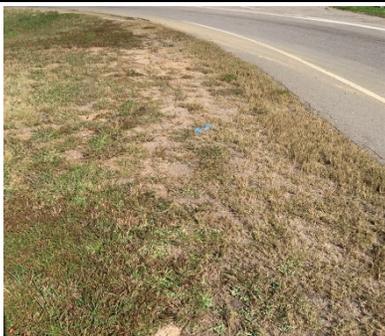
A17
16	Turf	TF_519	Bare Ground

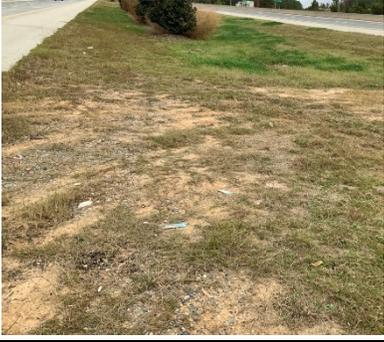
A10
18	Turf	TF_665	Bare Ground

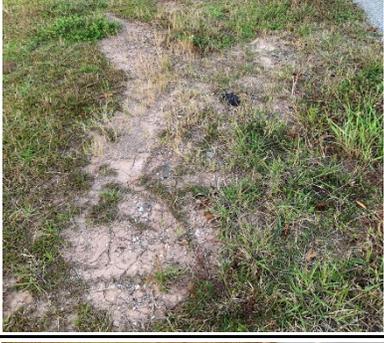
A17
19	Turf	TF_899	Bare Ground

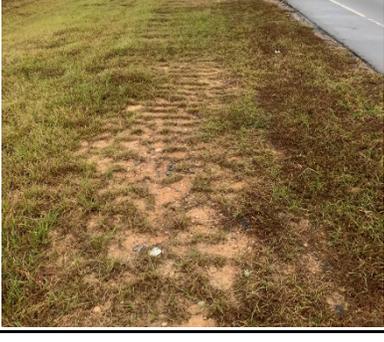
A33
20	Turf	TF_1037	Bare Ground

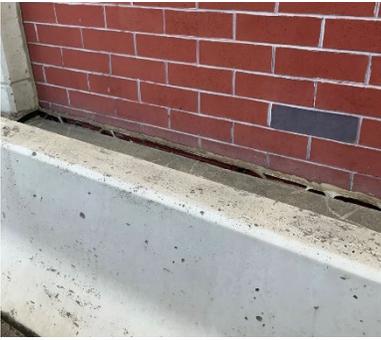
#	Material Type	Object ID	Failure Type	Photo	GIS Reference Page
1	Sound Wall	WL_99	Unsealed Joints
