NORTH CAROLINA  
**Turnpike Authority**

## Maintenance Rating Program

Triangle Expressway

## 2021 First Quarter and Annual Report

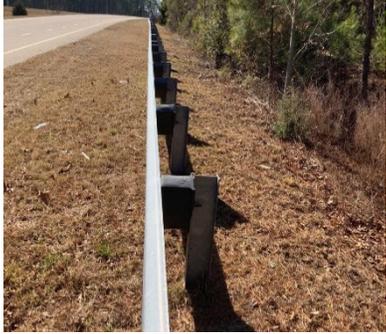
#	Material Type	Object ID	Failure Type	Photo	GIS Reference Page
1	Guardrail	BR_583	Twisted Blocks

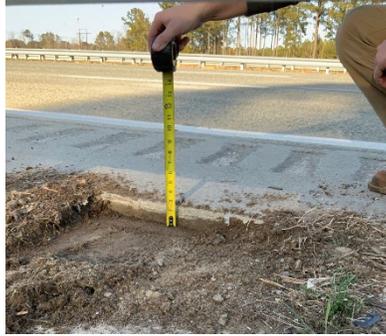
A13
2	Curb and Gutter	CG_207	Settlement

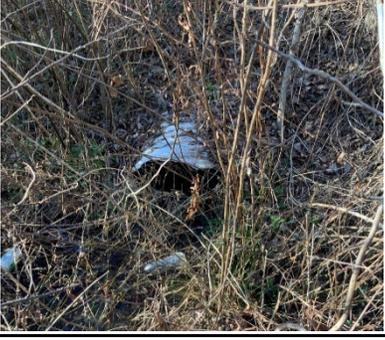
A27
4	Drain	DP_1171	Obstruction

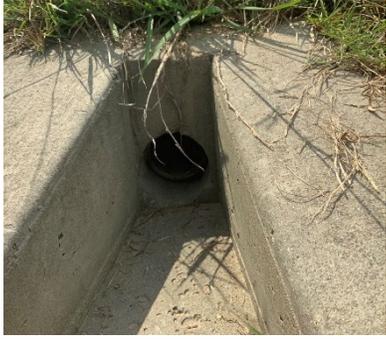
A16
2	Shoulder Drain	MDP_89	Rodent Screen

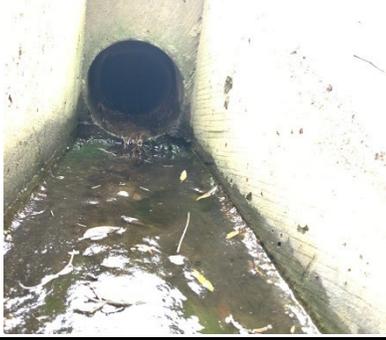
A19
3	Shoulder Drain	MDP_91	Rodent Screen

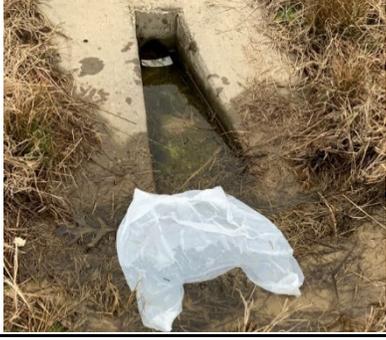
A19
4	Shoulder Drain	MDP_112	Rodent Screen

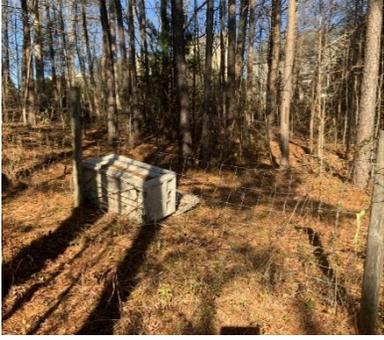
A14
2	Woven	FN_125	Fence Height

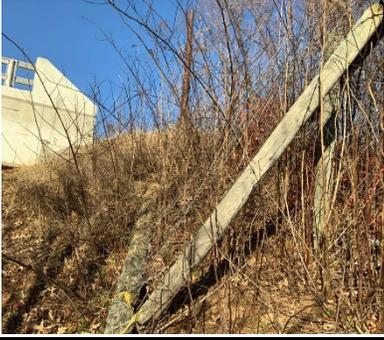
A13
3	Woven	FN_155	Fence Hole

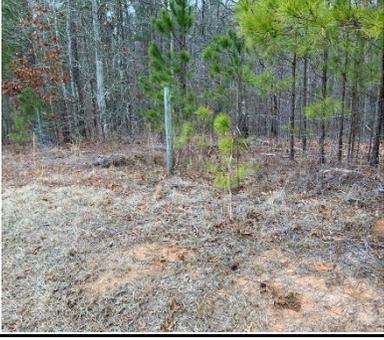
A9
4	Woven	FN_205	Fence Hole

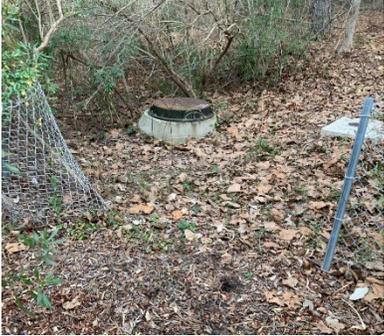
A5
6	Chain Link	FN_443	Fence Hole

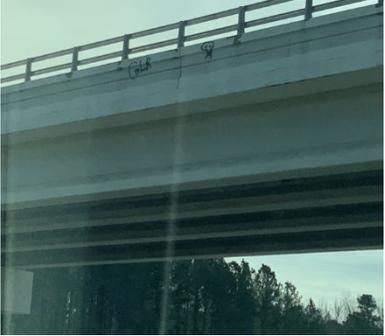
A14
2	Bridge Barrier	GR_2	Graffiti

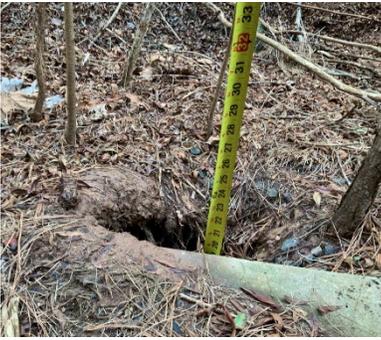
#	Material Type	Object ID	Failure Type	Photo	GIS Reference Page
1	Inlet	IN_216	Eroded Area

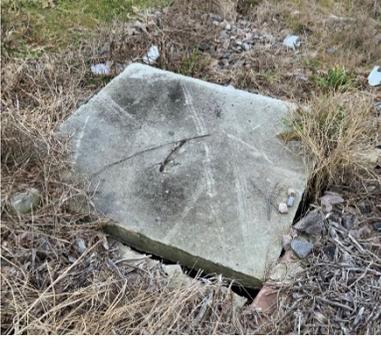
A33
2	Inlet	IN_482	Surface Damage

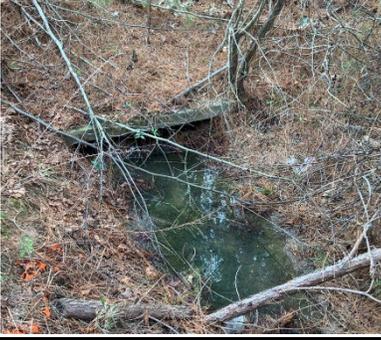
A1
3	Inlet	IN_921	Eroded Area

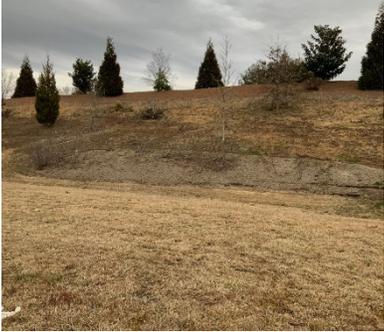
A35
2	Plant Bed	PB_56	Health

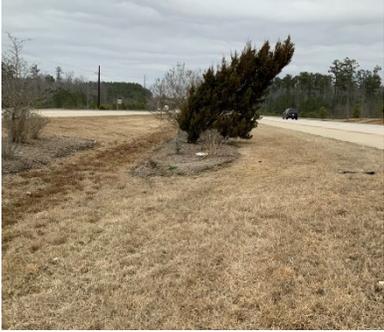
A35
3	Plant Bed	PB_136	Health

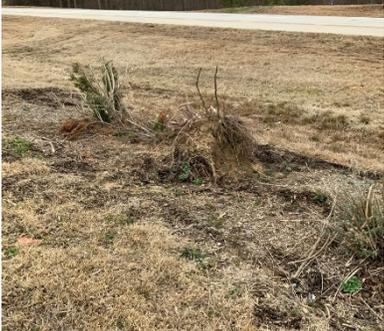
A14
4	Plant Bed	PB_138	Health

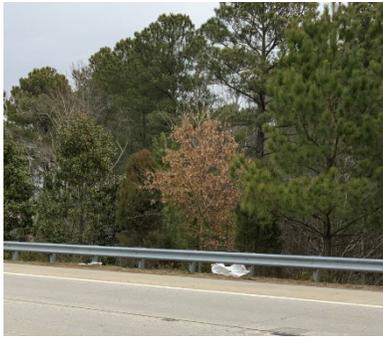
#	Material Type	Object ID	Failure Type	Photo	GIS Reference Page
1	Concrete	LS_71	Litter – 3CF

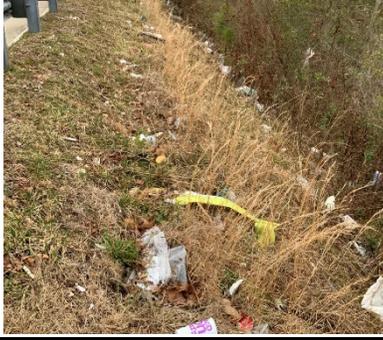
A32
3	Asphalt	LS_279	Litter – 3CF

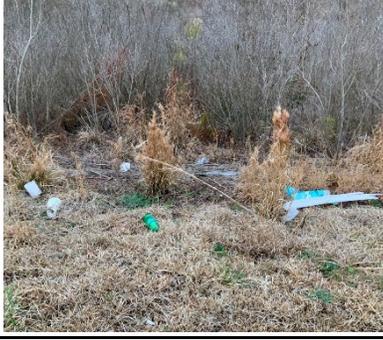
A33
4	Asphalt	LS_285	Litter – 3CF

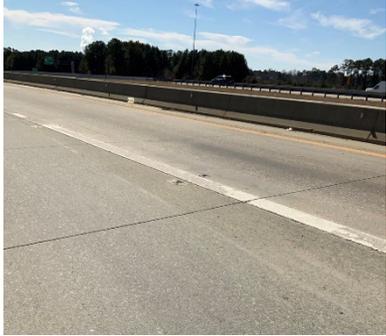
#	Material Type	Object ID	Failure Type	Photo	GIS Reference Page
5	Concrete	LS_635	Line Missing

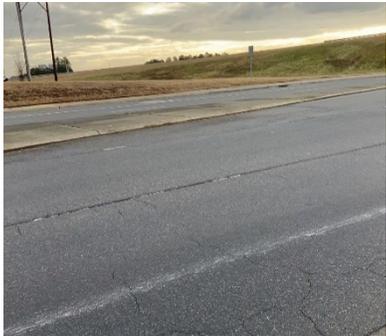
A19
6	Asphalt	LS_735	Line Missing

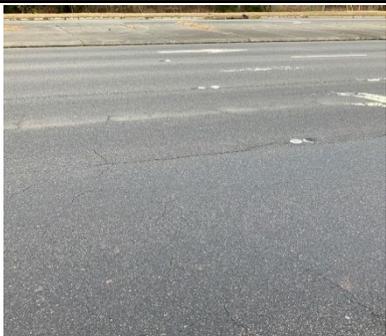
A1
7	Asphalt	LS_738	Line Missing

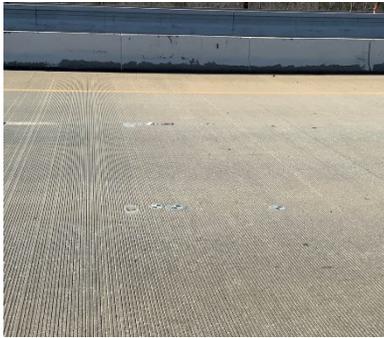
#	Material Type	Object ID	Failure Type	Photo	GIS Reference Page
1	Concrete	LS_609	Marker Missing

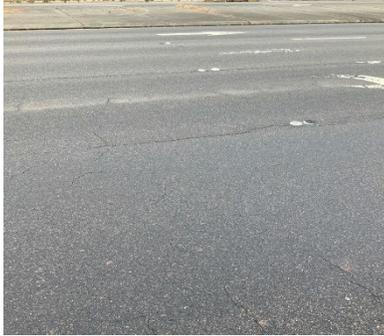
A15
2	Asphalt	LS_738	Nighttime Reflectivity

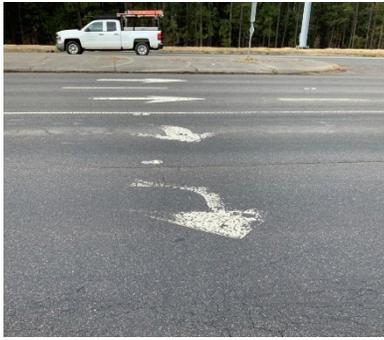
#	Material Type	Object ID	Failure Type	Photo	GIS Reference Page
1	Right Turn	PS_414	Daytime Assessment

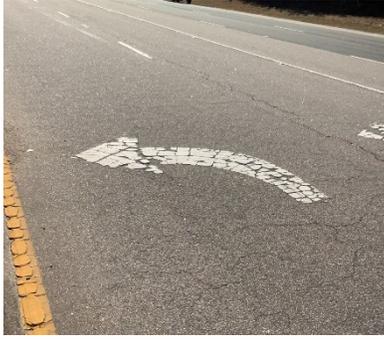
A1
2	Left Turn	PS_432	Daytime Assessment

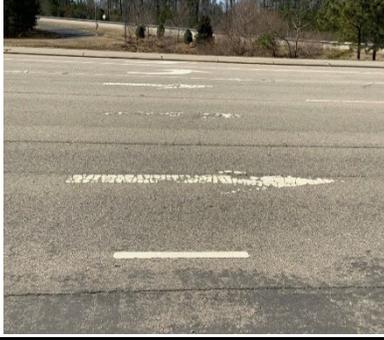
A6
3	Thru Lane	PS_461	Daytime Assessment

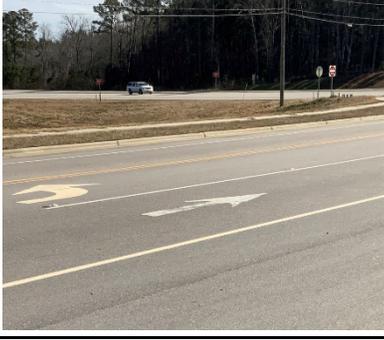
A6
4	Thru Lane	PS_568	Nighttime Reflectivity

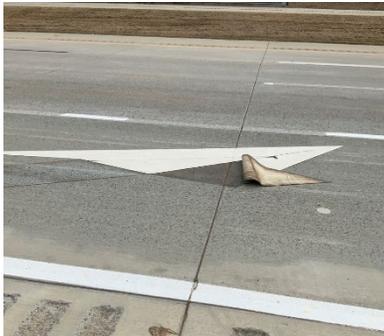
#	Material Type	Object ID	Failure Type	Photo	GIS Reference Page
5	Merge Left	PS_628	Daytime Assessment

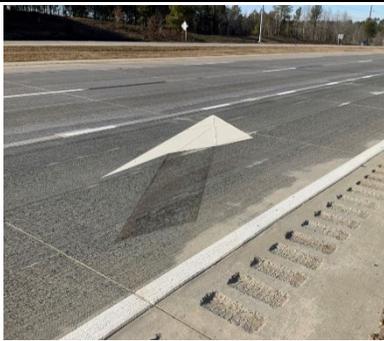
A11
6	Merge Left	PS_651	Daytime Assessment

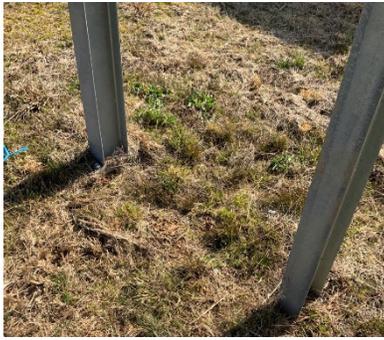
#	Sign Type	Object ID	Failure Type	Photo	GIS Reference Page
1	NC Route	SN_114	Slip Base

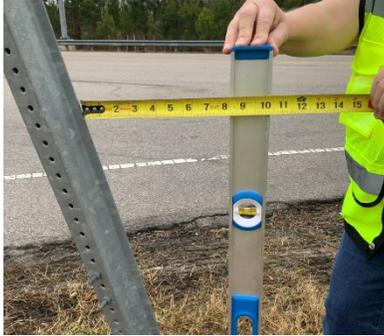
A28
2	Do Not Enter	SN_784	Leaning

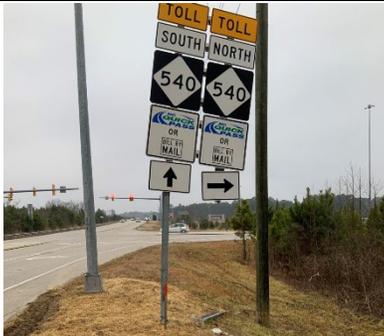
A24
3	NC Route	SN_794	Missing Parts

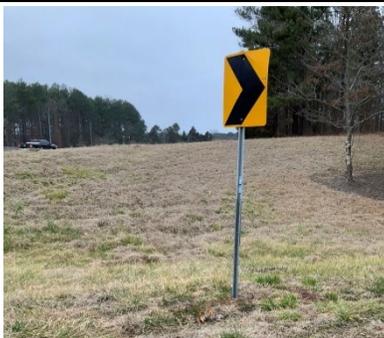
A24
4	Chevron	SN_1049	Leaning, Sign Support

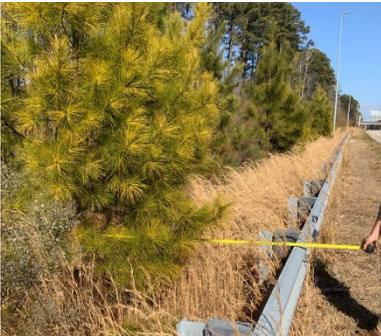
#	Material Type	Object ID	Failure Type	Photo	GIS Reference Page
1	Tree and Brush	TB_152	Barrier Clearance

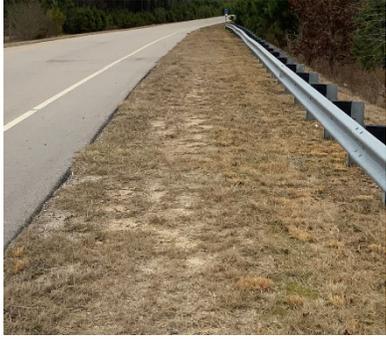
A9
2	Turf	TF_148	Bare Ground

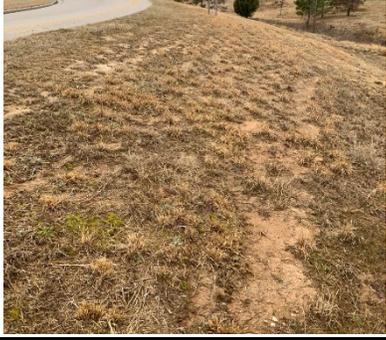
A26
3	Turf	TF_226	Bare Ground

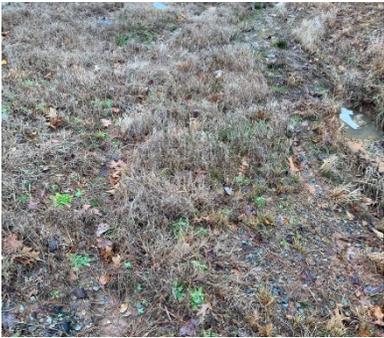
#	Material Type	Object ID	Failure Type	Photo	GIS Reference Page
5	Turf	TF_309	Bare Ground

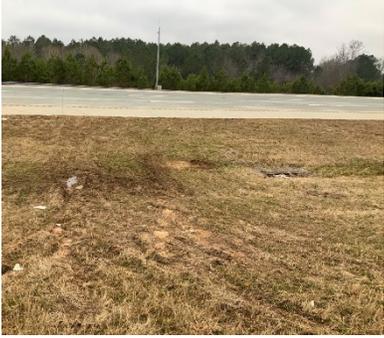
A29
6	Turf	TF_351	Bare Ground

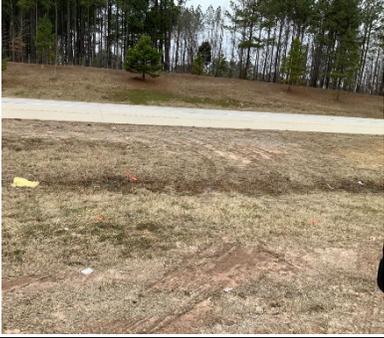
A26
7	Turf	TF_647	Bare Ground

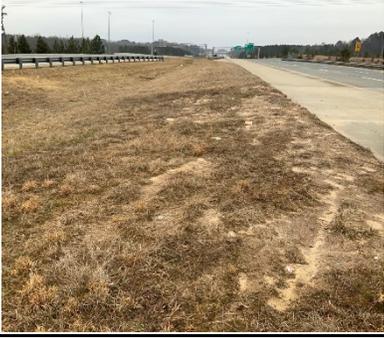
A8
8	Turf	TF_652	Bare Ground

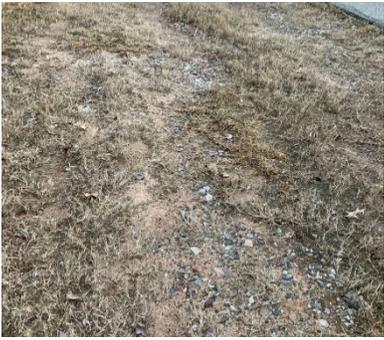
#	Material Type	Object ID	Failure Type	Photo	GIS Reference Page
9	Turf	TF_867	Bare Ground

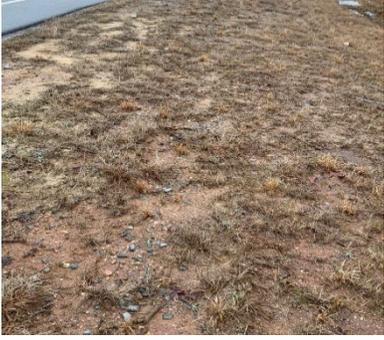
A35
10	Turf	TF_1027	Bare Ground

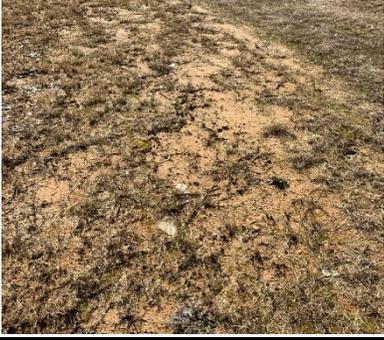
A29
11	Turf	TF_1041	Bare Ground

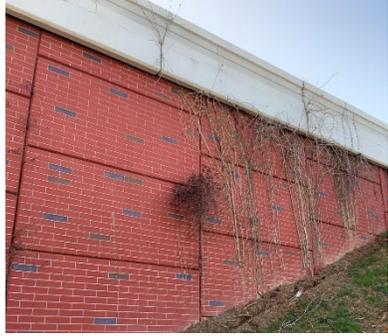
#	Material Type	Object ID	Failure Type	Photo	GIS Reference Page
1	Bridge Wall	WL_62	Vegetation
